21B1I Badger State Trail Stewart Tunnel Review of Alternatives

Wisconsin Department of Administration
Division of Facilities Development
Town of Exeter, Wisconsin

December 2, 2021
GEI Project No. 2102260

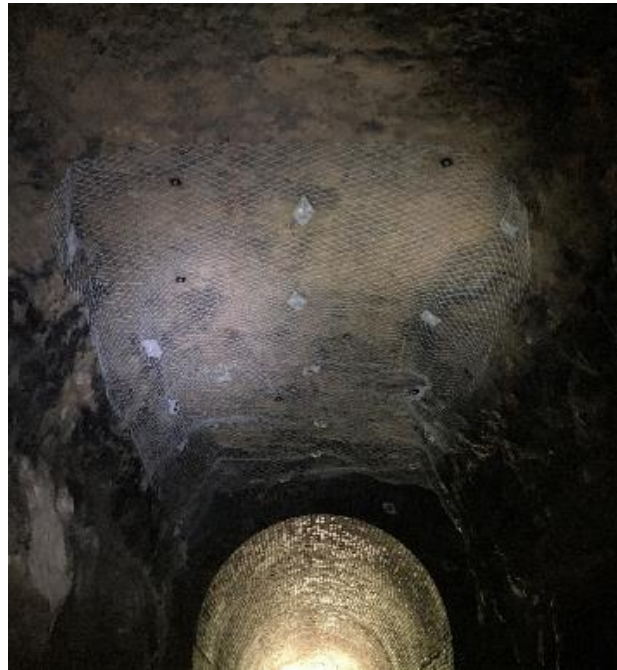
Figure 2 – Existing rock netting installed in 2017.

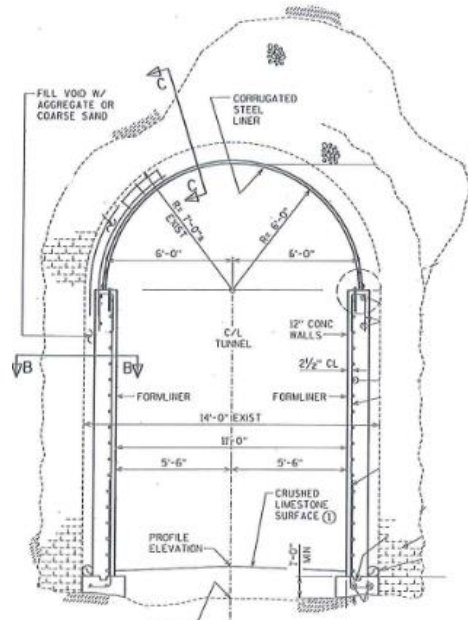
Figure 7 – Existing cast-in-place tunnel repair constructed in 2005.

Because this repair alternative has been performed previously and appears to remain in good condition approximately 16 years after construction, this is likely a viable solution that has proven to work. This alternative would cover the existing tunnel walls and ceiling.

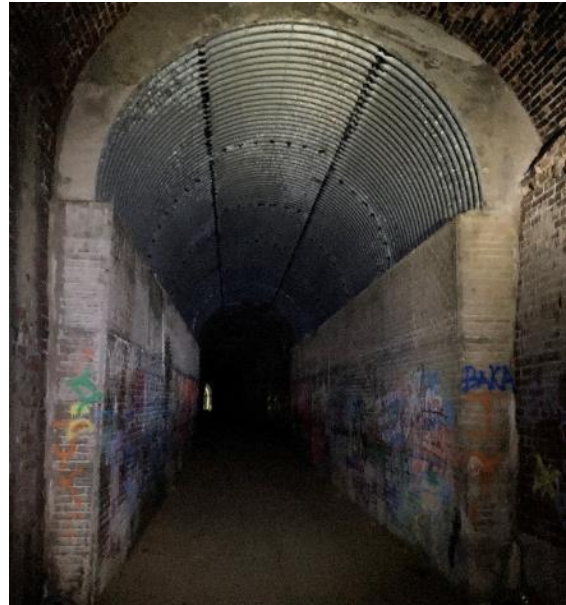
Figure 8 – Existing cast-in-place tunnel repair constructed in 2005.

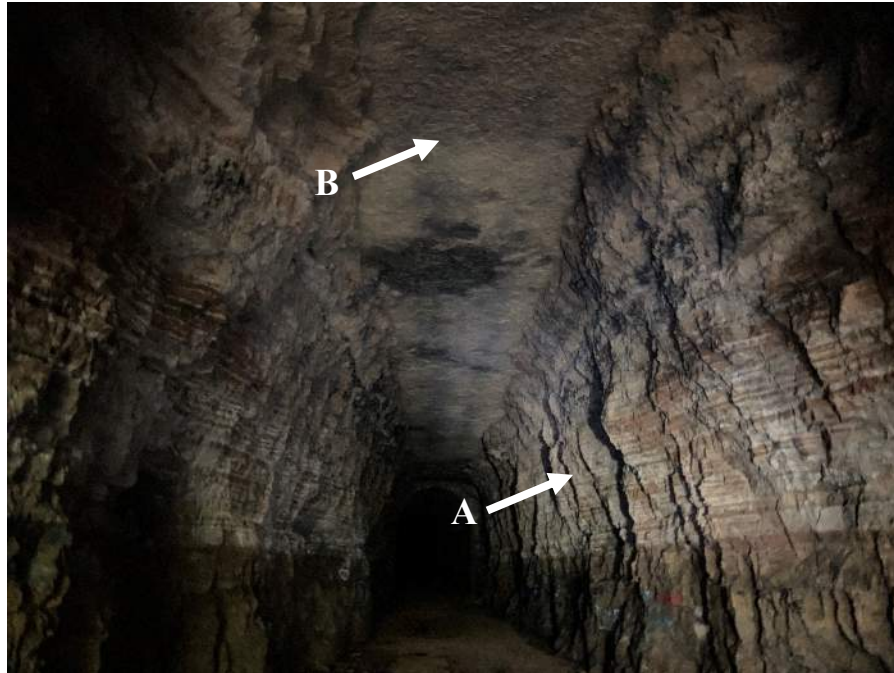
Photo No. 1 – Horizontal limestone rock bedding planes in the walls (A) and ceiling (B).

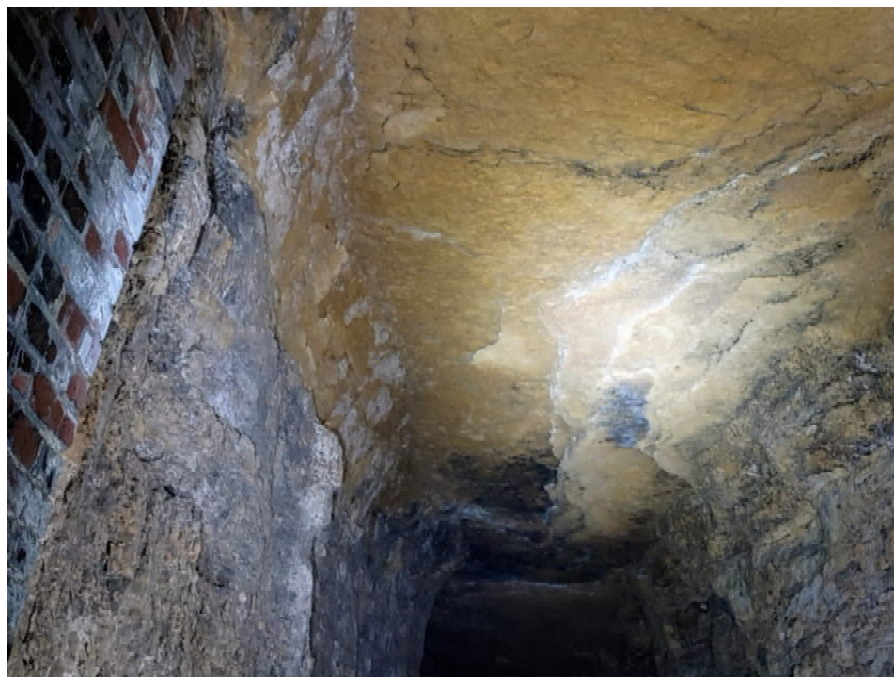
Photo No. 2 – Typical rock spalling at tunnel ceiling.

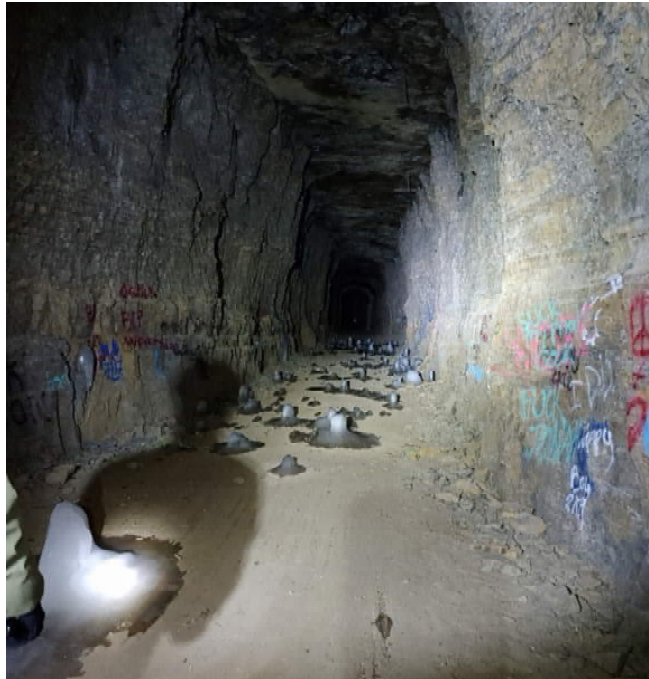
During the February site visit, ice buildup was observed on portions of the tunnel ceilings, walls, and floors (Photo 3). Ice had also formed at some of the wall drains within the brick-lined portion of the tunnel (Photo 4).

Photo No. 3 – Ice buildup on the tunnel floor from leakage through the ceiling. Note rock debris on floor along walls.

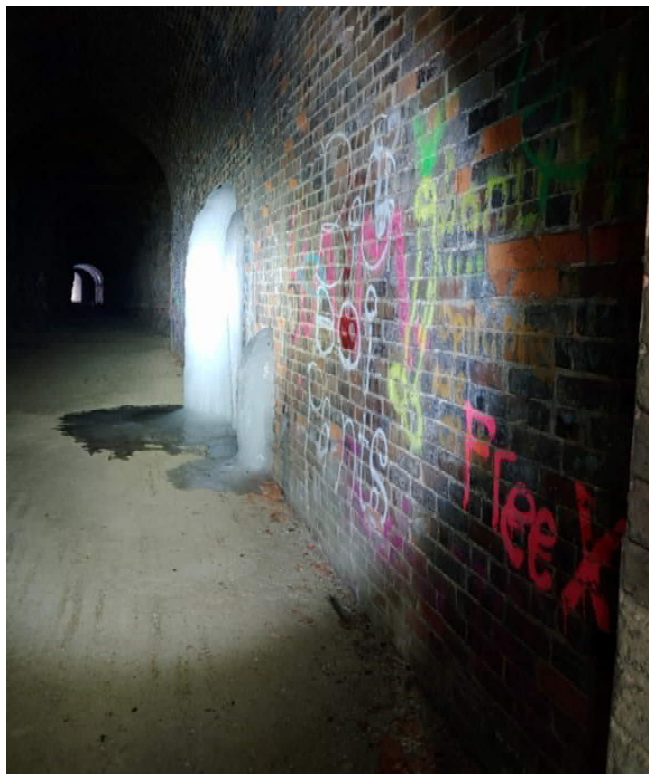
Photo No. 4 – Ice buildup from drain in brick-lined portion of tunnel wall.

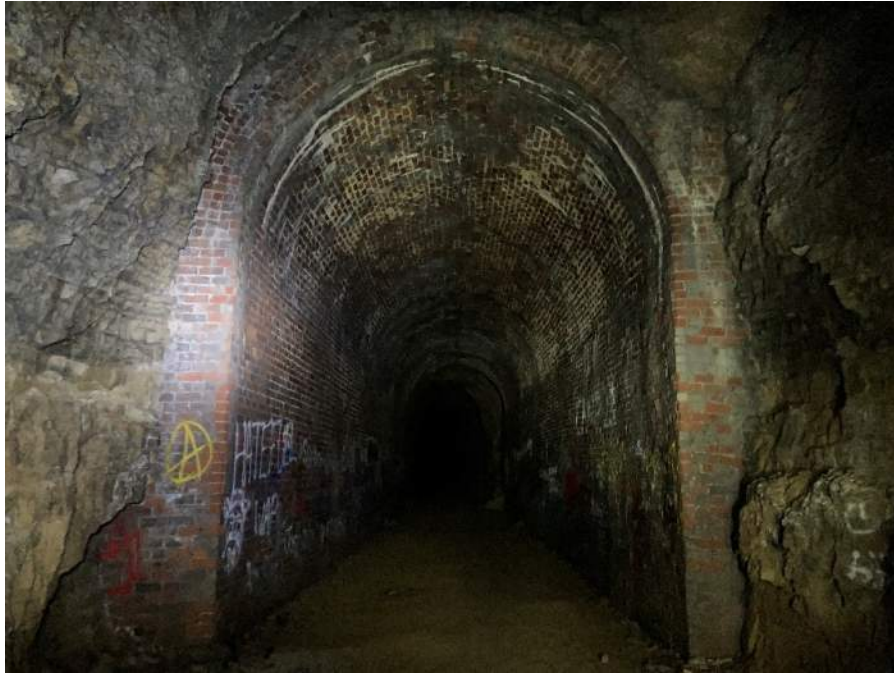
The walls of the sections of the tunnel previously repaired using bricks generally appeared to be in good condition with only minor surface deterioration observed (Photo 5). However, the ceiling portion of the brick sections were observed to be deteriorating in some locations including portions that showed signs of delamination (Photo 6).

Photo No. 5 – Existing brick-lined portion of tunnel.

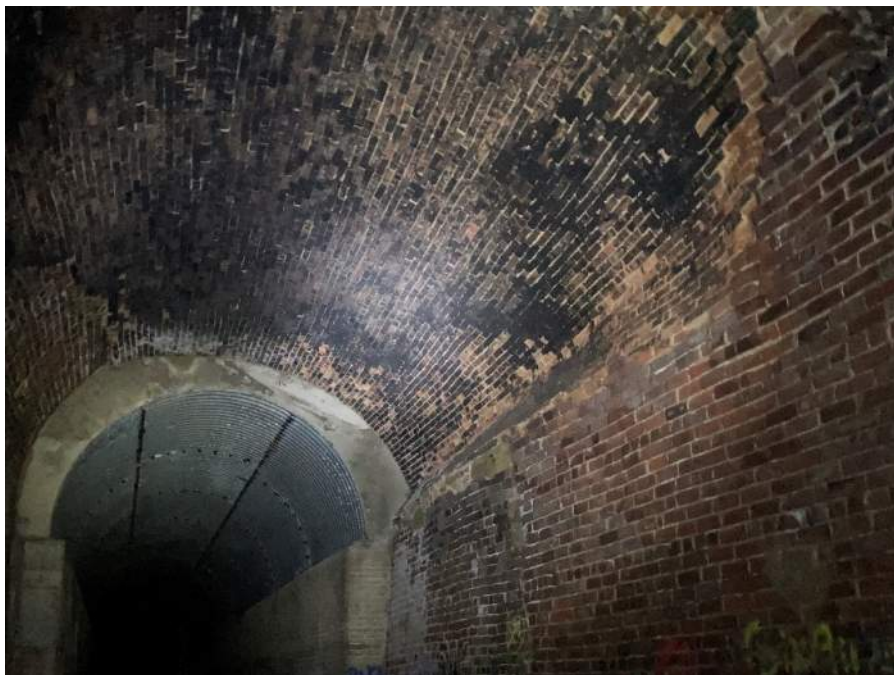
Photo No. 6 – Deteriorated ceiling at brick-lined section tunnel.

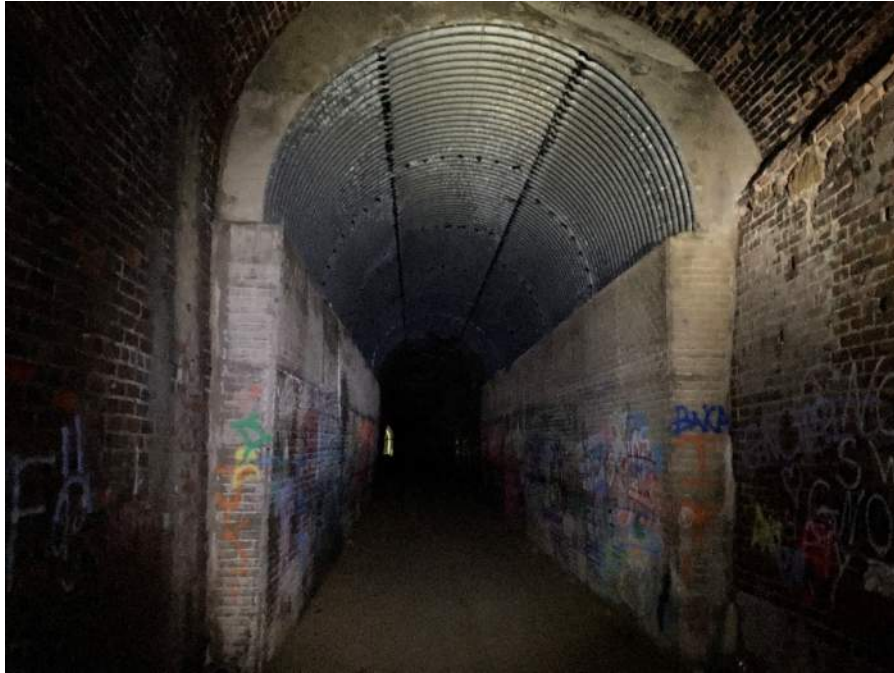
The concrete-lined portions of the tunnel (repaired in 2005) appeared to be in good condition (Photo 7). The concrete walls did not show significant signs of deterioration and the corrugated metal pipe arch forming the ceiling appeared to be in good condition.

Photo No. 7 – Existing cast-in-place concrete lining repair.

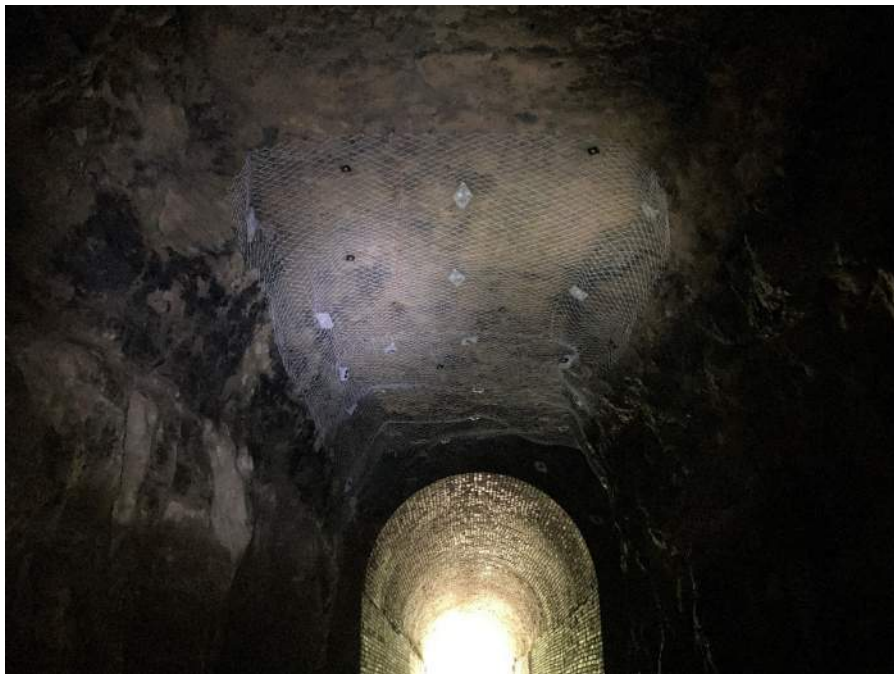
Photo No. 8 – Existing rock netting repairs.

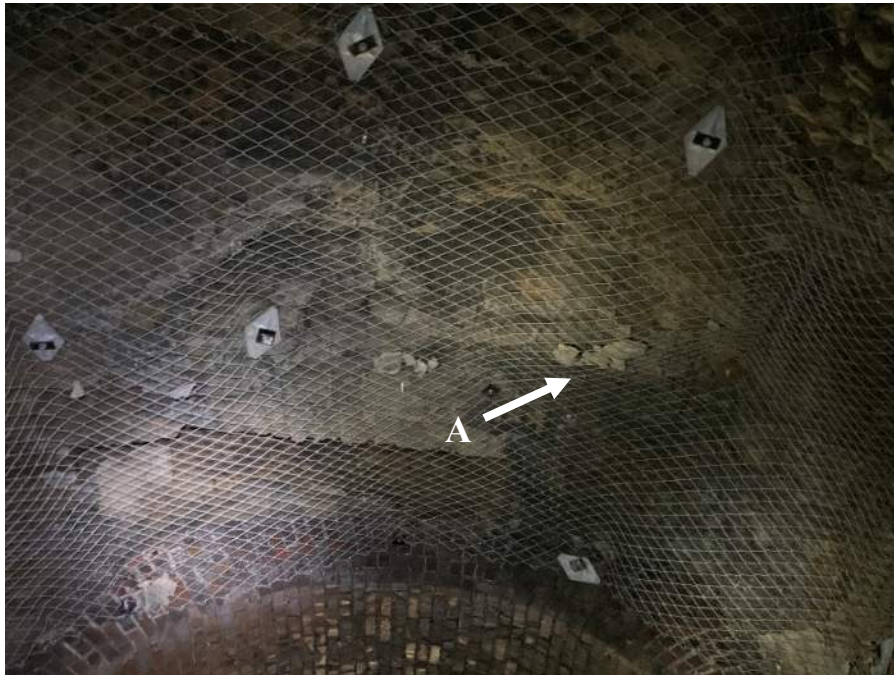
The rock netting, installed in a 30-foot section of the tunnel in 2017, was observed to be in good condition (Photo 8). The netting appeared to remain tight to the tunnel ceiling and was retaining some rock which had likely spalled since the installation of the netting (Photo 9).

Photo No. 9 – Existing rock netting repairs. Fallen rock captured by netting (A).

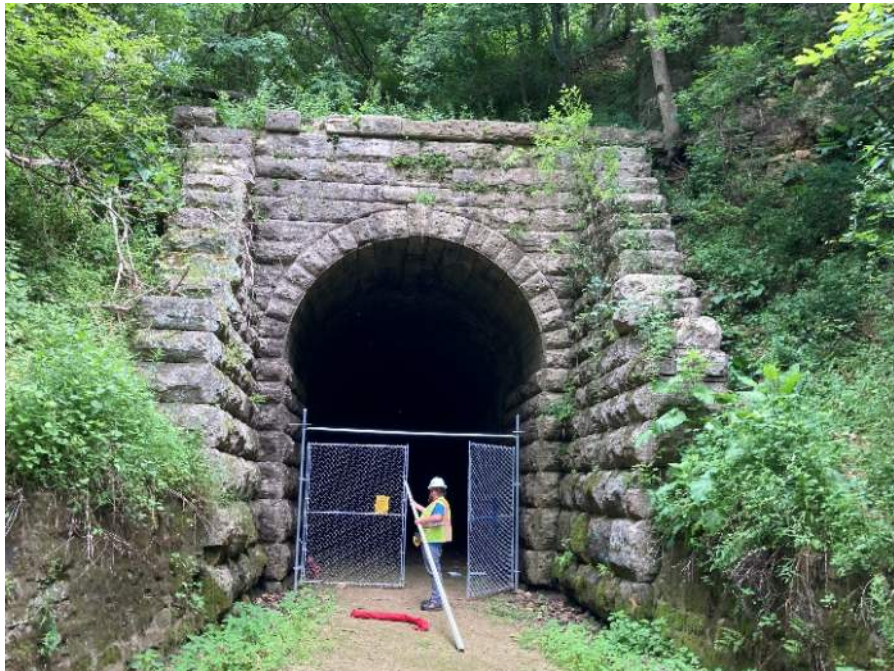
Photo No. 10 – South tunnel portal.

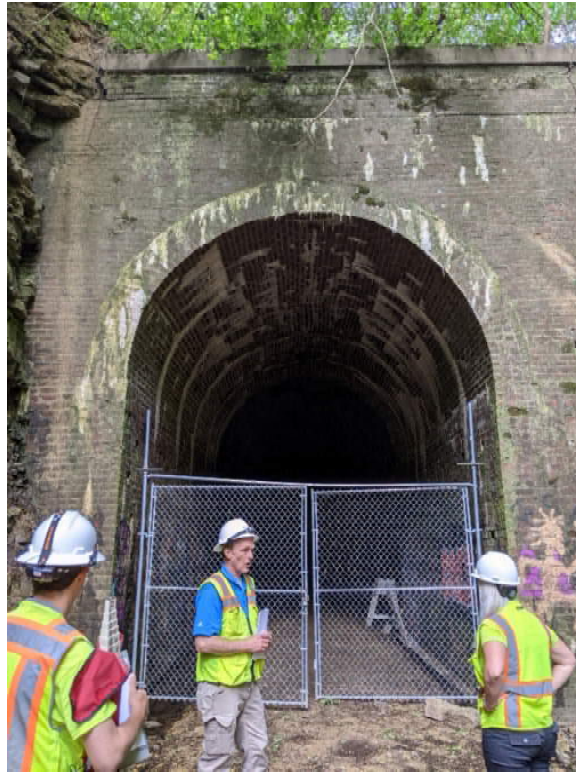
Both facades at the north (stacked sandstone blocks) and south (brick) tunnel portals generally appear to be in good structural condition although some surficial deterioration and woody vegetation growth was observed (Photos 10 and 11).

Photo No. 11 – North tunnel portal.

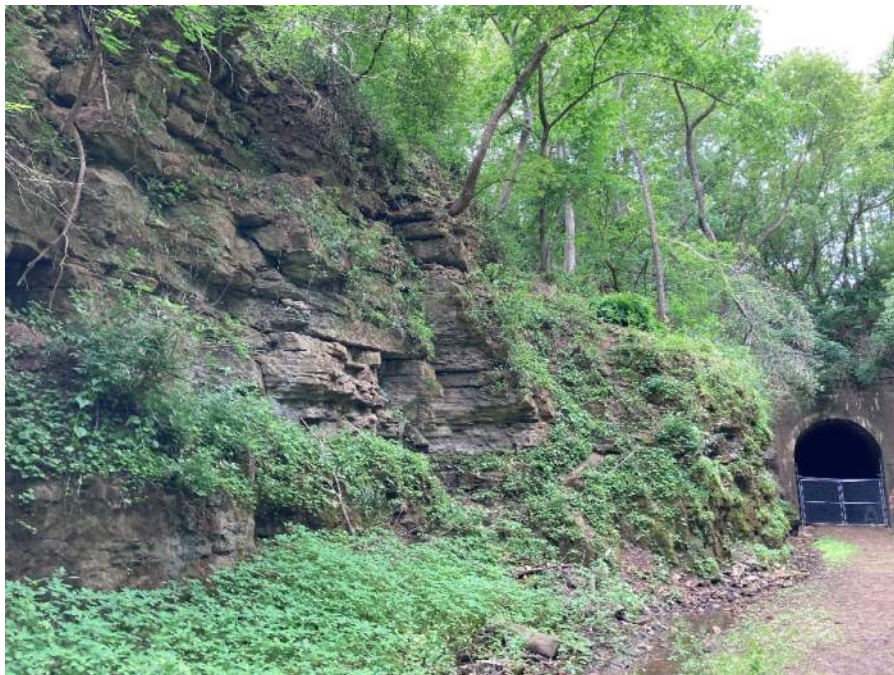
Photo No. 12 – Steep slopes, loose rock, and woody vegetation at south tunnel portal.

Note that the scaling of loose rock within the tunnel and at the tunnel portals is recommended for all alternatives which involve keeping the tunnel open for recreational use (Alternatives 1, 2, 3, 4, and 5). Based on our observations, we assumed a total of approximately 200 total feet along the trail beyond the north and south tunnel portals require scaling of loose / unstable weathered rock. Removal of loose rock within the tunnel would also be necessary prior to construction to reduce the risk of injury to workers during construction. Based on our visual inspection, we estimated that approximately 30% of the tunnel ceiling and wall surface area would require scaling of loose rock. The removal of loose rock was included in the opinions of probable cost for the repair alternatives listed above.

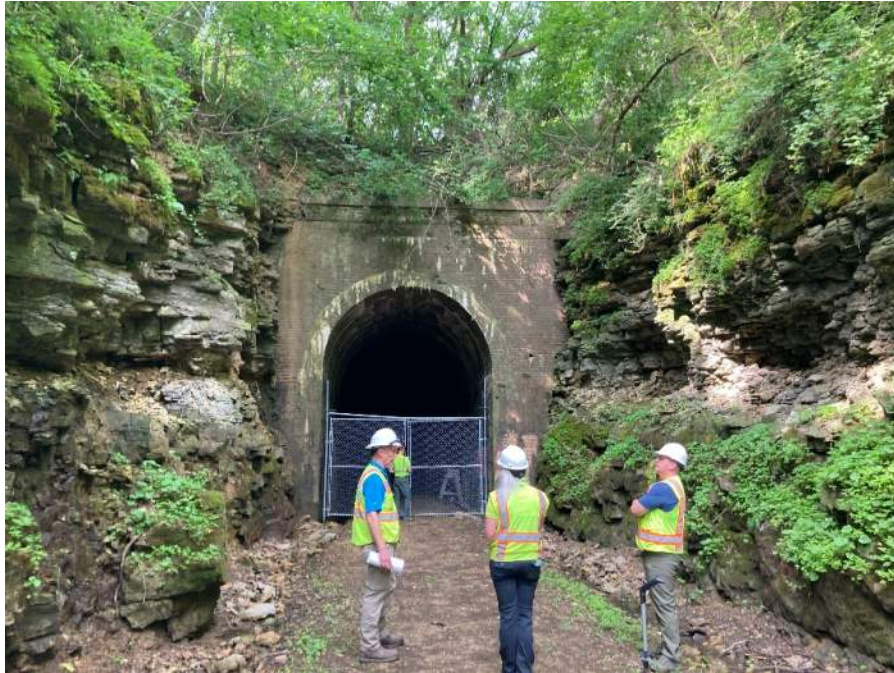
The excavated rock faces to the left and right of the trail approaches at the north and south tunnel portals were observed to be heavily weathered with steep slopes (Photos 12 and 13). At the north tunnel portal particularly, the excavated rock faces appeared to have significant amounts of loose rock and near vertical faces. The rock faces at both tunnel portals were overgrown with trees and brush.

Photo No. 13 – Steep slopes, loose rock, and woody vegetation at north tunnel portal.

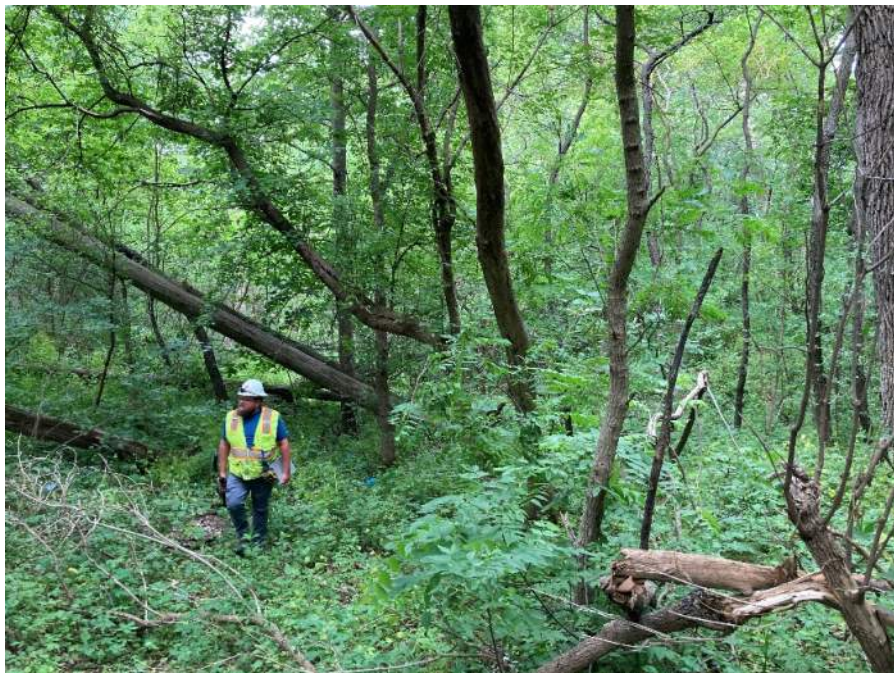
Photo No. 14 – Wooded area above the northern portion of the tunnel.

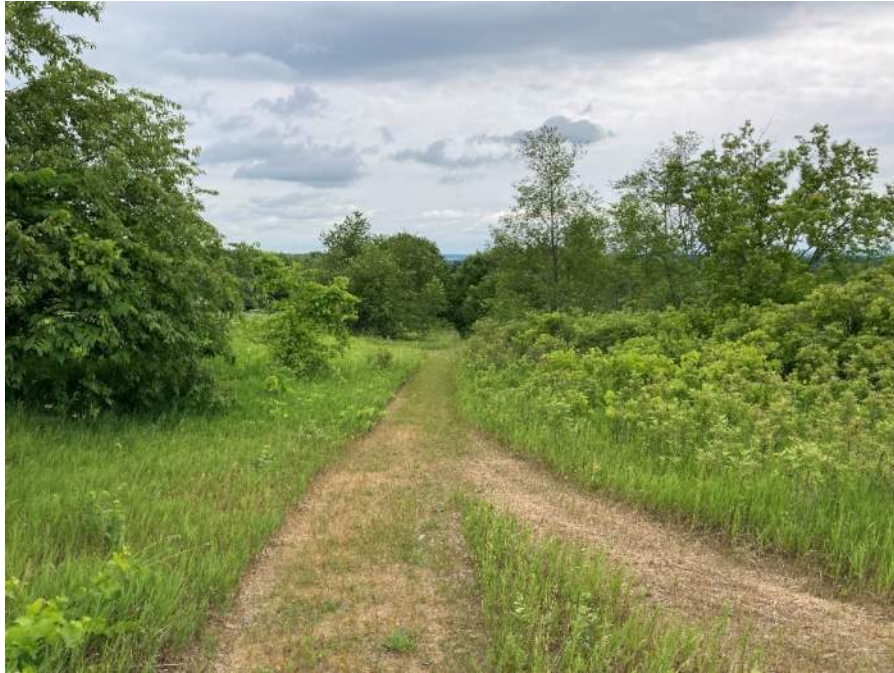
Photo No. 15 – Trail and grassy/lightly wooded area above the center portion of the tunnel.

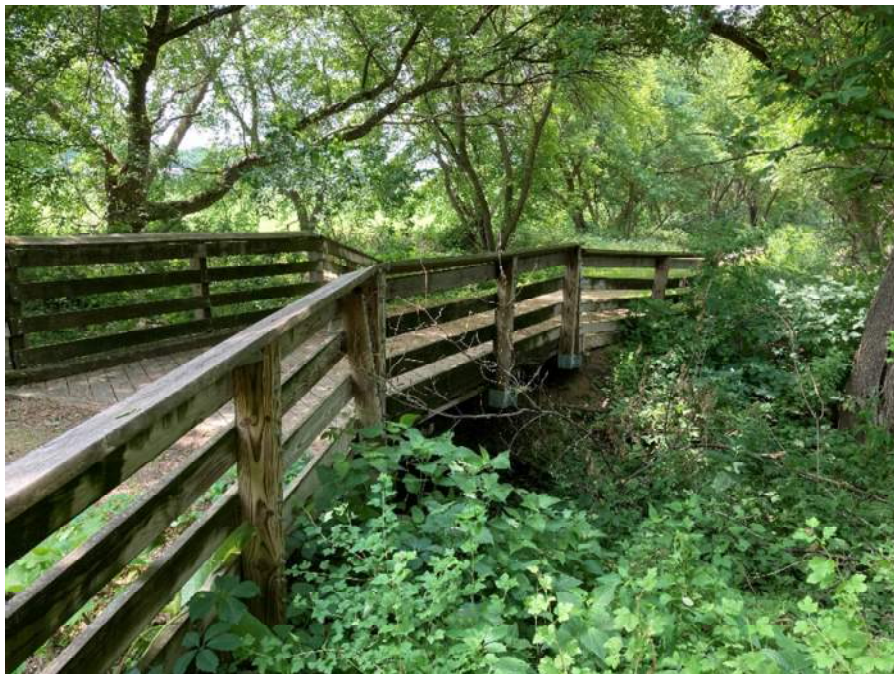
Photo No. 16 – Existing trail bridge at the approach to the northern tunnel portal.

Removal and replacement of the existing wooden bridge between the north portal and Tunnel Road is also recommended if this portion of the trail were to be used as a construction access route. The existing wooden bridge (Photos 16 and 17) is too narrow and is unlikely to have the capacity to safely support construction traffic. A wider, more substantial temporary bridge or permanent culvert is recommended to accommodate construction equipment for all alternatives. Replacement of the existing bridge with a culvert and fill is included in the respective opinions of probable cost.

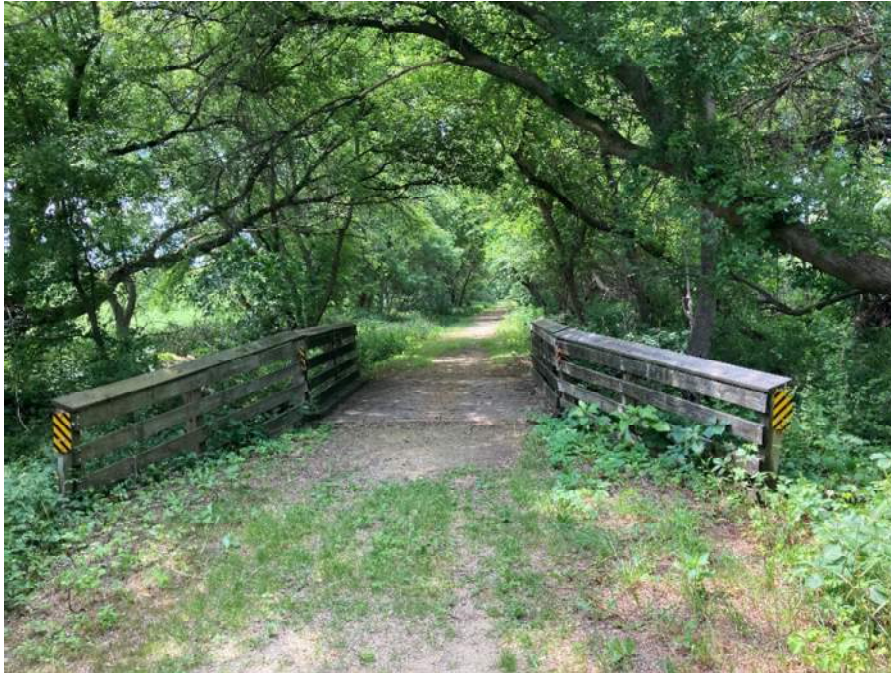
Photo No. 17 – Existing trail bridge at the approach to the northern tunnel portal.
