## Memorandum

RE: Lower Fox River OU3 *COMMP* Hydrographic Survey – Year Zero

This memorandum presents the methods utilized and the results of the Year Zero hydrographic survey for OU3.

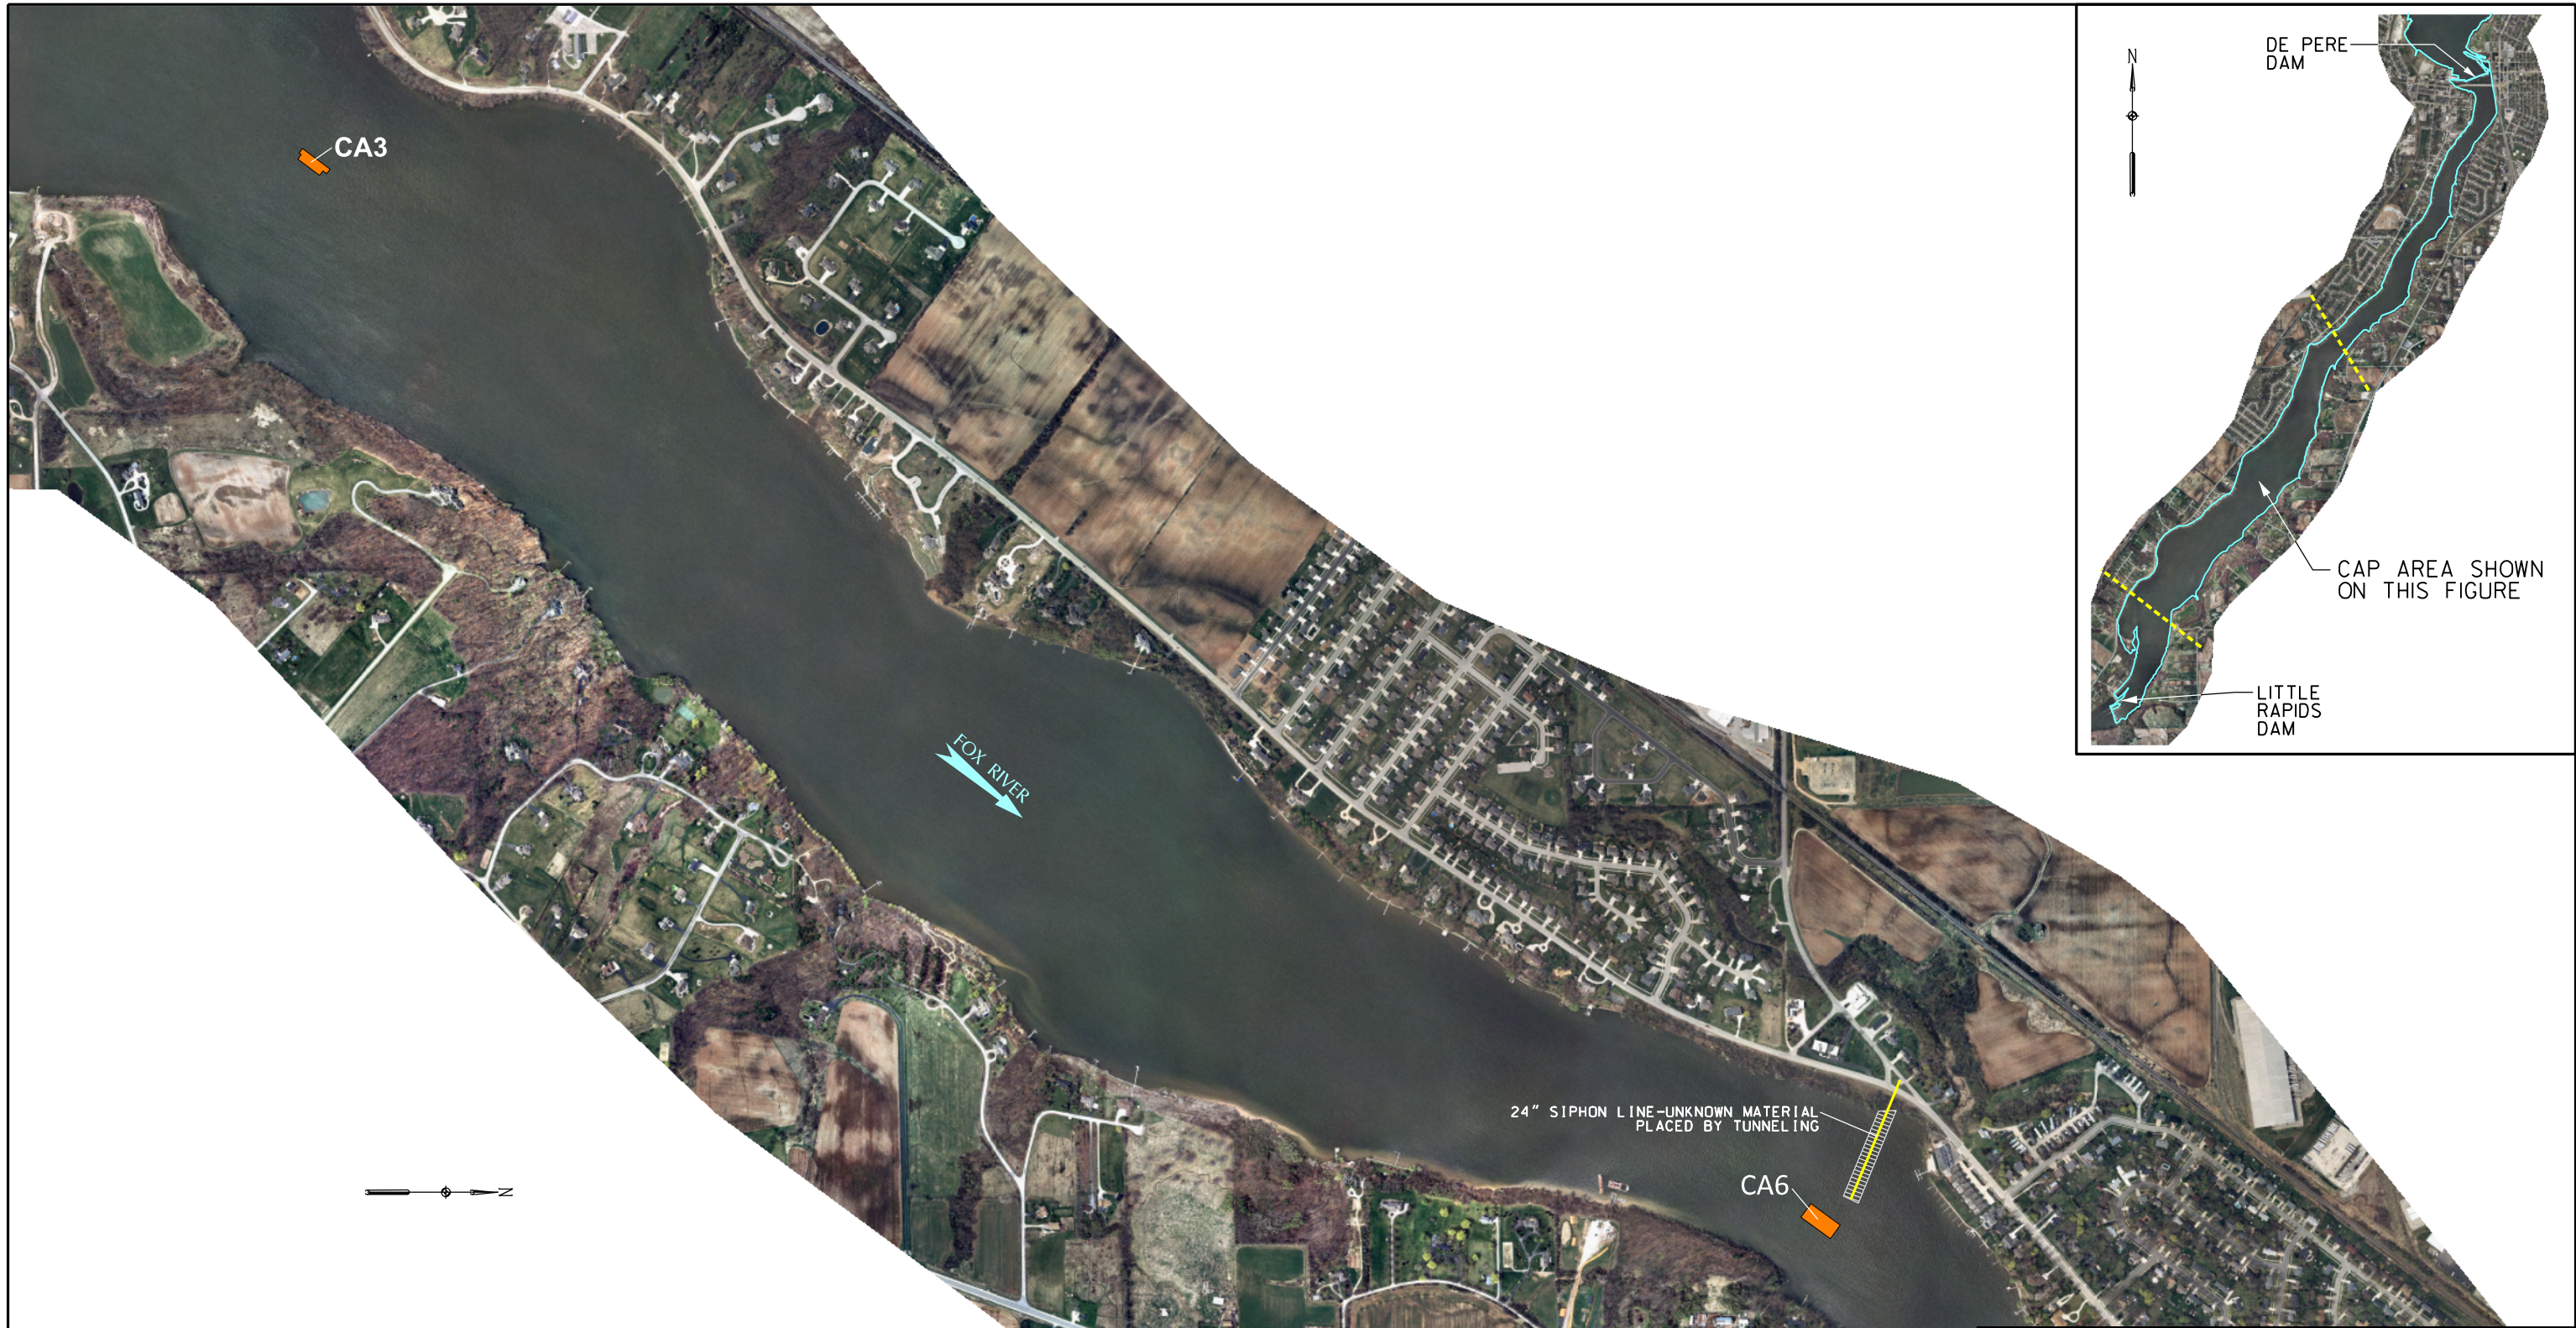
**FIGURE 1**  
**LOWER FOX RIVER - OU3**  
**CAP PLACEMENT LOCATIONS**

**CA6** DESIGN CAP PLACEMENT LOCATION AND IDENTIFICATION

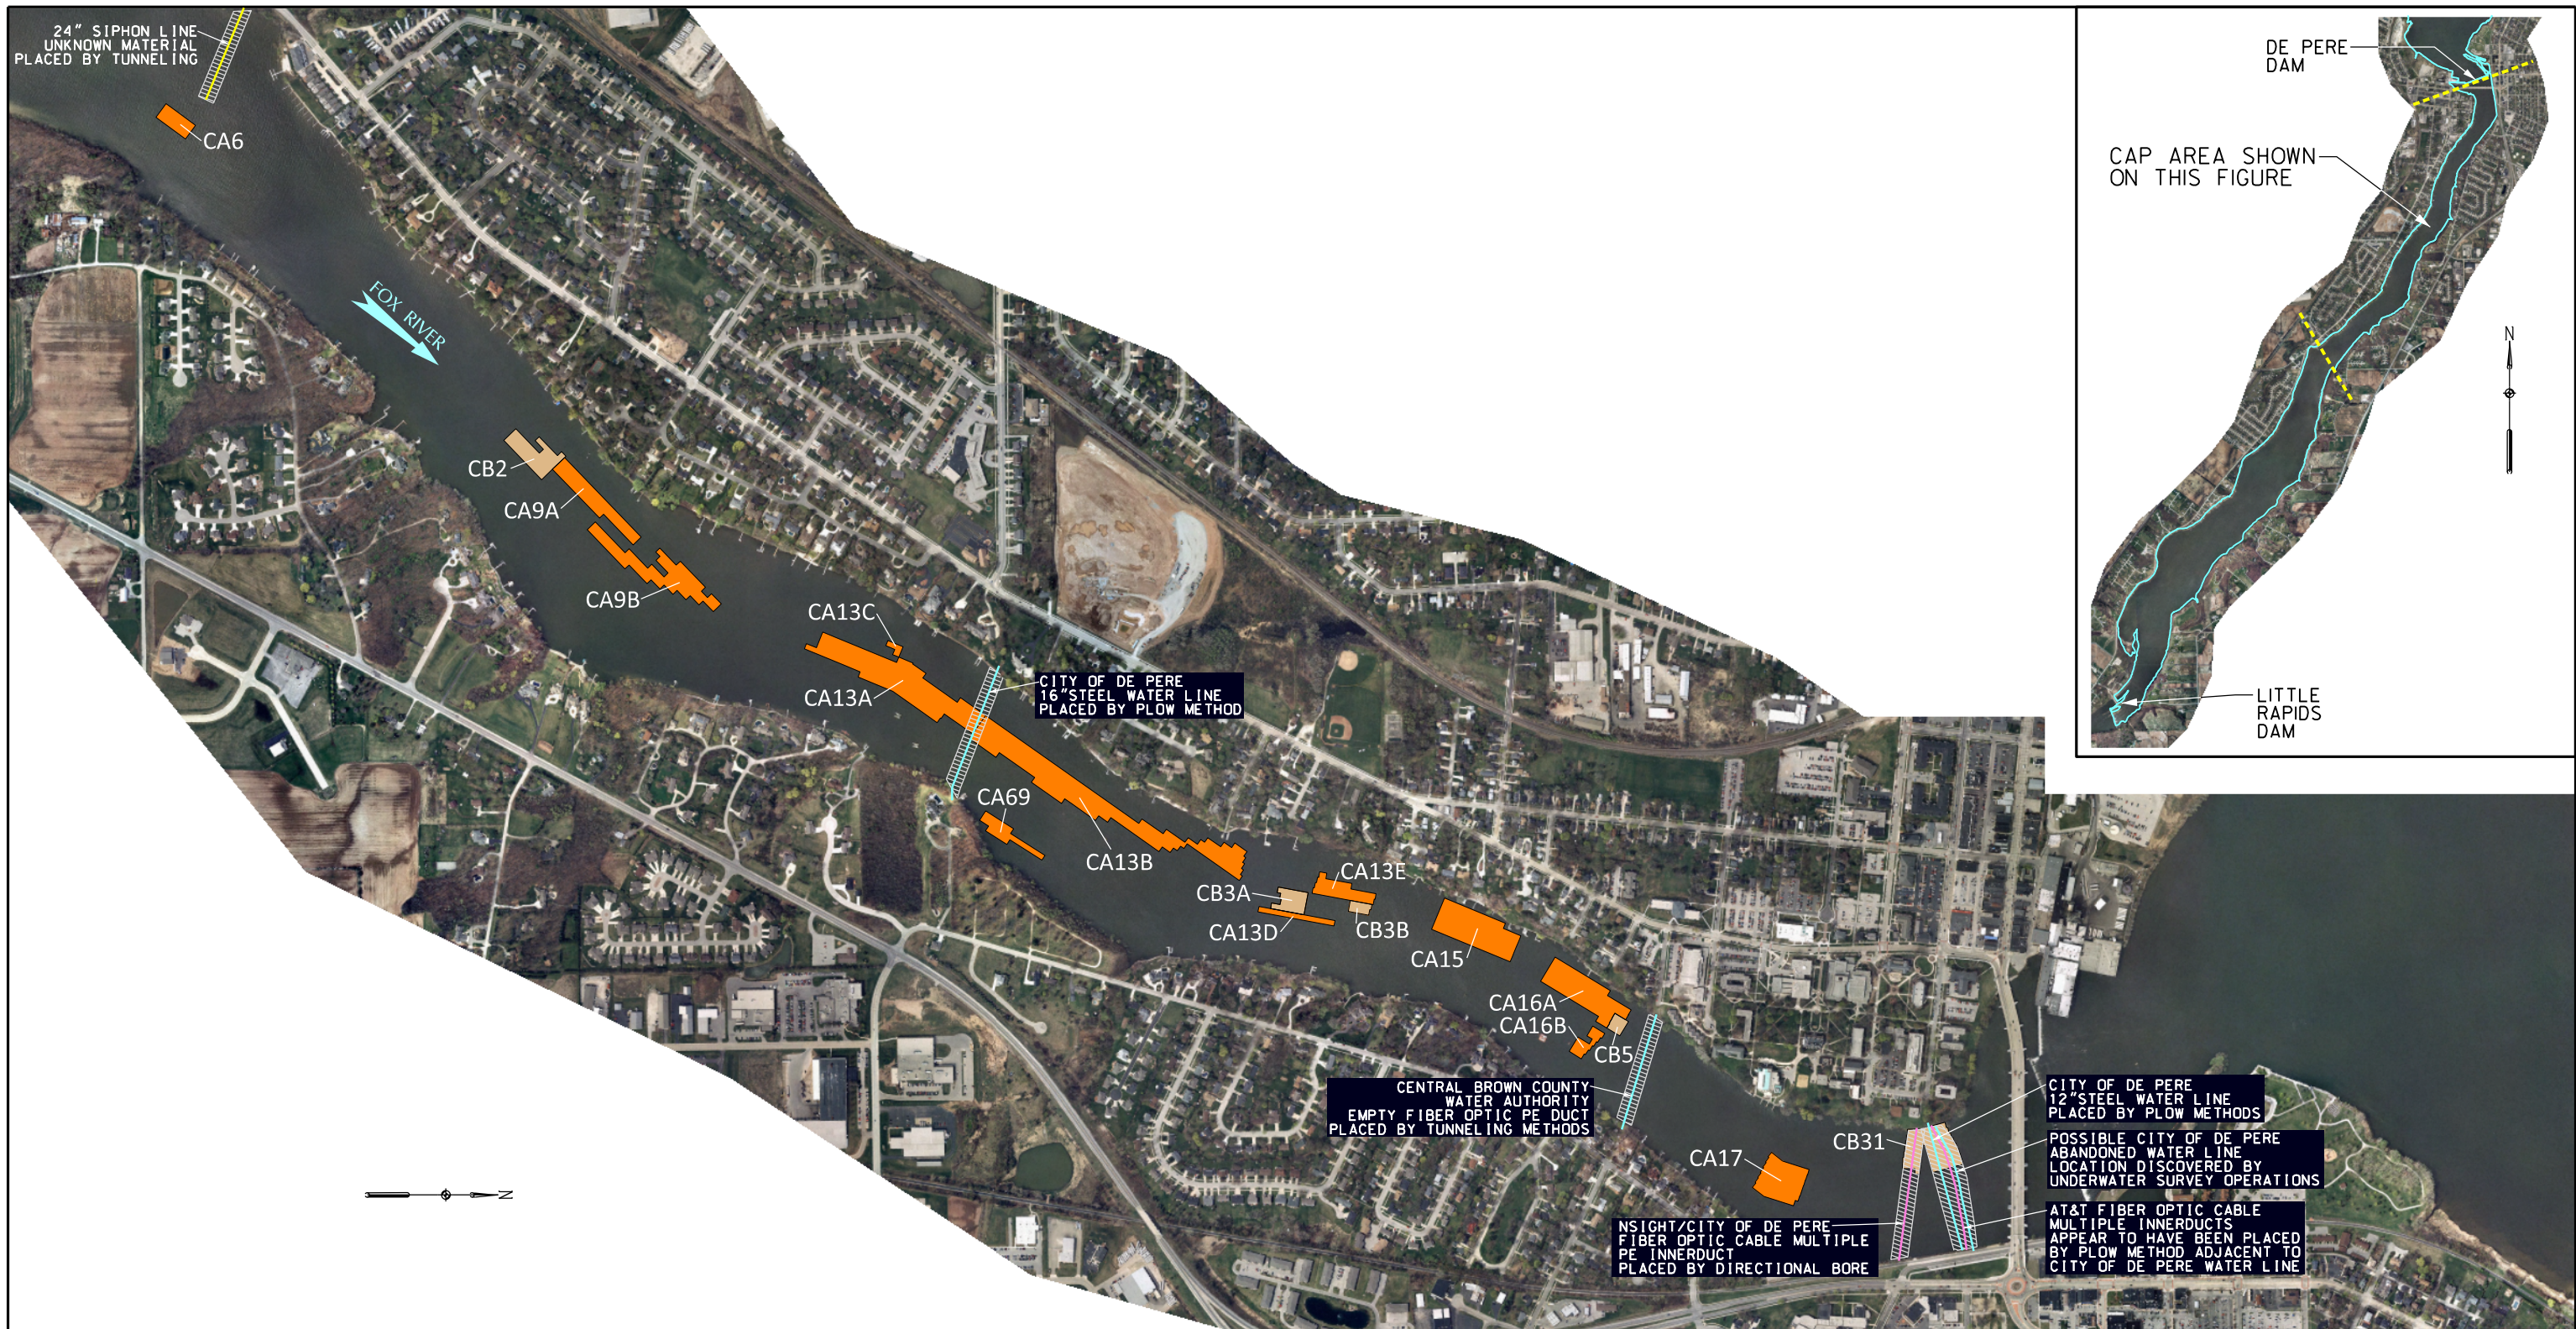
**FIGURE 2**  
**LOWER FOX RIVER - OU3**  
**CAP PLACEMENT LOCATIONS**

- CA15 "A" CAP DESIGN PLACEMENT LOCATION AND IDENTIFICATION
- CB31 "B" CAP DESIGN PLACEMENT LOCATION AND IDENTIFICATION

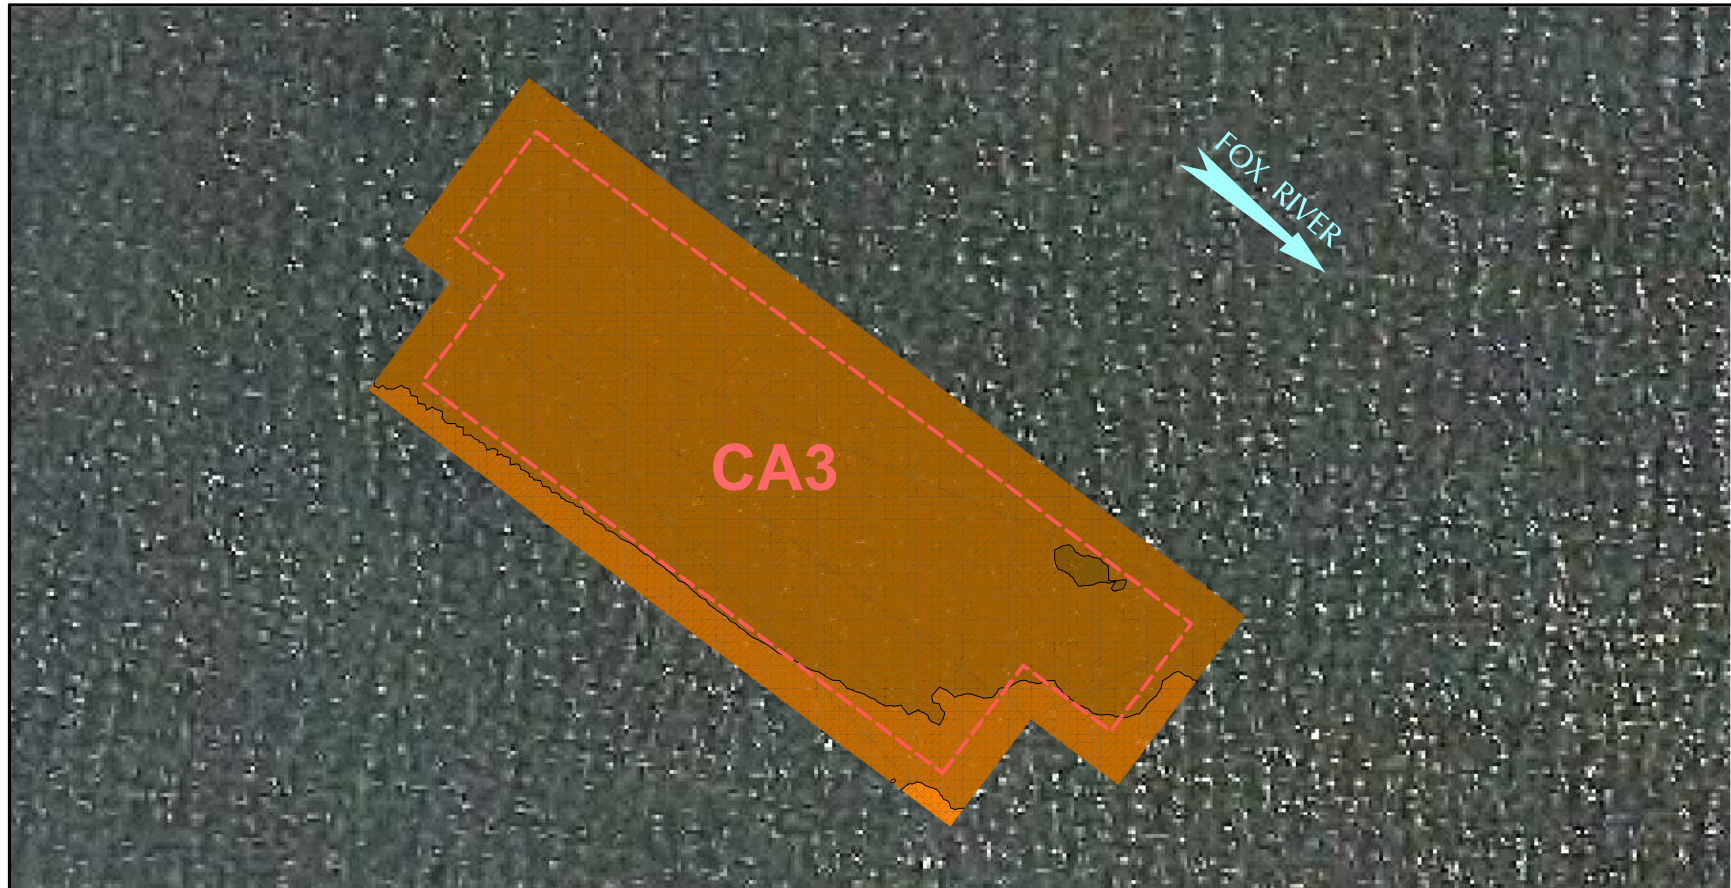
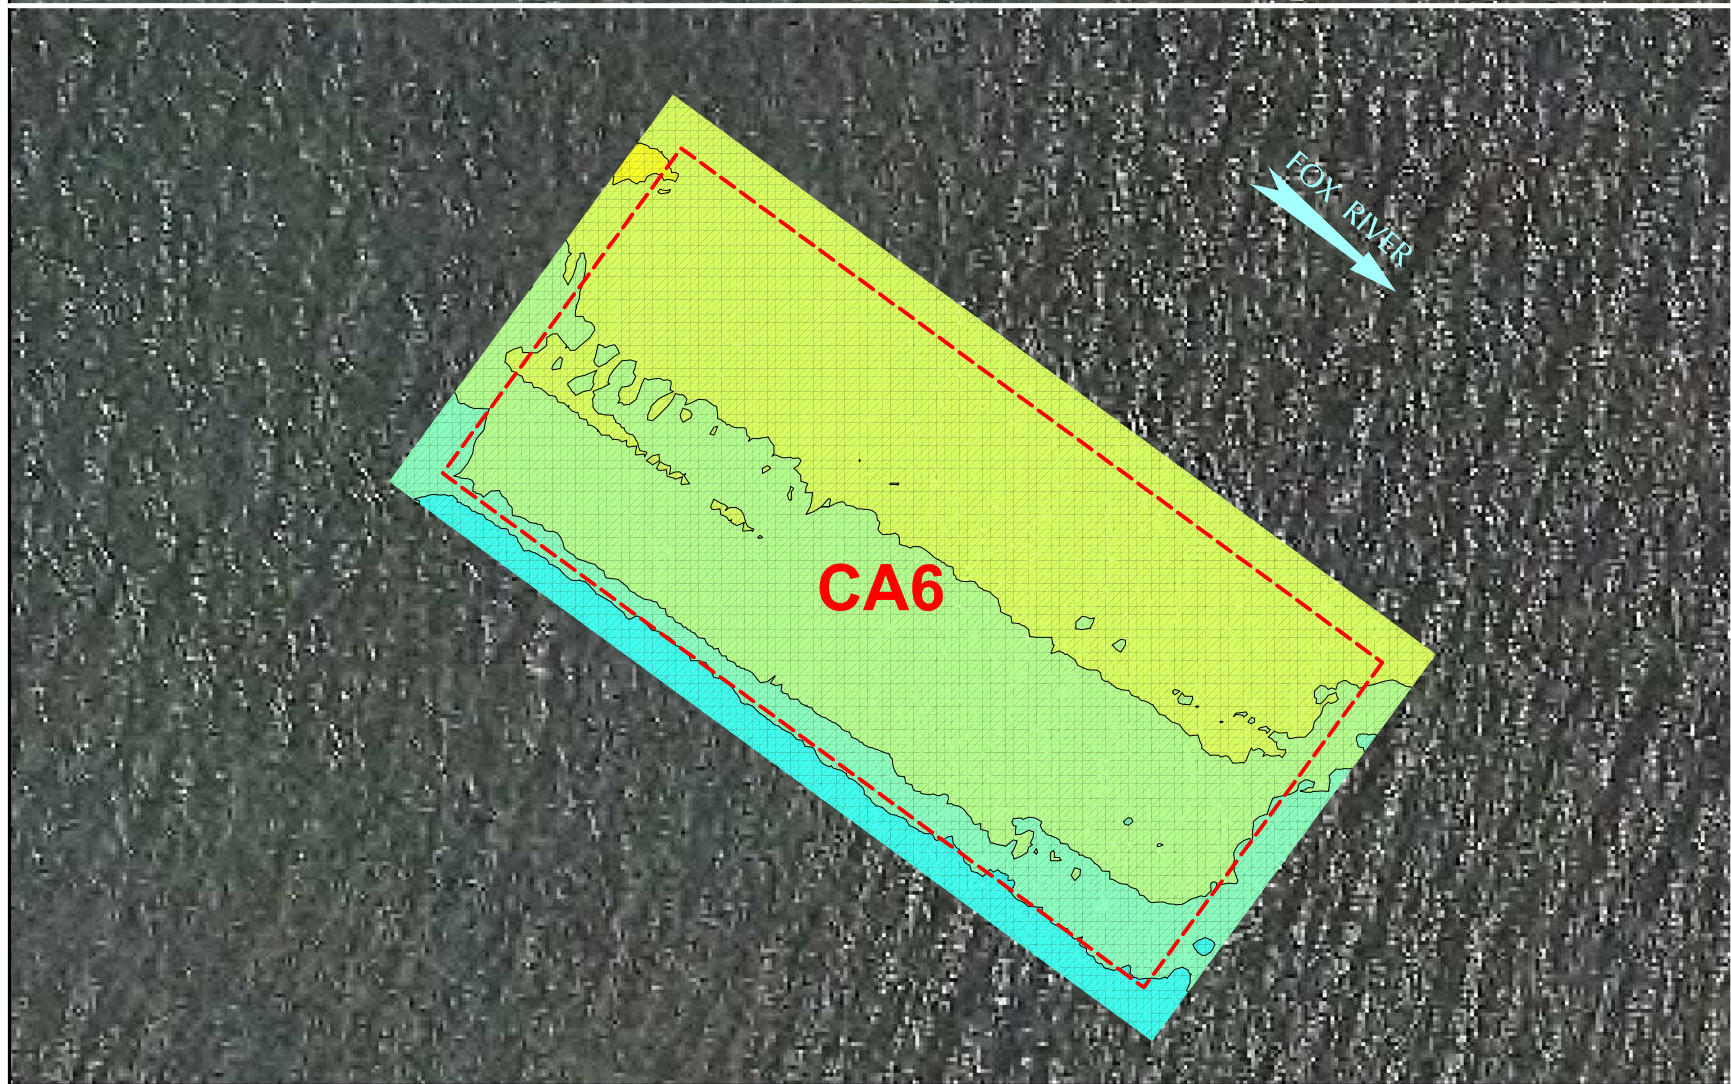
**FIGURE 3A**  
 LOWER FOX RIVER - OU3  
 TOP OF CAP ELEVATIONS

**COLOR ELEVATION CHART**  
 COLOR CONTOURS SHOWN REPRESENT NOVEMBER 2011 TOP OF ENGINEERED CAP ELEVATIONS

- NOTES:**
- 200 KILOHERTZ (kHz) MULTI-BEAM HYDROGRAPHIC SURVEY PERFORMED BY J.F. BRENNAN, CO. DATES OF SURVEYS: NOVEMBER 2 & 3, 2011.
  - THE HORIZONTAL CONTROL IS REFERENCED TO THE NAD83 WISCONSIN STATE PLANE COORDINATE SYSTEM (WISCONSIN CENTRAL ZONE). THE VERTICAL CONTROL IS REFERENCED TO NAVD 88.
  - ORTHO PHOTO SUPPLIED BY BROWN COUNTY L.I.O. COMPILED IN NOVEMBER 2010.
  - DESIGN CAP PLACEMENT LIMITS DERIVED FROM DESIGN FILES PROVIDED BY TETRA TECH EC, INC.

Upon completion of the hydrographic surveys, the data were processed and top of cap contours were created. For each cap in OU3 (excluding CA 69), Foth produced two figures to show top of cap elevations (Figures 3A and 3B through 14A and 14B). The first figure, in each series of two, shows the post construction top of cap elevation in a two dimensional plan view. This figure also shows the designed cap-placement limits. The second figure in the series shows a three dimensional (3-D) isometric view, which better depicts potential minor surface irregularities as compared to the two dimensional views. The results of these multi-beam surveys will be used as the baseline information for future monitoring events.

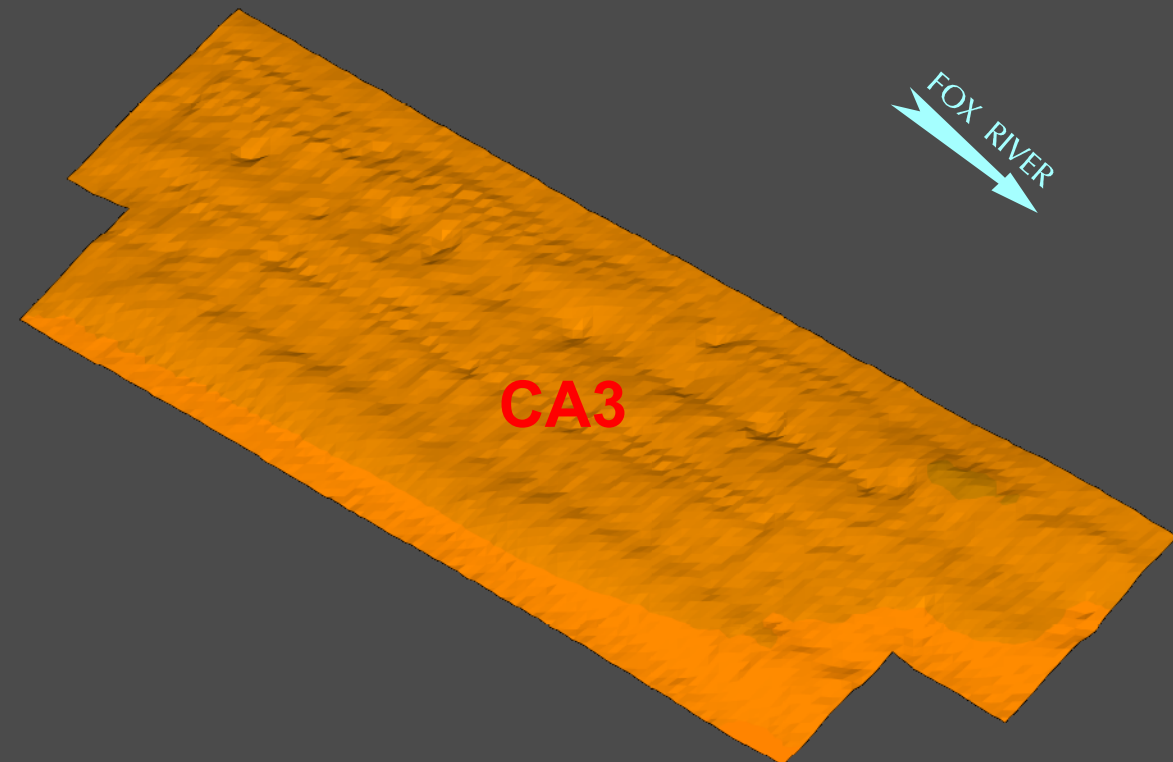
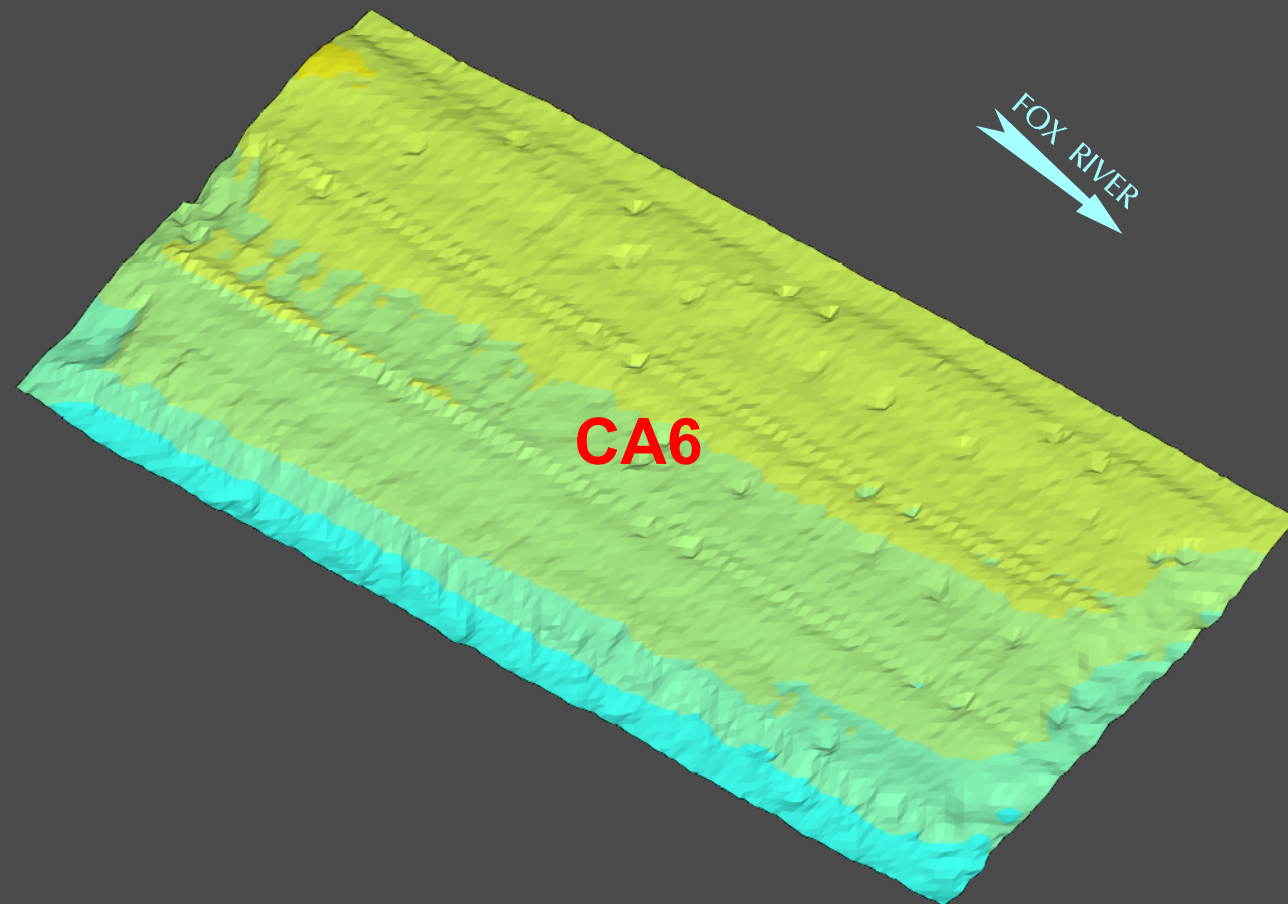
**FIGURE 3B**  
 LOWER FOX RIVER - OU3  
 TOP OF CAP ELEVATIONS  
 ISOMETRIC VIEW

**COLOR ELEVATION CHART**  
 COLOR CONTOURS SHOWN REPRESENT NOVEMBER  
 2011 TOP OF ENGINEERED CAP ELEVATIONS

- 200 KILOHERTZ (kHz) MULTI-BEAM HYDROGRAPHIC SURVEY PERFORMED BY J.F. BRENNAN, CO. DATES OF SURVEYS: NOVEMBER 2 & 3, 2011.
- THE HORIZONTAL CONTROL IS REFERENCED TO THE NAD83 WISCONSIN STATE PLANE COORDINATE SYSTEM (WISCONSIN CENTRAL ZONE). THE VERTICAL CONTROL IS REFERENCED TO NAVD 88.

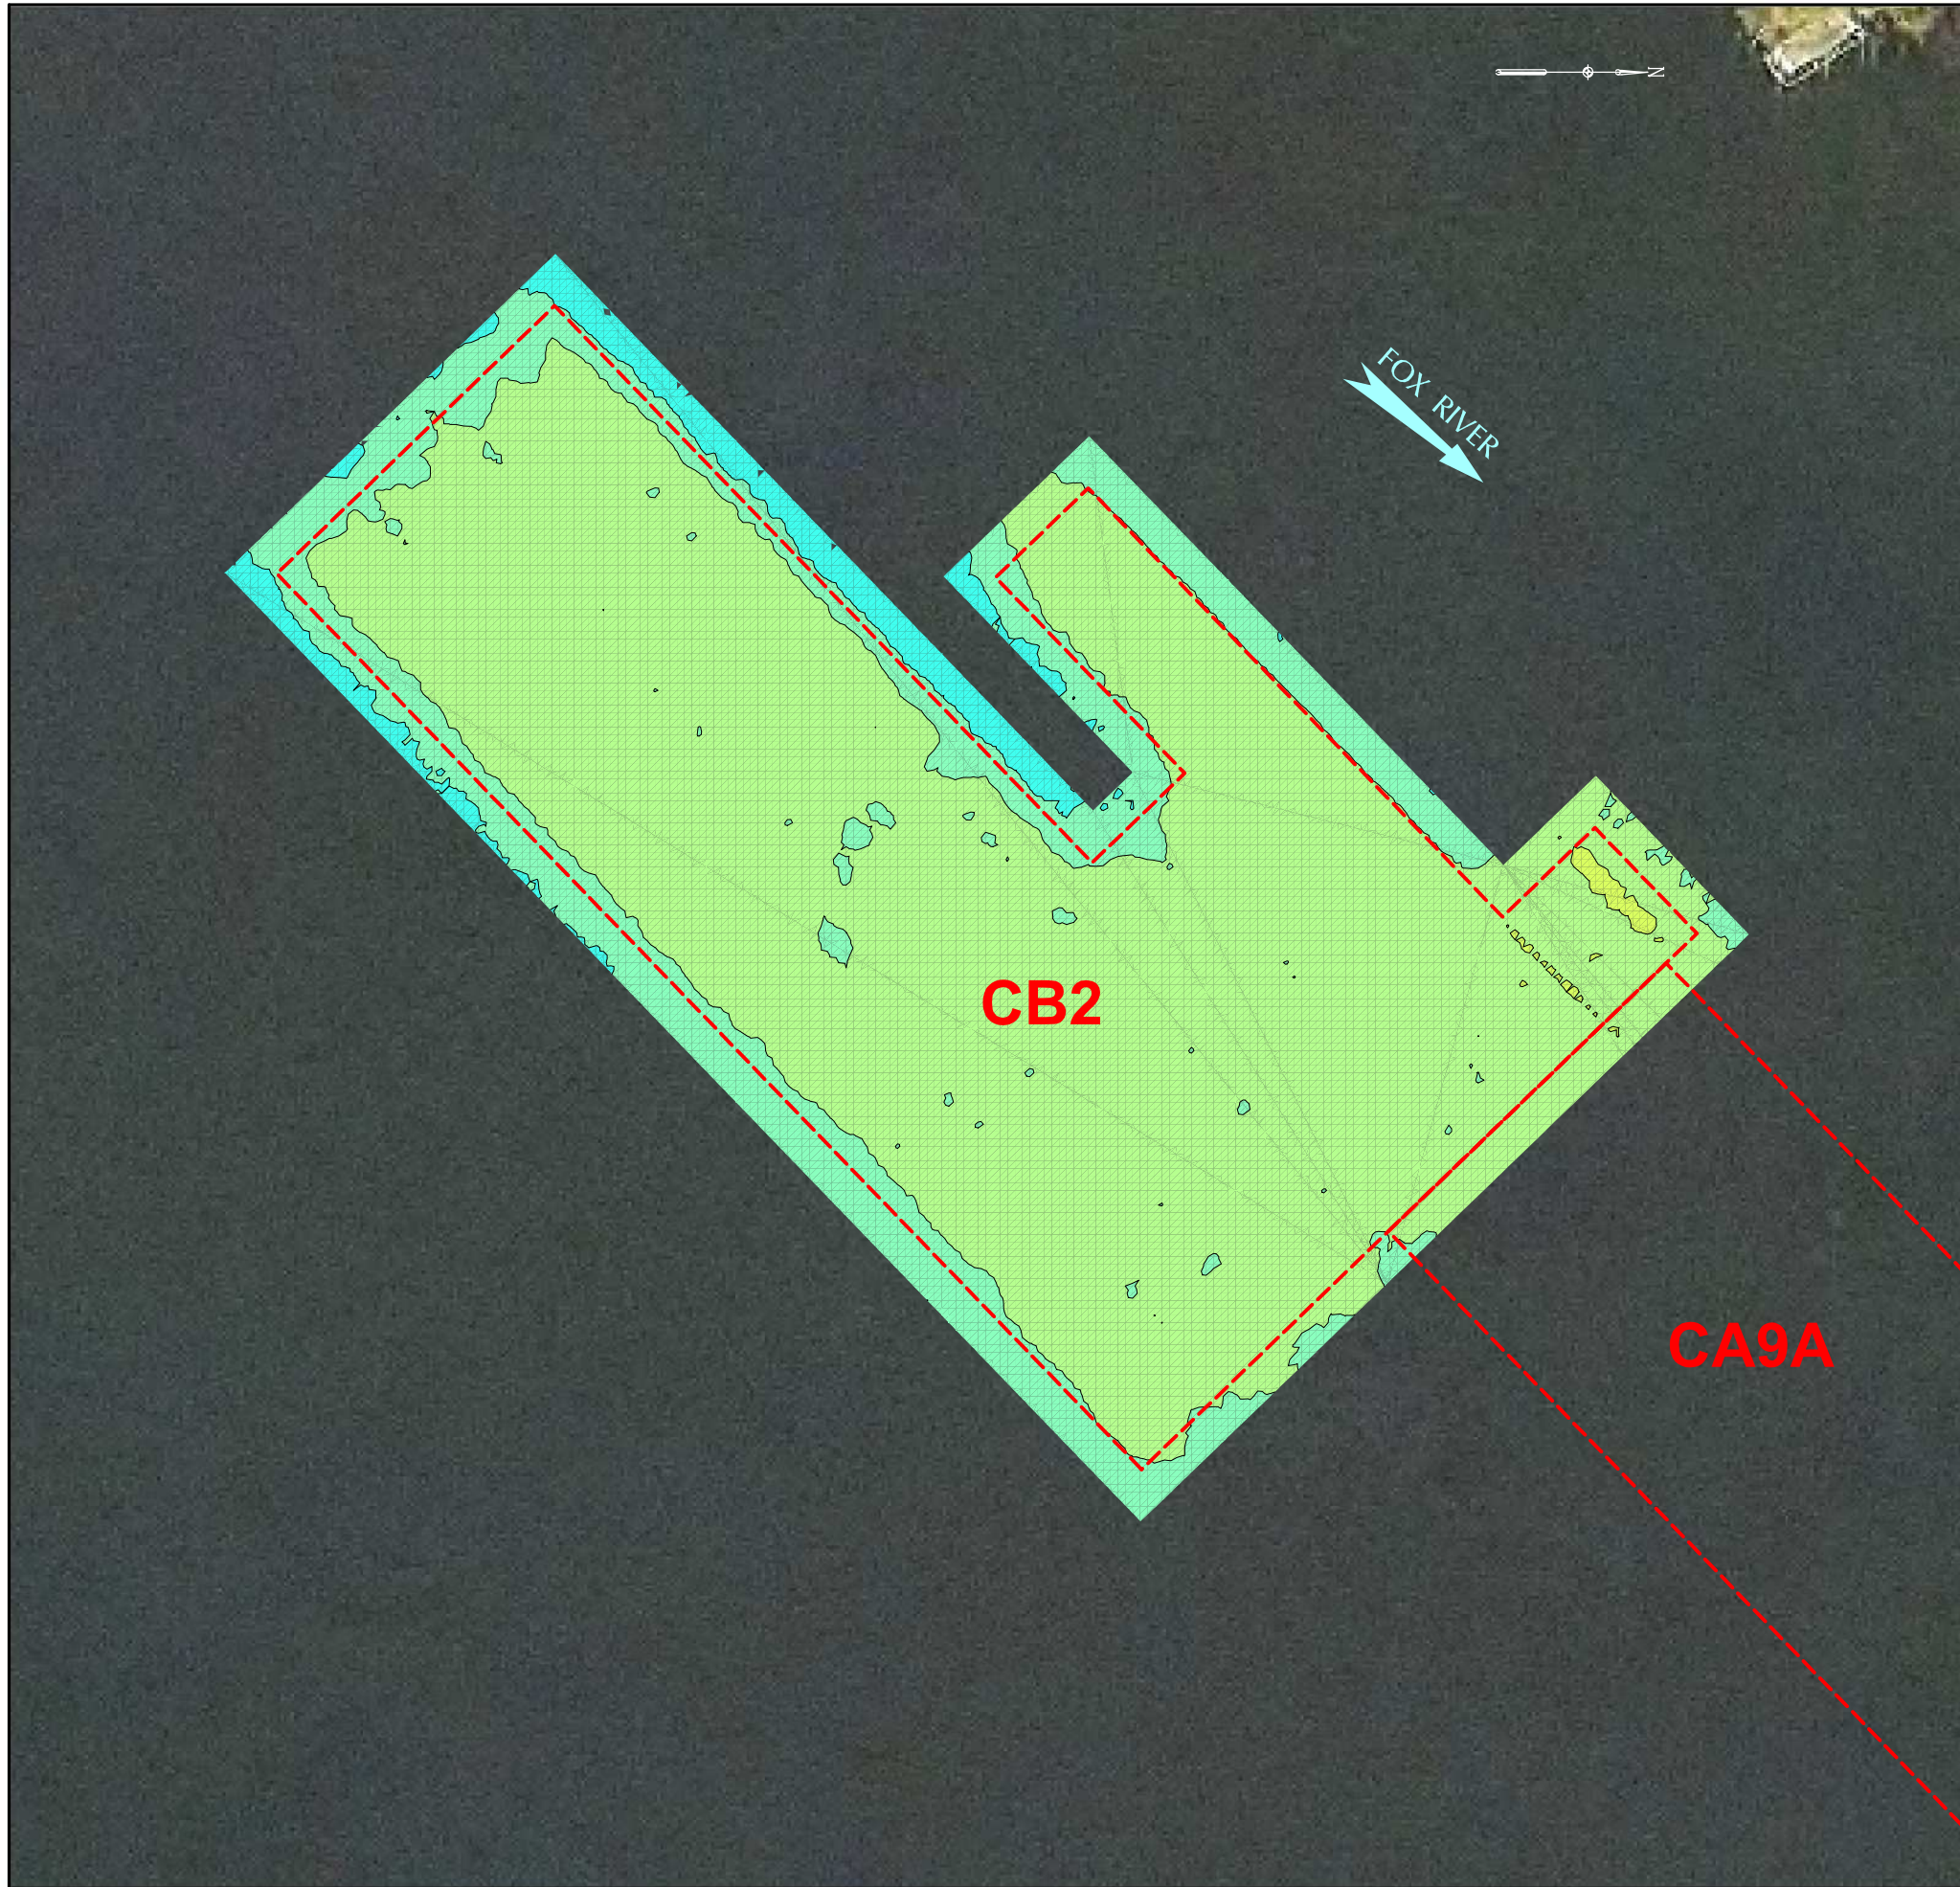
**FIGURE 4A**

**COLOR ELEVATION CHART**  
 COLOR CONTOURS SHOWN REPRESENT NOVEMBER 2011 TOP OF ENGINEERED CAP ELEVATIONS

1. 200 KILOHERTZ (kHz) MULTI-BEAM HYDROGRAPHIC SURVEY PERFORMED BY J.F. BRENNAN, CO. DATES OF SURVEYS: NOVEMBER 2 & 3, 2011.
2. THE HORIZONTAL CONTROL IS REFERENCED TO THE NAD83 WISCONSIN STATE PLANE COORDINATE SYSTEM (WISCONSIN CENTRAL ZONE). THE VERTICAL CONTROL IS REFERENCED TO NAVD 88.
3. ORTHO PHOTO SUPPLIED BY BROWN COUNTY L.I.O. COMPILED IN NOVEMBER 2010.
4. DESIGN CAP PLACEMENT LIMITS DERIVED FROM DESIGN FILES PROVIDED BY TETRA TECH EC, INC.

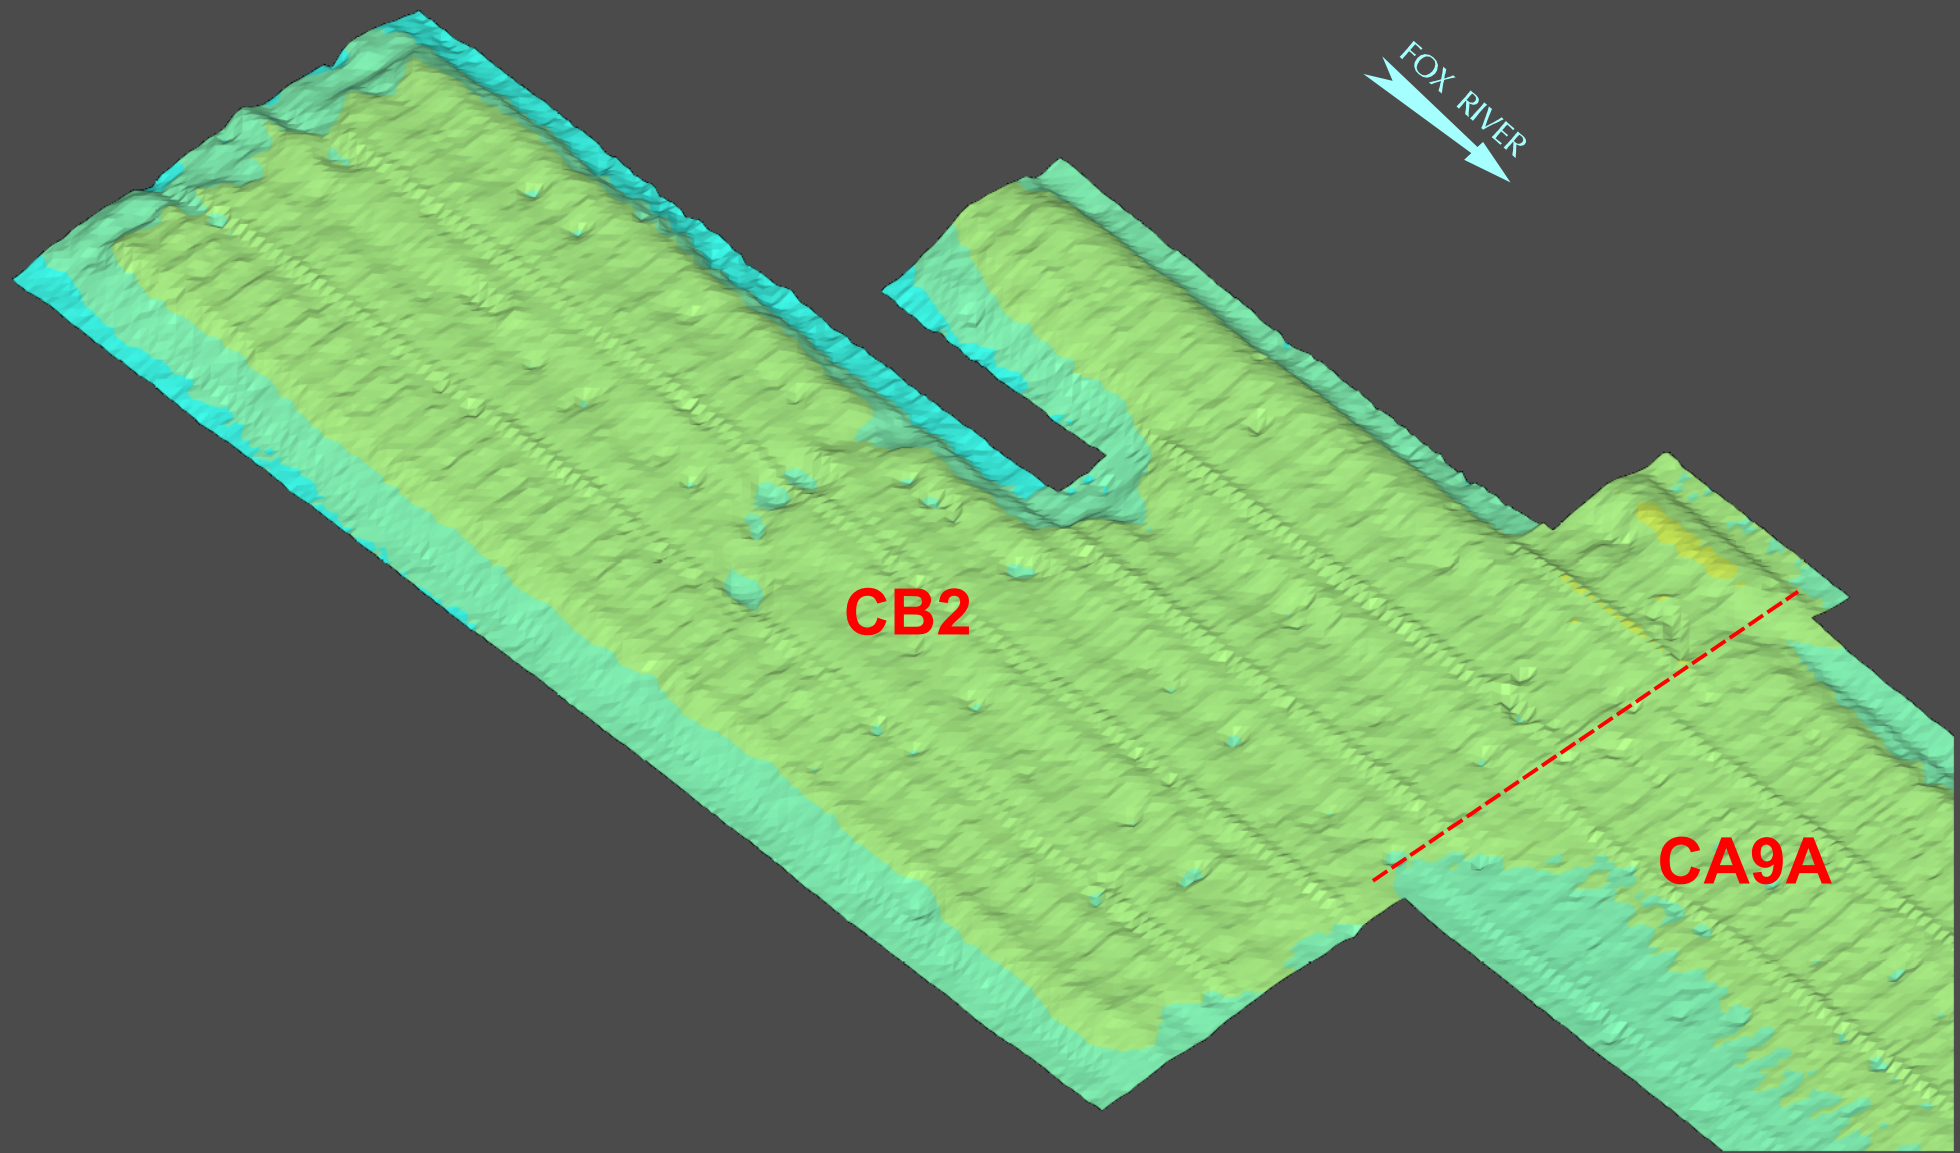
**FIGURE 4B**  
LOWER FOX RIVER - OU3  
TOP OF CAP ELEVATIONS  
ISOMETRIC VIEW

COLOR ELEVATION CHART  
COLOR CONTOURS SHOWN REPRESENT NOVEMBER  
2011 TOP OF ENGINEERED CAP ELEVATIONS

- 200 KILOHERTZ (kHz) MULTI-BEAM HYDROGRAPHIC SURVEY PERFORMED BY J.F. BRENNAN, CO. DATES OF SURVEYS: NOVEMBER 2 & 3, 2011.
- THE HORIZONTAL CONTROL IS REFERENCED TO THE NAD83 WISCONSIN STATE PLANE COORDINATE SYSTEM (WISCONSIN CENTRAL ZONE). THE VERTICAL CONTROL IS REFERENCED TO NAVD 88.
