## Memorandum

RE: Lower Fox River OU3 *COMMP* Hydrographic Survey – Year Zero

This memorandum presents the methods utilized and the results of the Year Zero hydrographic survey for OU3.

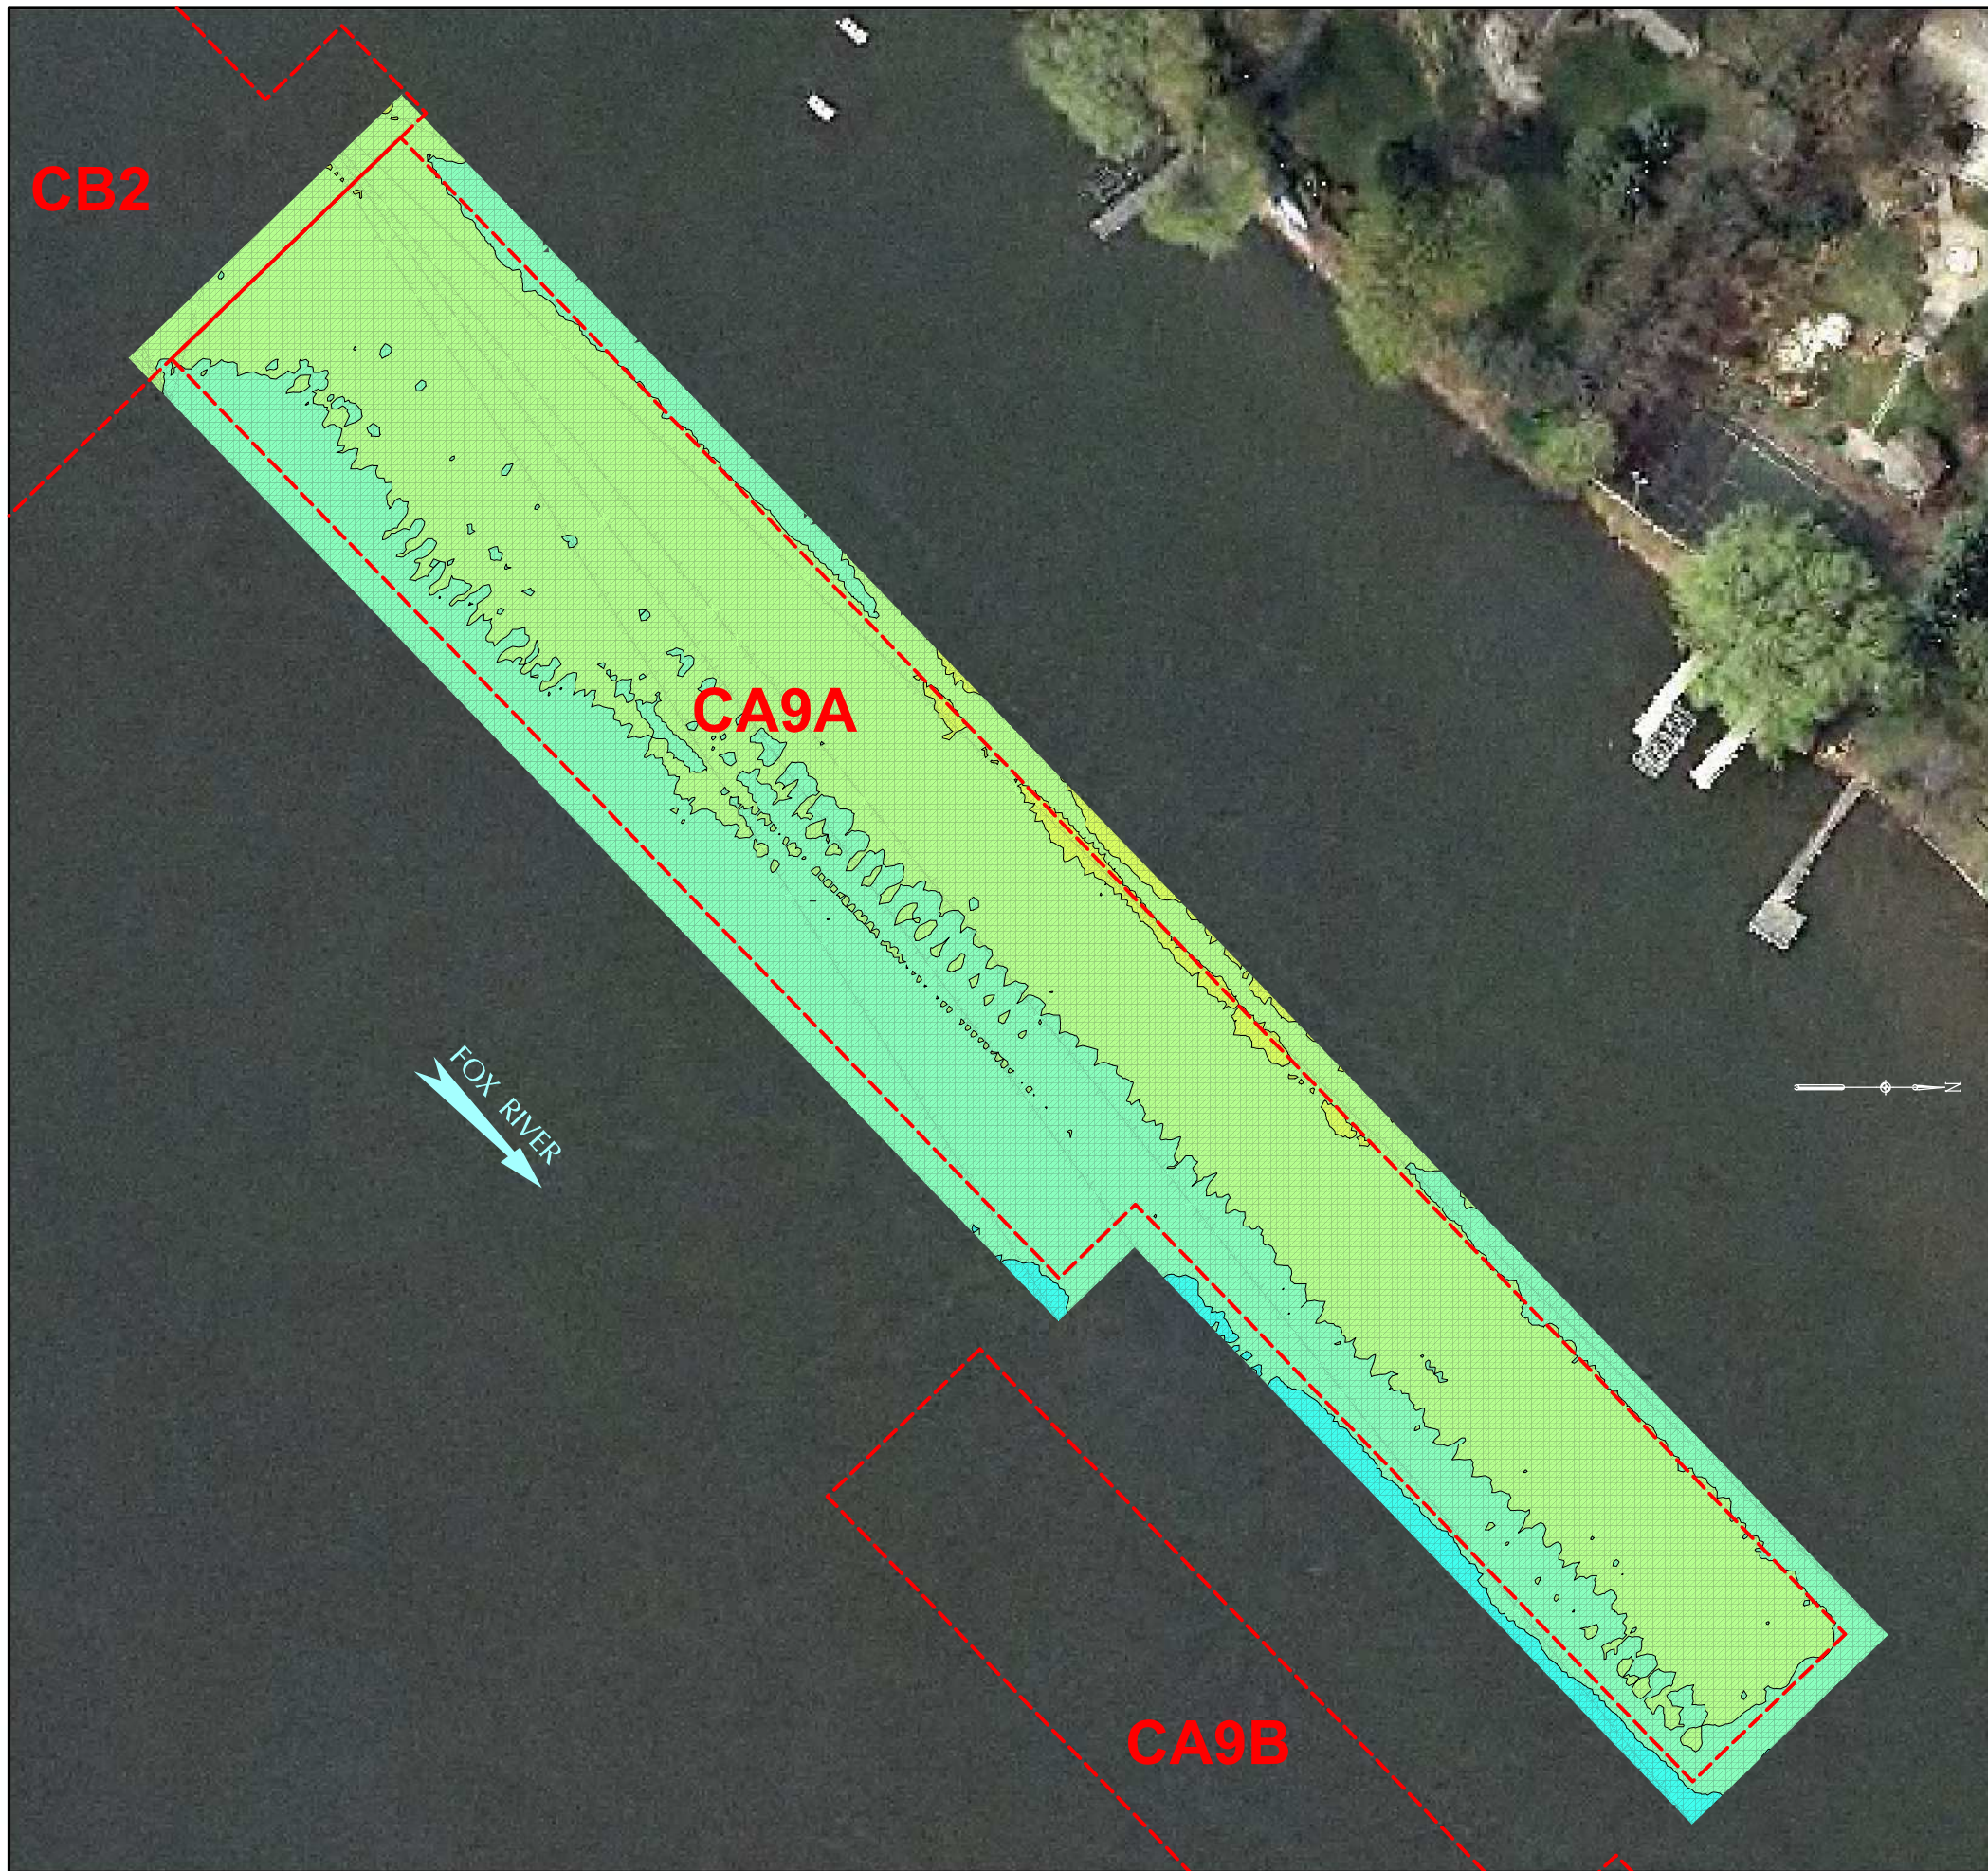
**FIGURE 5A**

COLOR CONTOURS SHOWN REPRESENT NOVEMBER 2011 TOP OF ENGINEERED CAP ELEVATIONS

- 200 KILOHERTZ (kHz) MULTI-BEAM HYDROGRAPHIC SURVEY PERFORMED BY J.F. BRENNAN, CO. DATES OF SURVEYS: NOVEMBER 2 & 3, 2011.
- THE HORIZONTAL CONTROL IS REFERENCED TO THE NAD83 WISCONSIN STATE PLANE COORDINATE SYSTEM (WISCONSIN CENTRAL ZONE). THE VERTICAL CONTROL IS REFERENCED TO NAVD 88.
- ORTHO PHOTO SUPPLIED BY BROWN COUNTY L.I.O. COMPILED IN NOVEMBER 2010.
- DESIGN CAP PLACEMENT LIMITS DERIVED FROM DESIGN FILES PROVIDED BY TETRA TECH EC, INC.

Upon completion of the hydrographic surveys, the data were processed and top of cap contours were created. For each cap in OU3 (excluding CA 69), Foth produced two figures to show top of cap elevations (Figures 3A and 3B through 14A and 14B). The first figure, in each series of two, shows the post construction top of cap elevation in a two dimensional plan view. This figure also shows the designed cap-placement limits. The second figure in the series shows a three dimensional (3-D) isometric view, which better depicts potential minor surface irregularities as compared to the two dimensional views. The results of these multi-beam surveys will be used as the baseline information for future monitoring events.

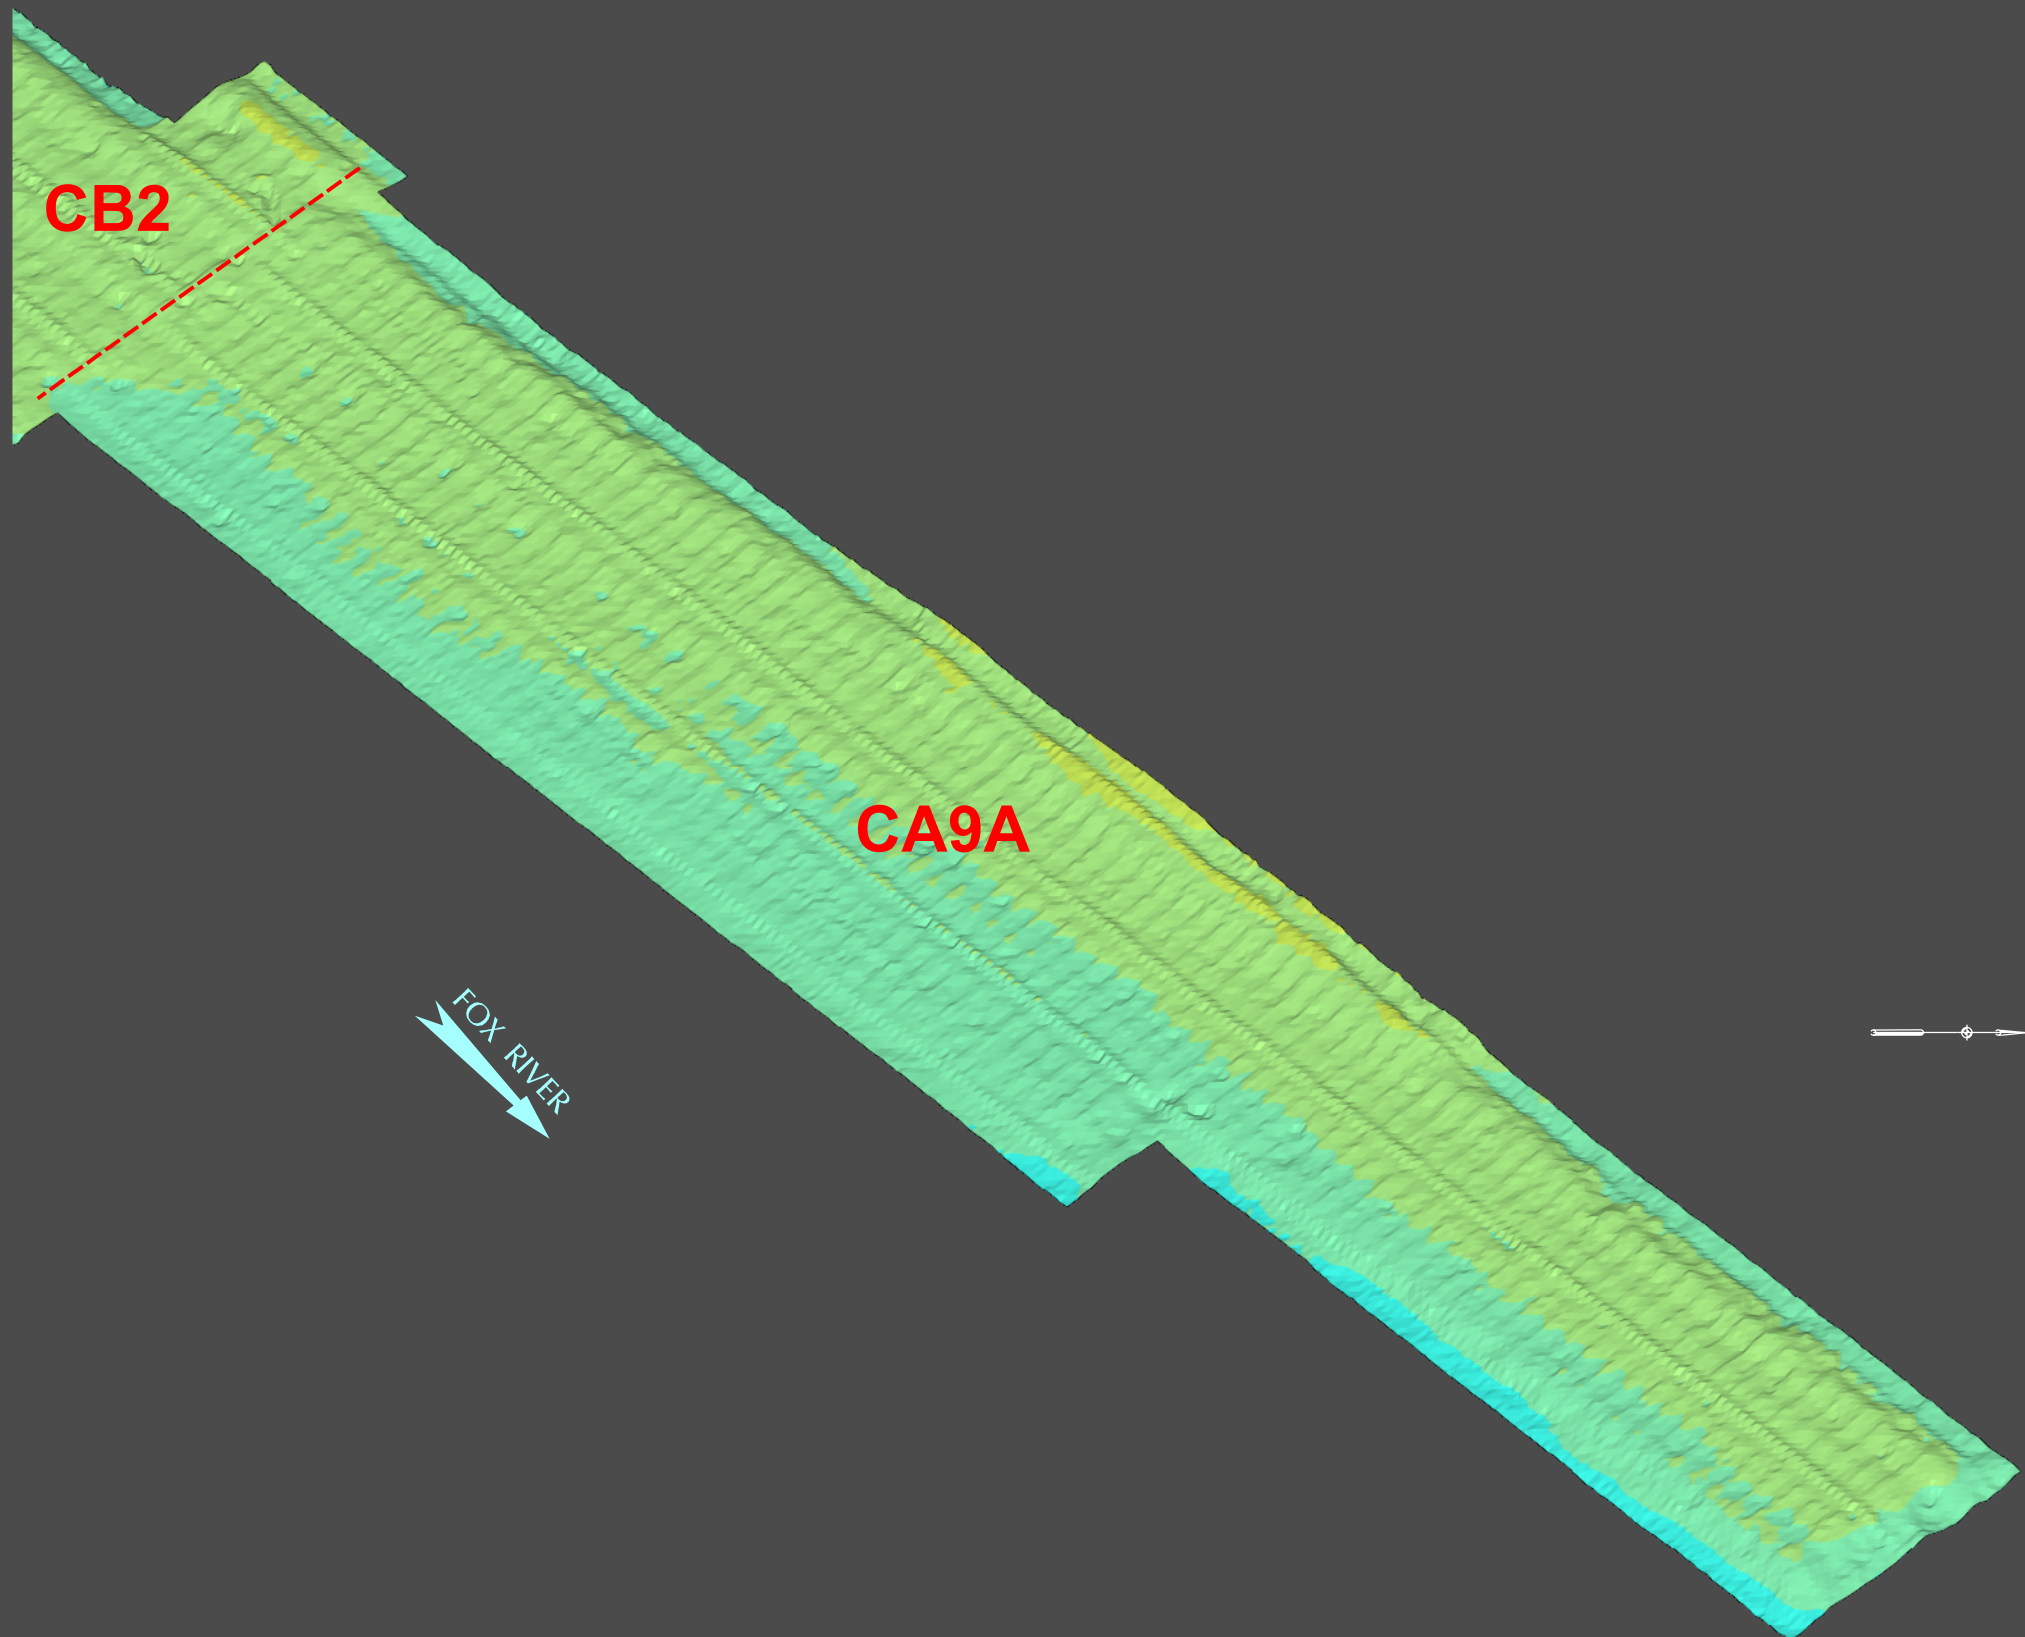
**FIGURE 5B**  
 LOWER FOX RIVER - OU3  
 TOP OF CAP ELEVATIONS  
 ISOMETRIC VIEW

**COLOR ELEVATION CHART**  
 COLOR CONTOURS SHOWN REPRESENT NOVEMBER  
 2011 TOP OF ENGINEERED CAP ELEVATIONS

1. 200 KILOHERTZ (kHz) MULTI-BEAM HYDROGRAPHIC SURVEY PERFORMED BY J.F. BRENNAN, CO. DATES OF SURVEYS: NOVEMBER 2 & 3, 2011.
2. THE HORIZONTAL CONTROL IS REFERENCED TO THE NAD83 WISCONSIN STATE PLANE COORDINATE SYSTEM (WISCONSIN CENTRAL ZONE). THE VERTICAL CONTROL IS REFERENCED TO NAVD 88.

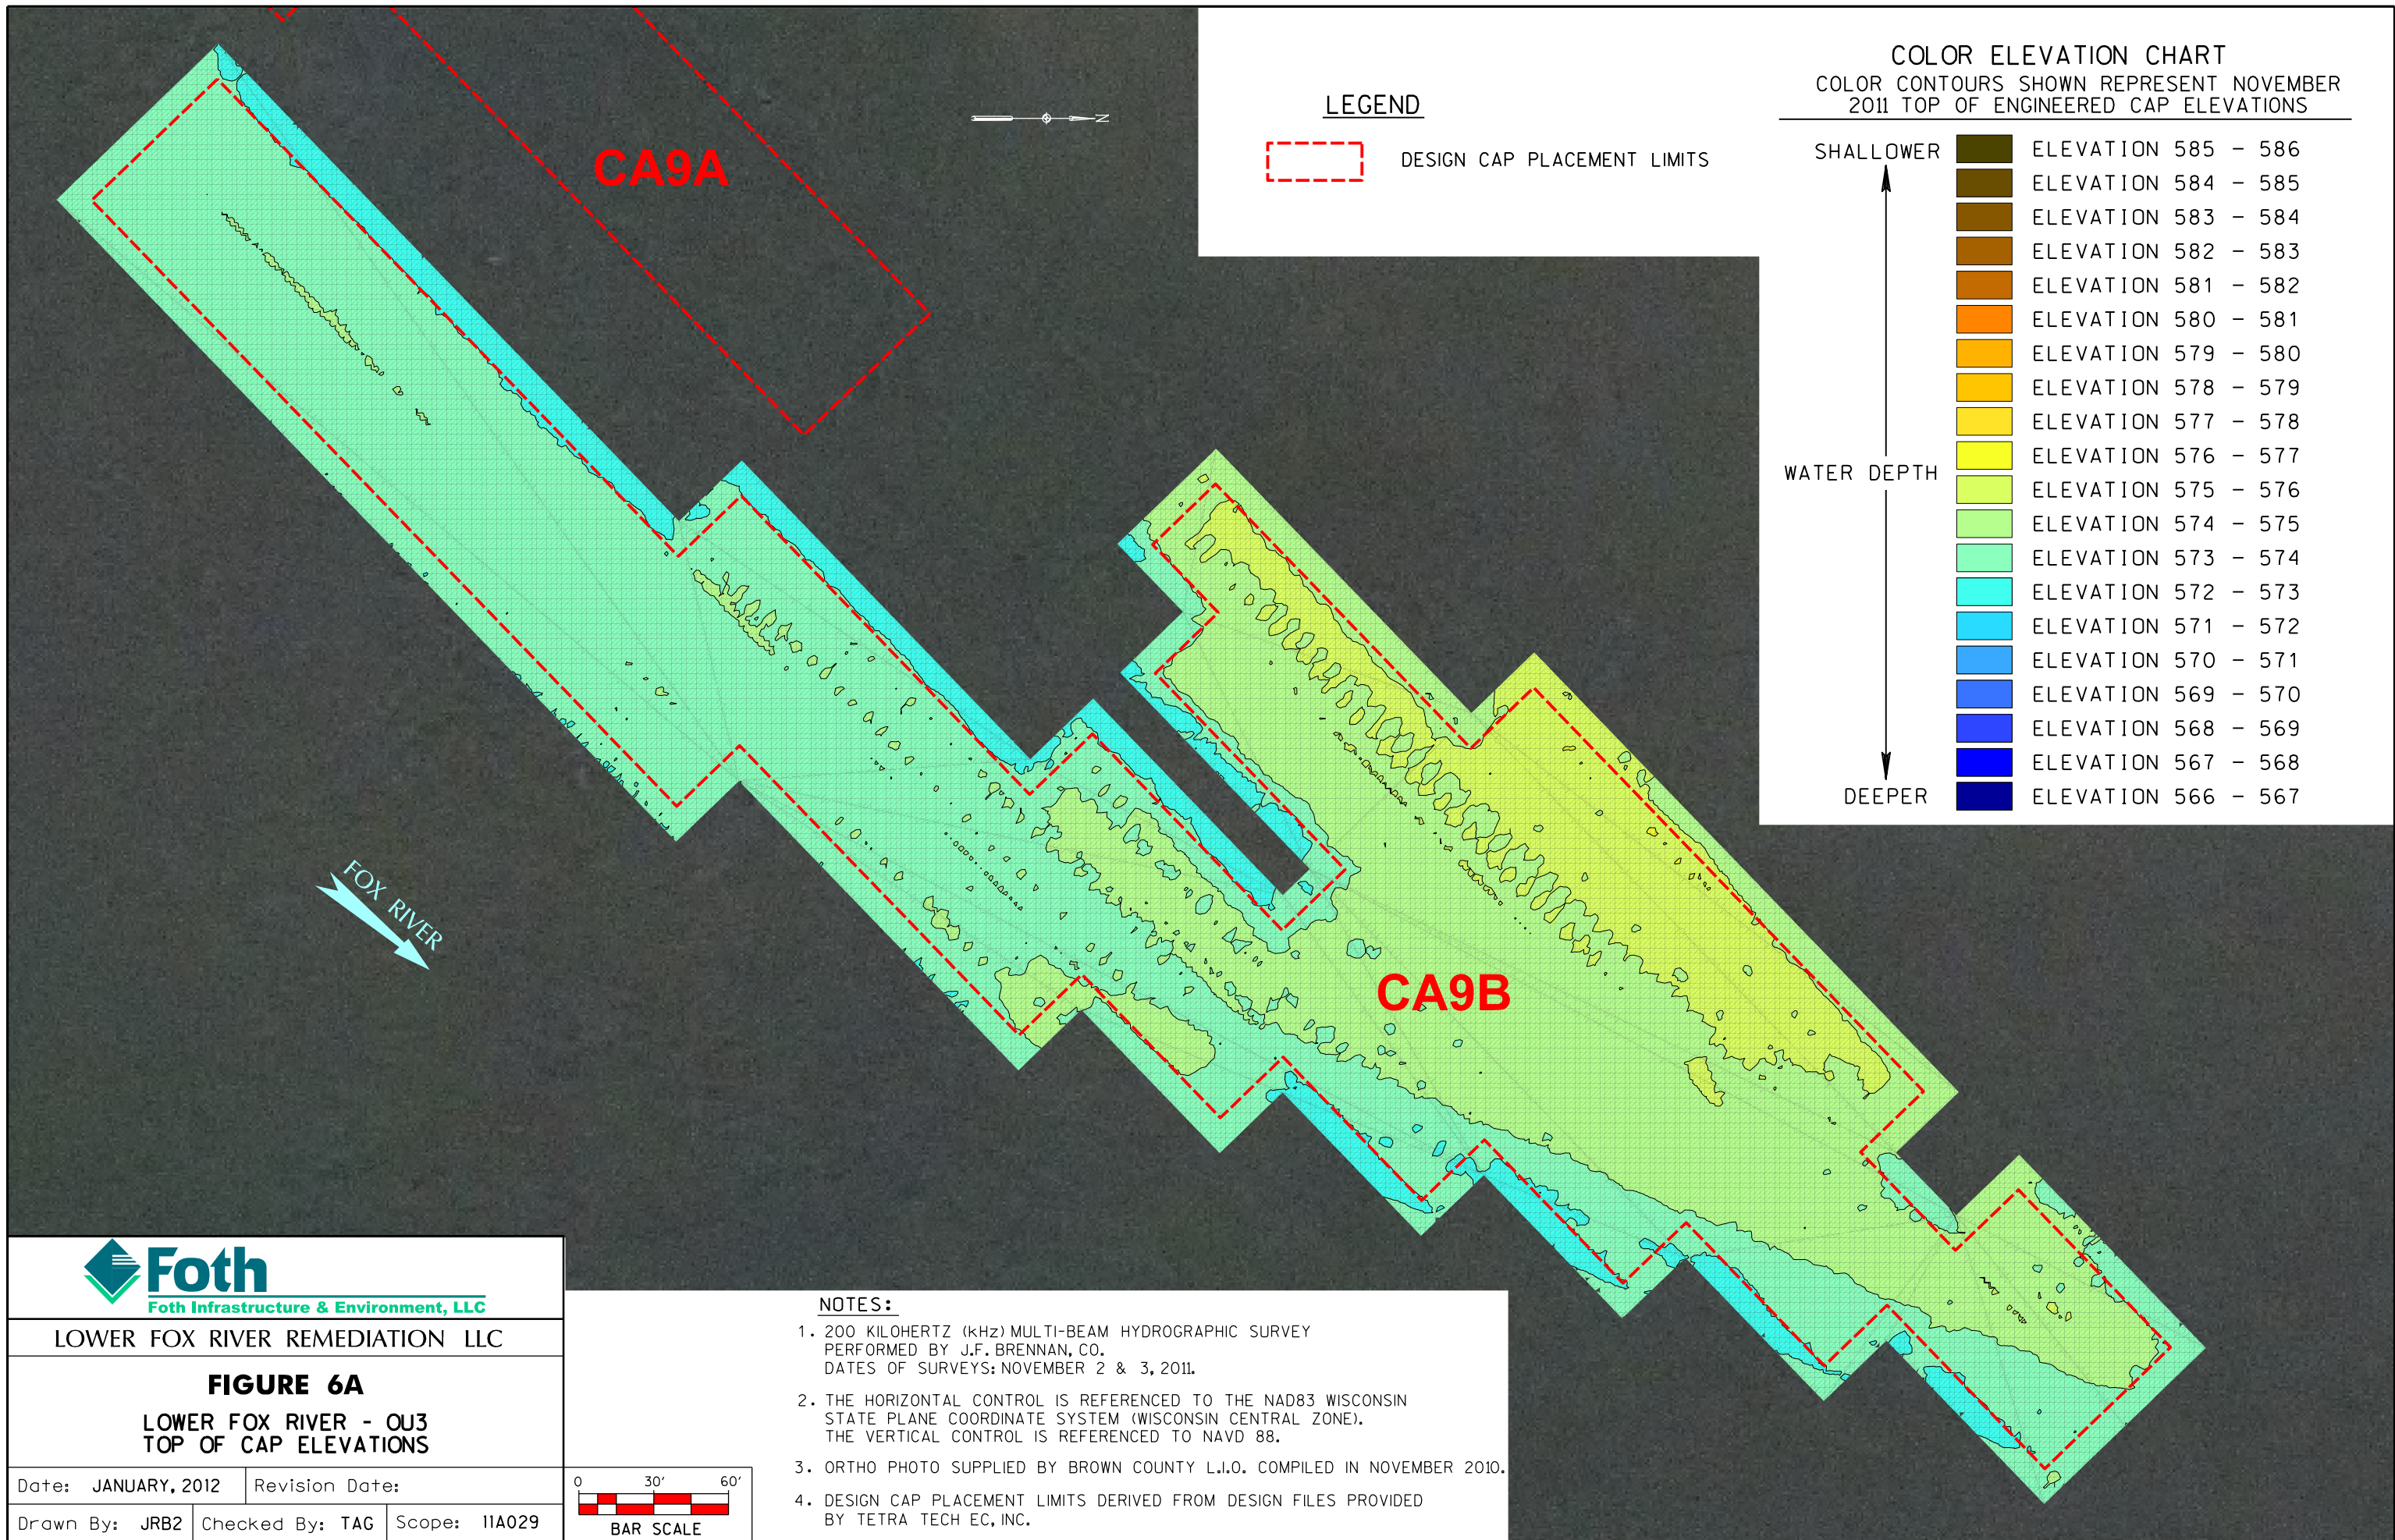
**FIGURE 6A**

**COLOR ELEVATION CHART**  
 COLOR CONTOURS SHOWN REPRESENT NOVEMBER 2011 TOP OF ENGINEERED CAP ELEVATIONS

- NOTES:**
- 200 KILOHERTZ (KHZ) MULTI-BEAM HYDROGRAPHIC SURVEY PERFORMED BY J.F. BRENNAN, CO. DATES OF SURVEYS: NOVEMBER 2 & 3, 2011.
  - THE HORIZONTAL CONTROL IS REFERENCED TO THE NAD83 WISCONSIN STATE PLANE COORDINATE SYSTEM (WISCONSIN CENTRAL ZONE). THE VERTICAL CONTROL IS REFERENCED TO NAVD 88.
  - ORTHO PHOTO SUPPLIED BY BROWN COUNTY L.I.O. COMPILED IN NOVEMBER 2010.
  - DESIGN CAP PLACEMENT LIMITS DERIVED FROM DESIGN FILES PROVIDED BY TETRA TECH EC, INC.

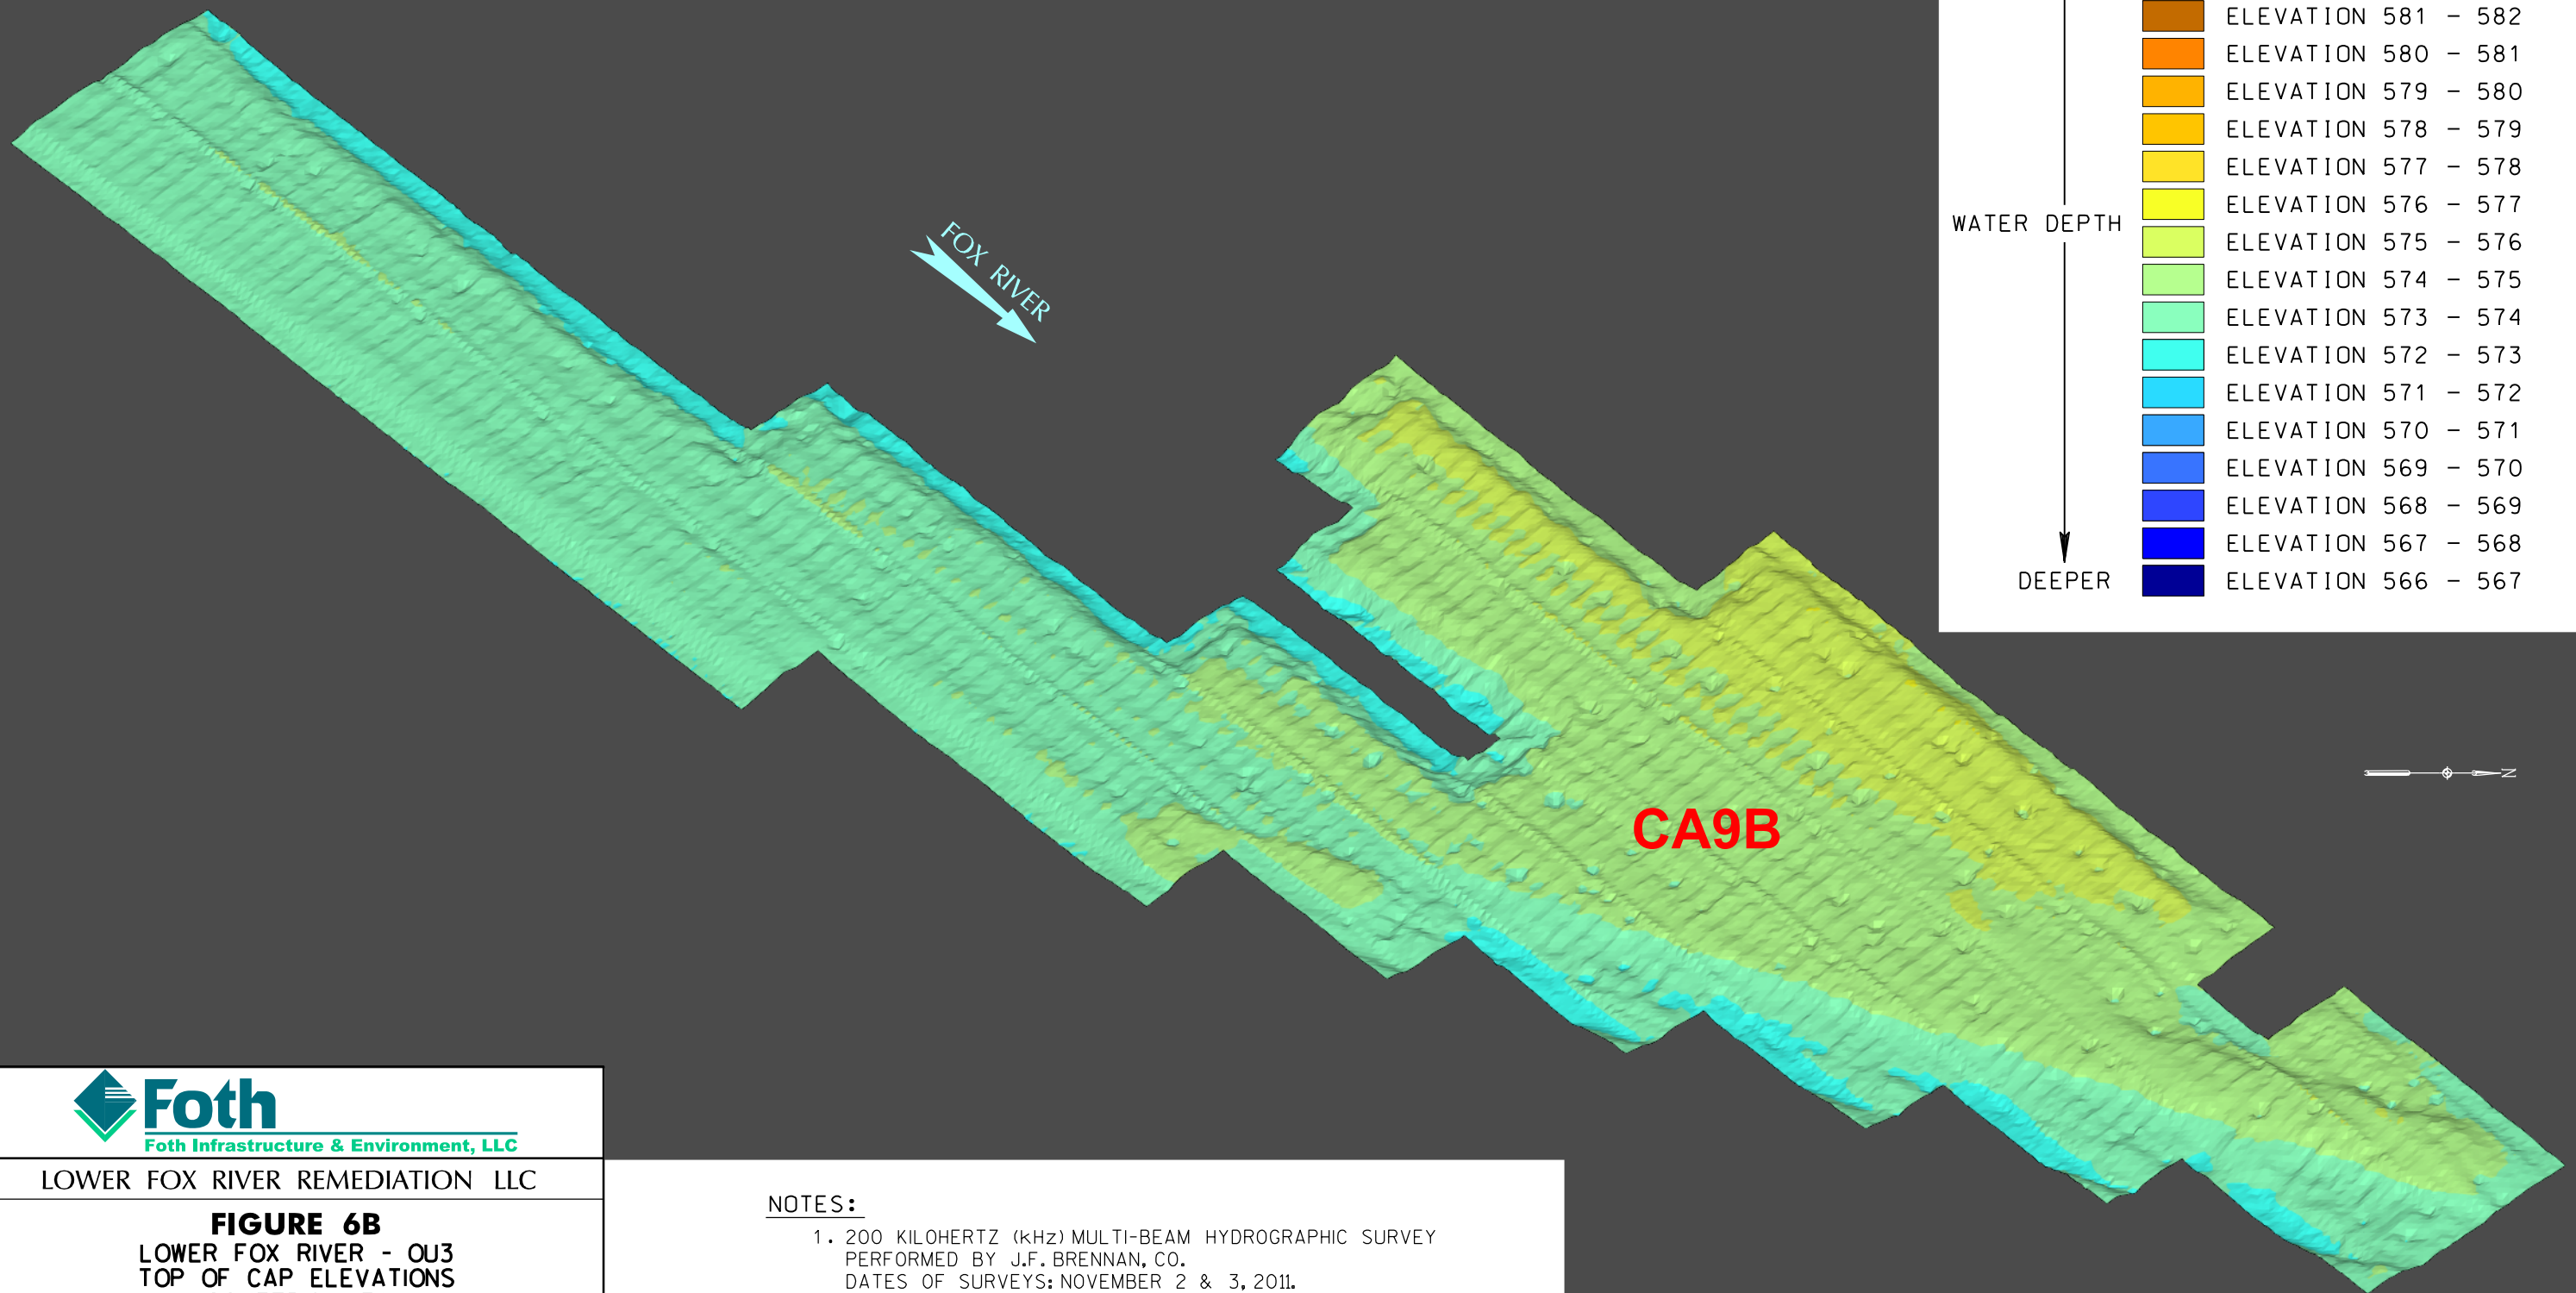
**FIGURE 6B**  
 LOWER FOX RIVER - OU3  
 TOP OF CAP ELEVATIONS  
 ISOMETRIC VIEW

1. 200 KILOHERTZ (kHz) MULTI-BEAM HYDROGRAPHIC SURVEY PERFORMED BY J.F. BRENNAN, CO. DATES OF SURVEYS: NOVEMBER 2 & 3, 2011.
2. THE HORIZONTAL CONTROL IS REFERENCED TO THE NAD83 WISCONSIN STATE PLANE COORDINATE SYSTEM (WISCONSIN CENTRAL ZONE). THE VERTICAL CONTROL IS REFERENCED TO NAVD 88.

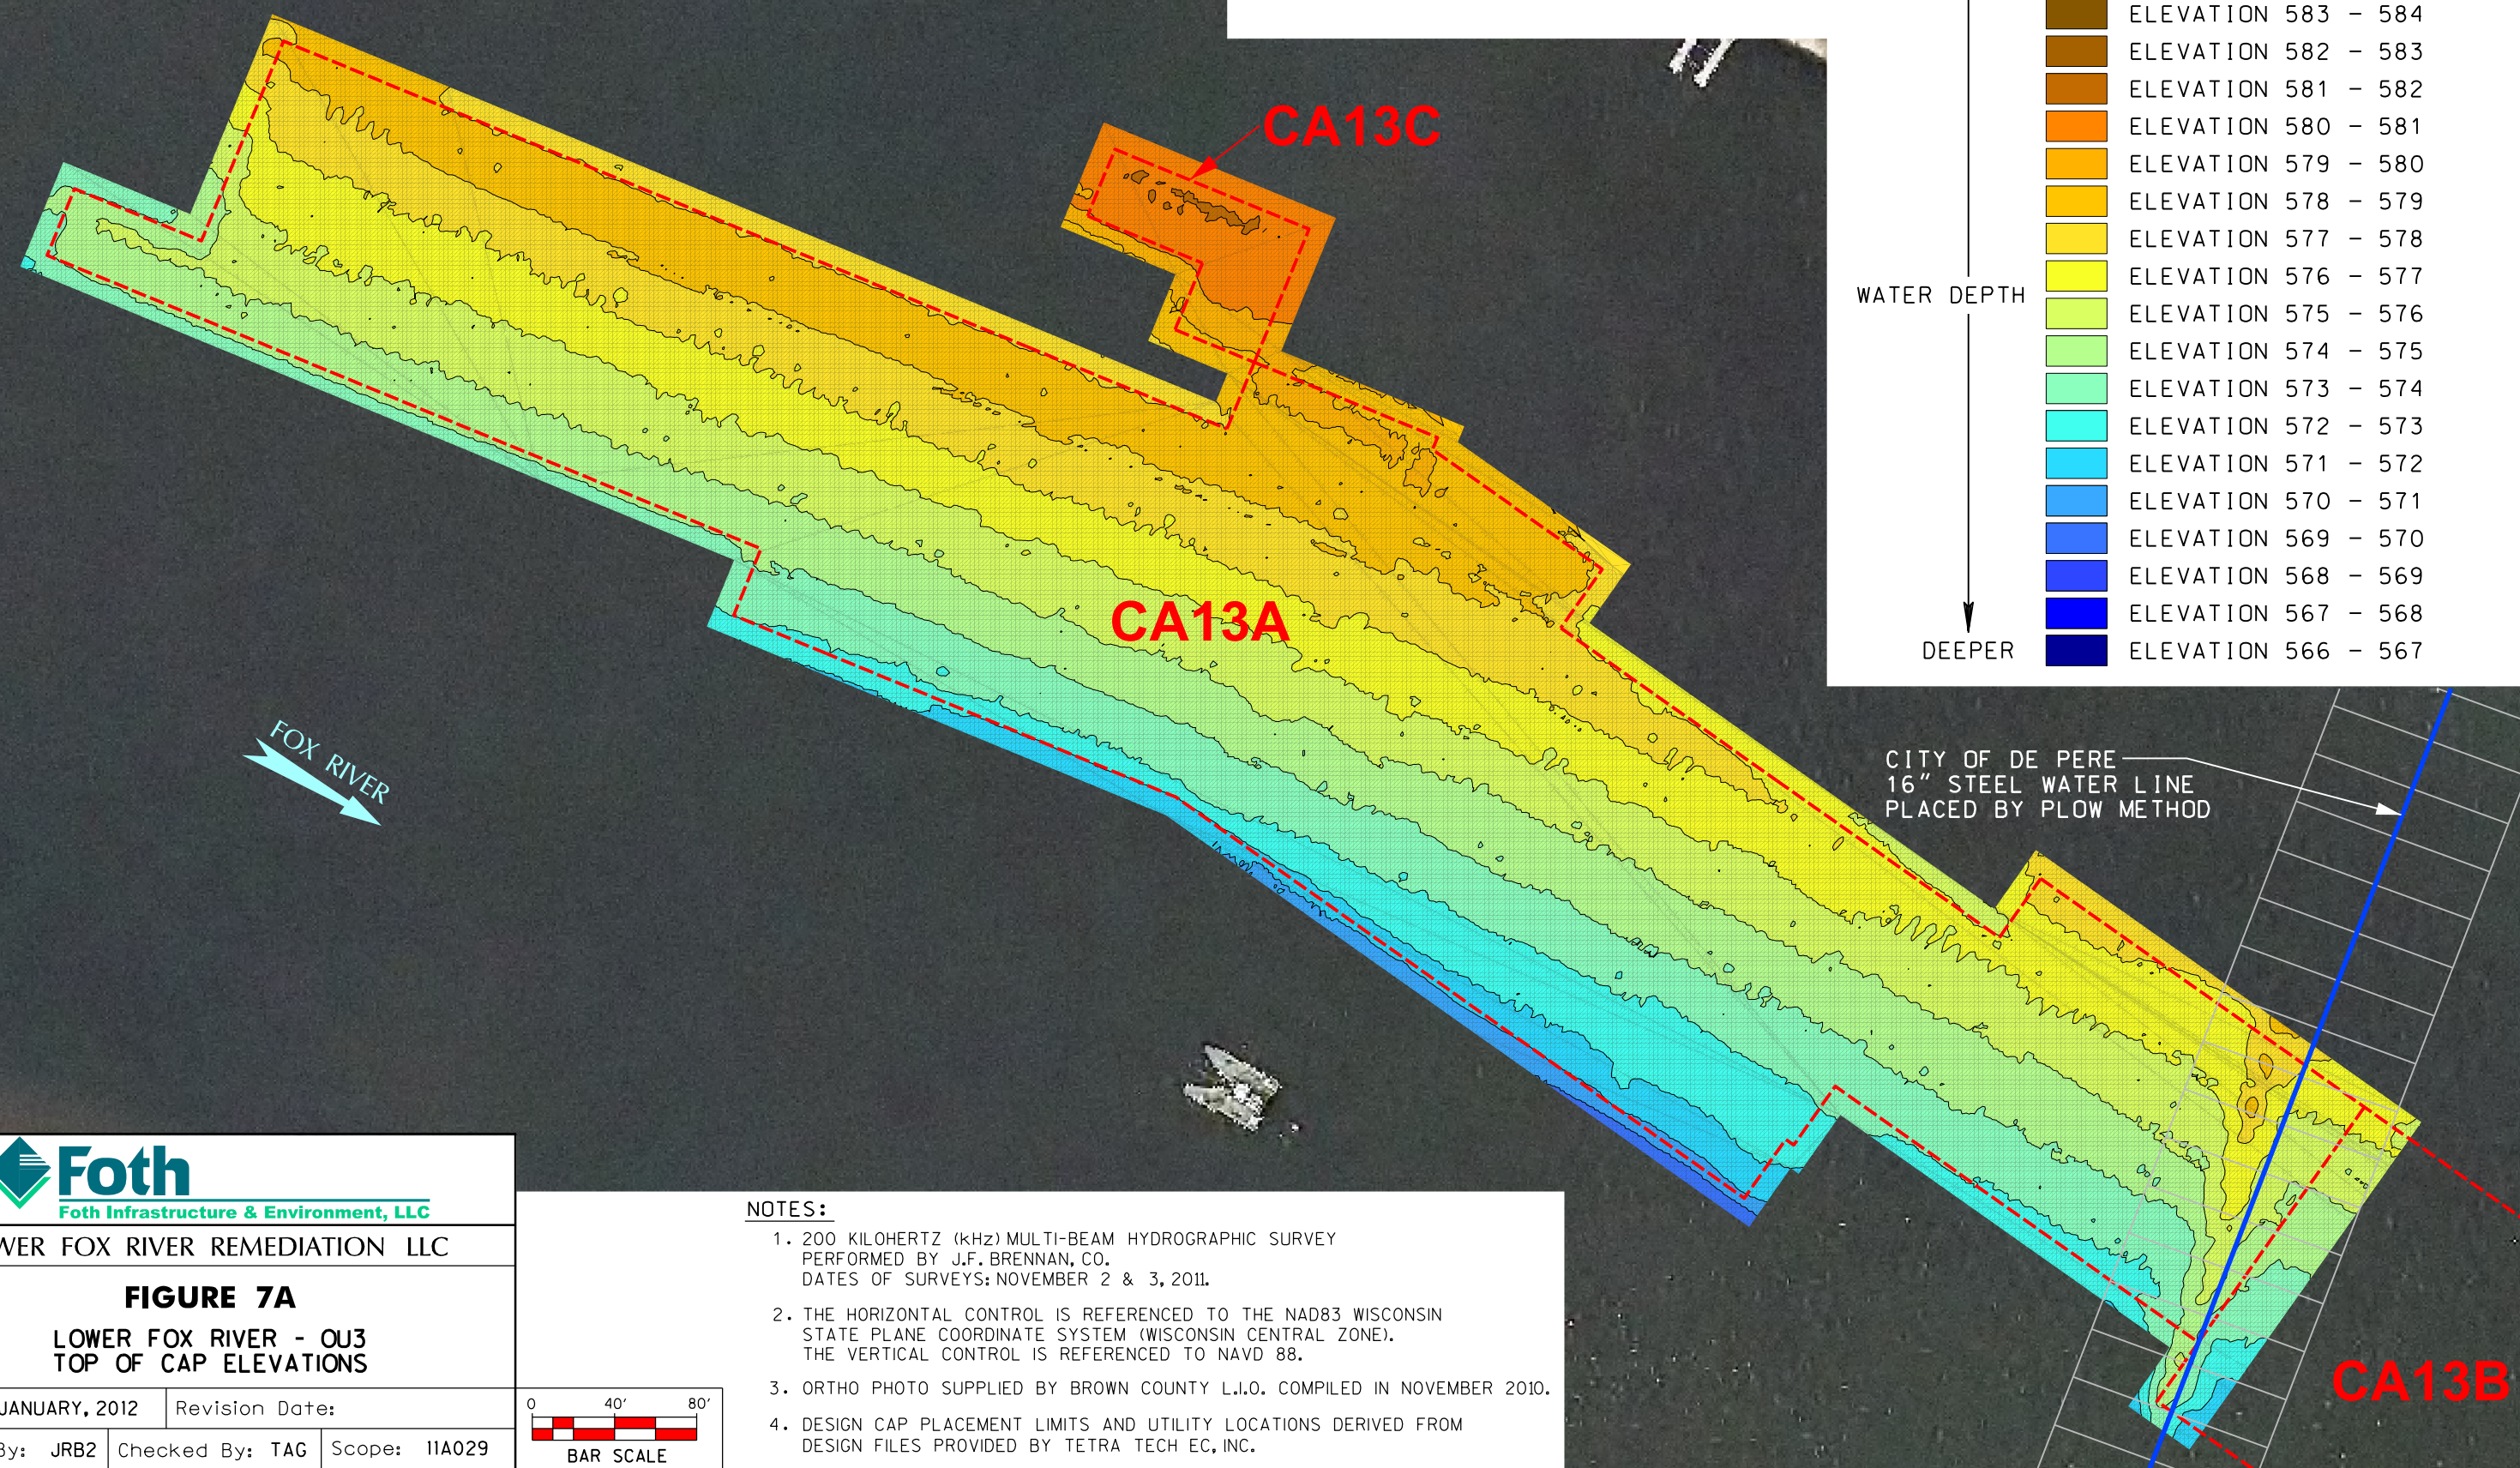
**FIGURE 7A**

CITY OF DE PERE  
 16" STEEL WATER LINE  
 PLACED BY PLOW METHOD

- 200 KILOHERTZ (kHz) MULTI-BEAM HYDROGRAPHIC SURVEY PERFORMED BY J.F. BRENNAN, CO. DATES OF SURVEYS: NOVEMBER 2 & 3, 2011.
- THE HORIZONTAL CONTROL IS REFERENCED TO THE NAD83 WISCONSIN STATE PLANE COORDINATE SYSTEM (WISCONSIN CENTRAL ZONE). THE VERTICAL CONTROL IS REFERENCED TO NAVD 88.
- ORTHO PHOTO SUPPLIED BY BROWN COUNTY L.I.O. COMPILED IN NOVEMBER 2010.
- DESIGN CAP PLACEMENT LIMITS AND UTILITY LOCATIONS DERIVED FROM DESIGN FILES PROVIDED BY TETRA TECH EC, INC.

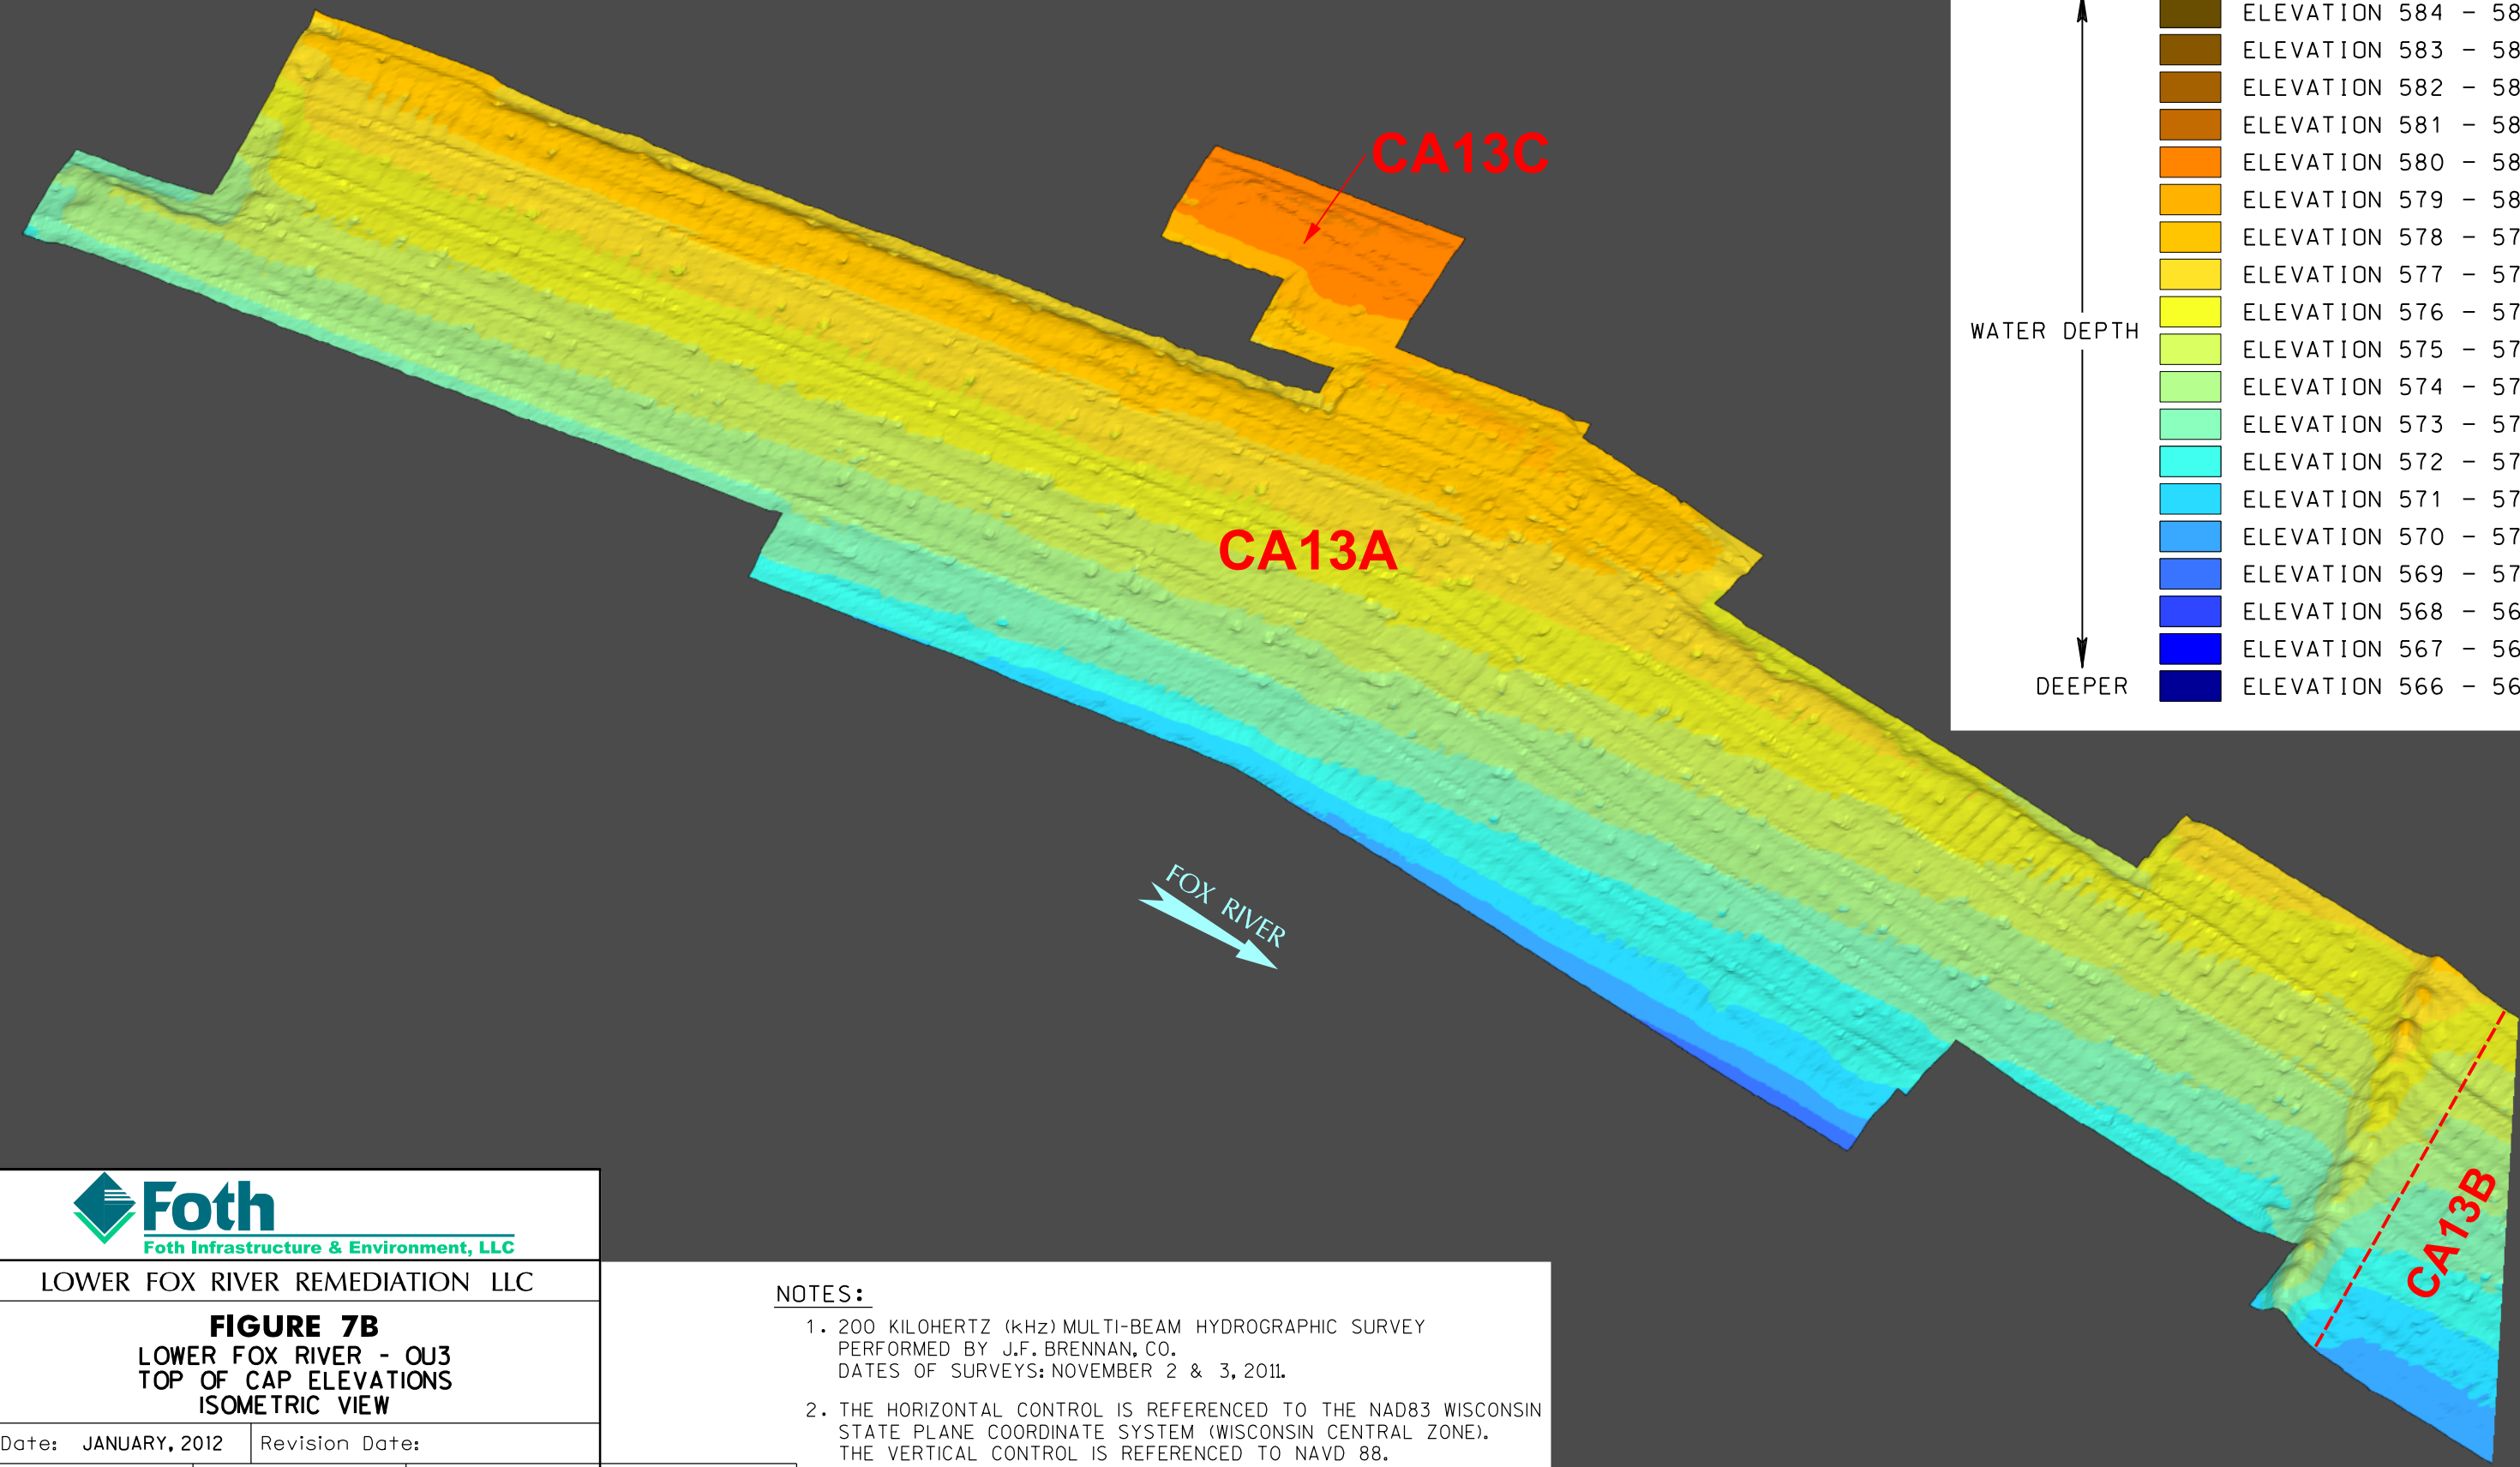
**FIGURE 7B**  
 LOWER FOX RIVER - OU3  
 TOP OF CAP ELEVATIONS  
 ISOMETRIC VIEW

1. 200 KILOHERTZ (kHz) MULTI-BEAM HYDROGRAPHIC SURVEY PERFORMED BY J.F. BRENNAN, CO. DATES OF SURVEYS: NOVEMBER 2 & 3, 2011.
2. THE HORIZONTAL CONTROL IS REFERENCED TO THE NAD83 WISCONSIN STATE PLANE COORDINATE SYSTEM (WISCONSIN CENTRAL ZONE). THE VERTICAL CONTROL IS REFERENCED TO NAVD 88.
