## Memorandum

RE: Lower Fox River OU3 *COMMP* Hydrographic Survey – Year Zero

This memorandum presents the methods utilized and the results of the Year Zero hydrographic survey for OU3.

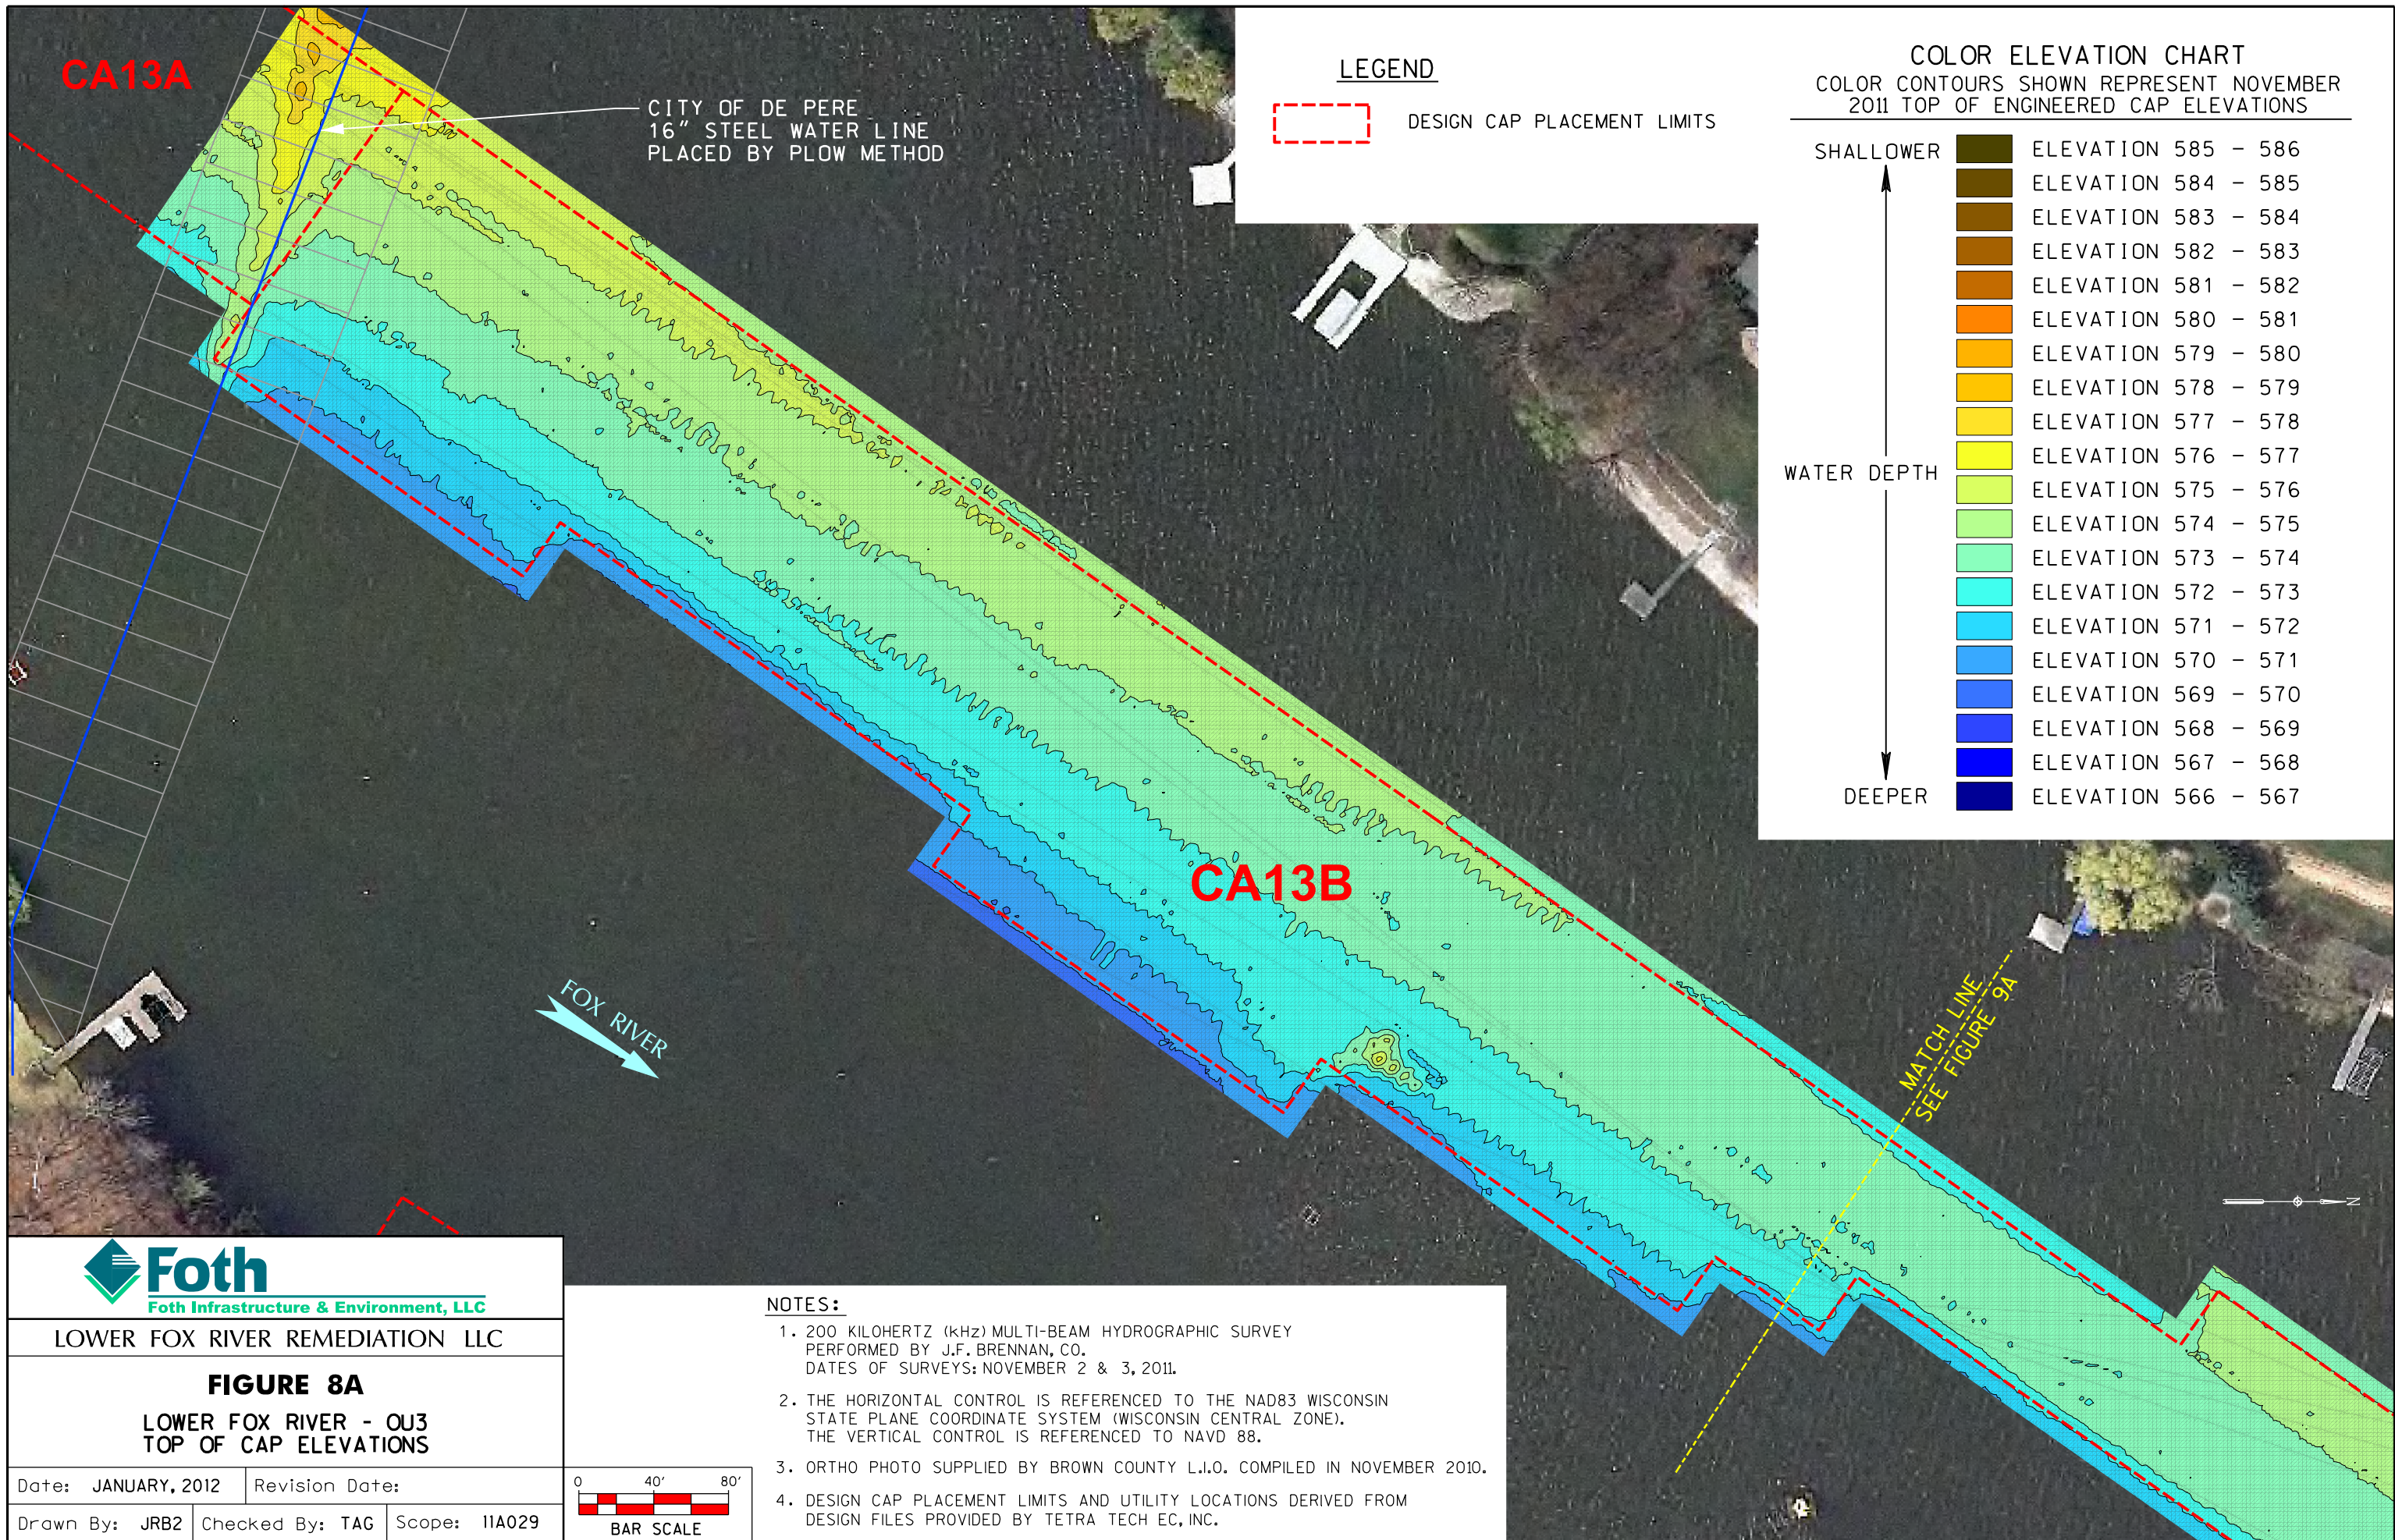
**FIGURE 8A**

CITY OF DE PERE  
16" STEEL WATER LINE  
PLACED BY PLOW METHOD

- 200 KILOHERTZ (kHz) MULTI-BEAM HYDROGRAPHIC SURVEY PERFORMED BY J.F. BRENNAN, CO. DATES OF SURVEYS: NOVEMBER 2 & 3, 2011.
- THE HORIZONTAL CONTROL IS REFERENCED TO THE NAD83 WISCONSIN STATE PLANE COORDINATE SYSTEM (WISCONSIN CENTRAL ZONE). THE VERTICAL CONTROL IS REFERENCED TO NAVD 88.
- ORTHO PHOTO SUPPLIED BY BROWN COUNTY L.I.O. COMPILED IN NOVEMBER 2010.
- DESIGN CAP PLACEMENT LIMITS AND UTILITY LOCATIONS DERIVED FROM DESIGN FILES PROVIDED BY TETRA TECH EC, INC.

Upon completion of the hydrographic surveys, the data were processed and top of cap contours were created. For each cap in OU3 (excluding CA 69), Foth produced two figures to show top of cap elevations (Figures 3A and 3B through 14A and 14B). The first figure, in each series of two, shows the post construction top of cap elevation in a two dimensional plan view. This figure also shows the designed cap-placement limits. The second figure in the series shows a three dimensional (3-D) isometric view, which better depicts potential minor surface irregularities as compared to the two dimensional views. The results of these multi-beam surveys will be used as the baseline information for future monitoring events.

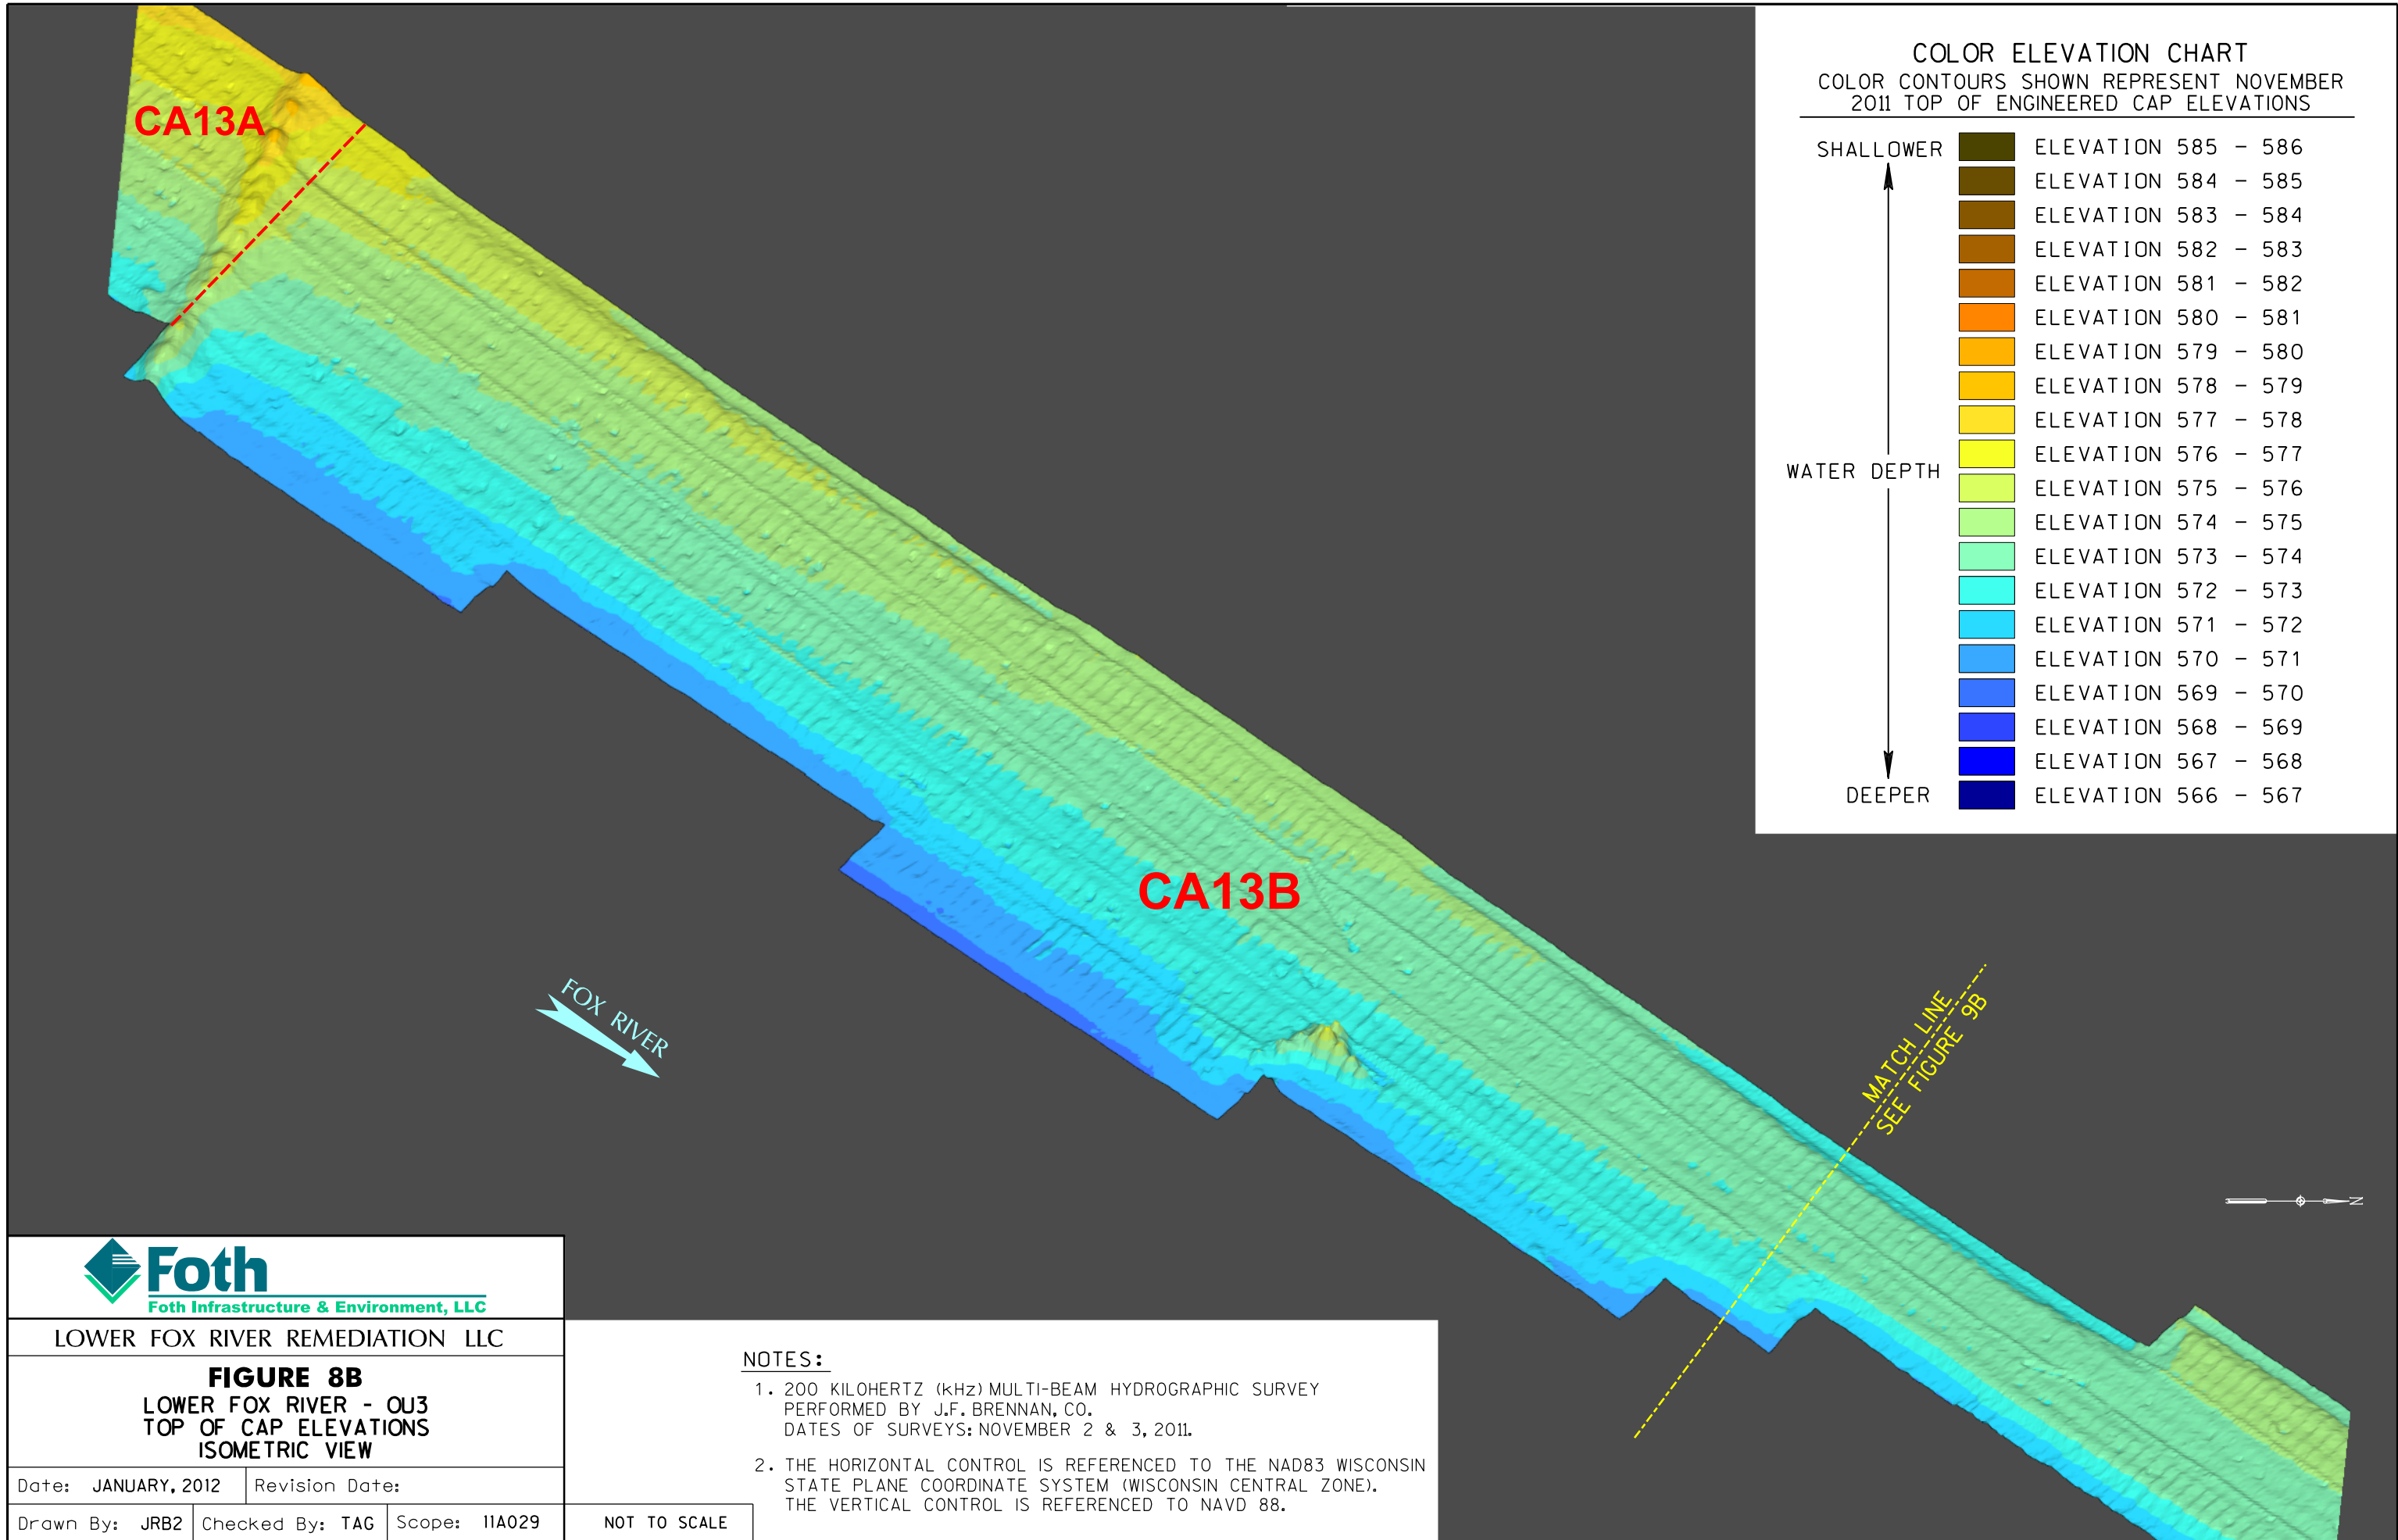
**FIGURE 8B**  
 LOWER FOX RIVER - OU3  
 TOP OF CAP ELEVATIONS  
 ISOMETRIC VIEW

1. 200 KILOHERTZ (kHz) MULTI-BEAM HYDROGRAPHIC SURVEY PERFORMED BY J.F. BRENNAN, CO. DATES OF SURVEYS: NOVEMBER 2 & 3, 2011.
2. THE HORIZONTAL CONTROL IS REFERENCED TO THE NAD83 WISCONSIN STATE PLANE COORDINATE SYSTEM (WISCONSIN CENTRAL ZONE). THE VERTICAL CONTROL IS REFERENCED TO NAVD 88.

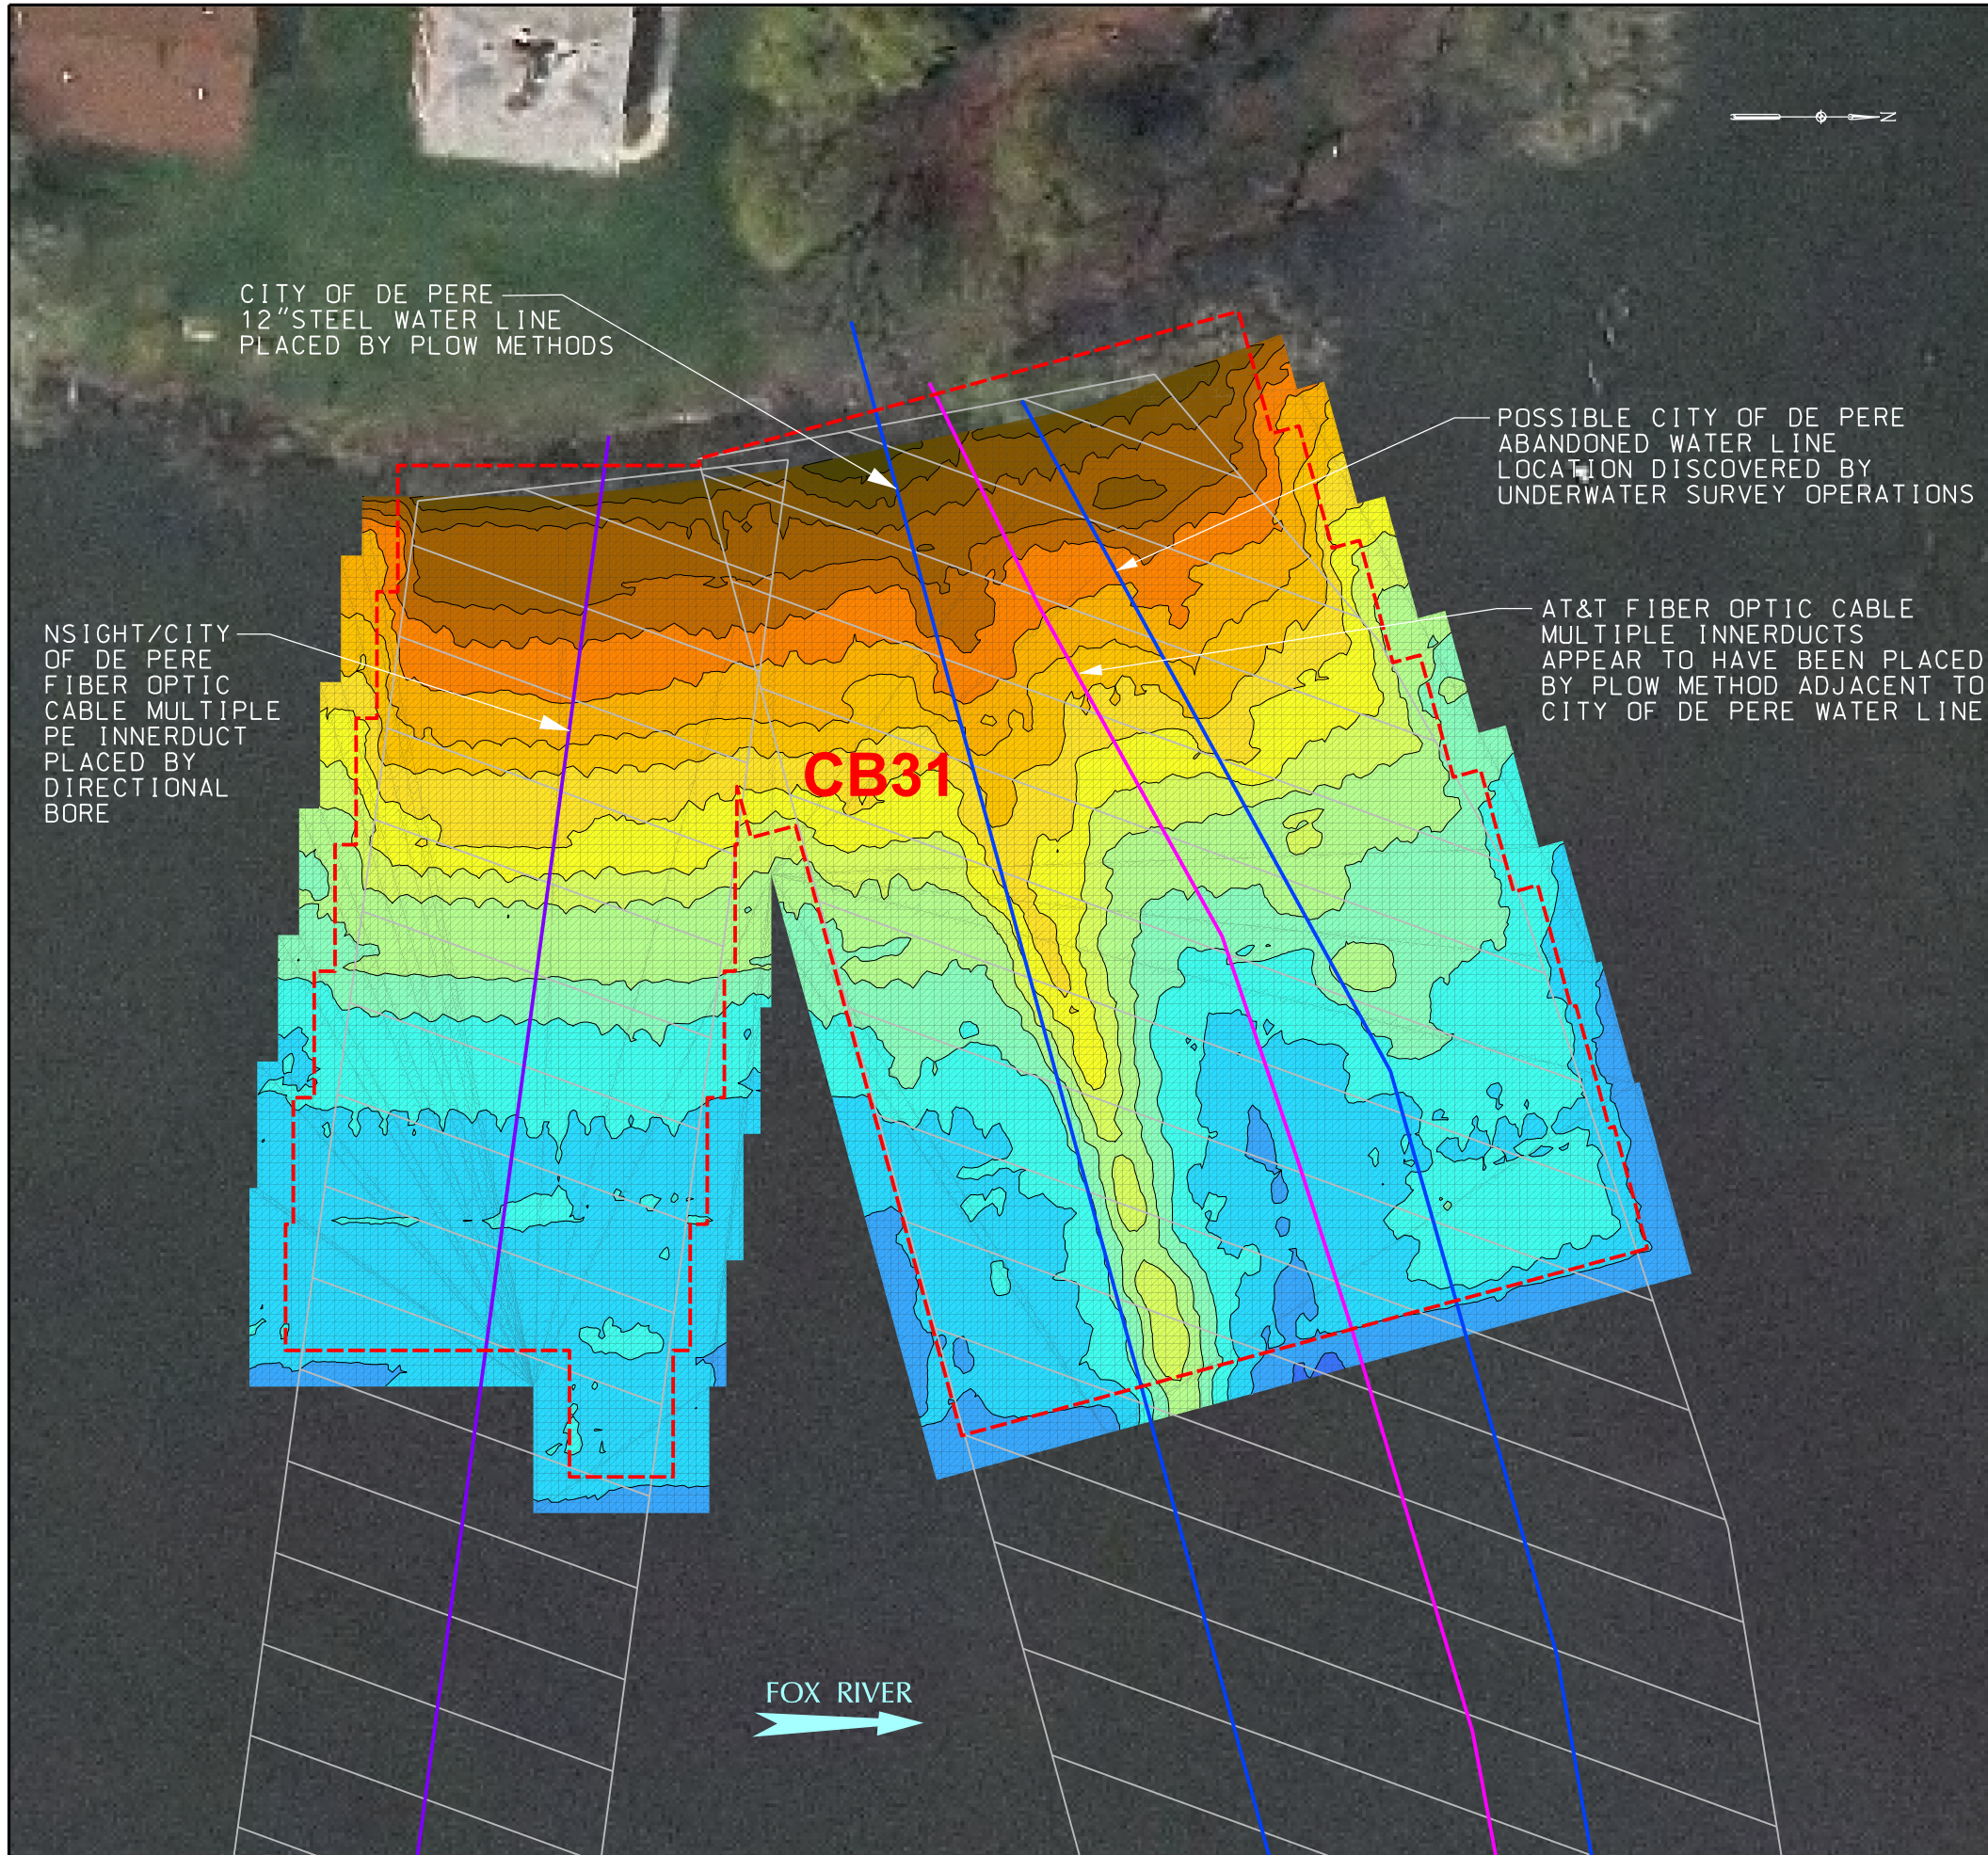
CITY OF DE PERE  
12" STEEL WATER LINE  
PLACED BY PLOW METHODS

POSSIBLE CITY OF DE PERE  
ABANDONED WATER LINE  
LOCATION DISCOVERED BY  
UNDERWATER SURVEY OPERATIONS

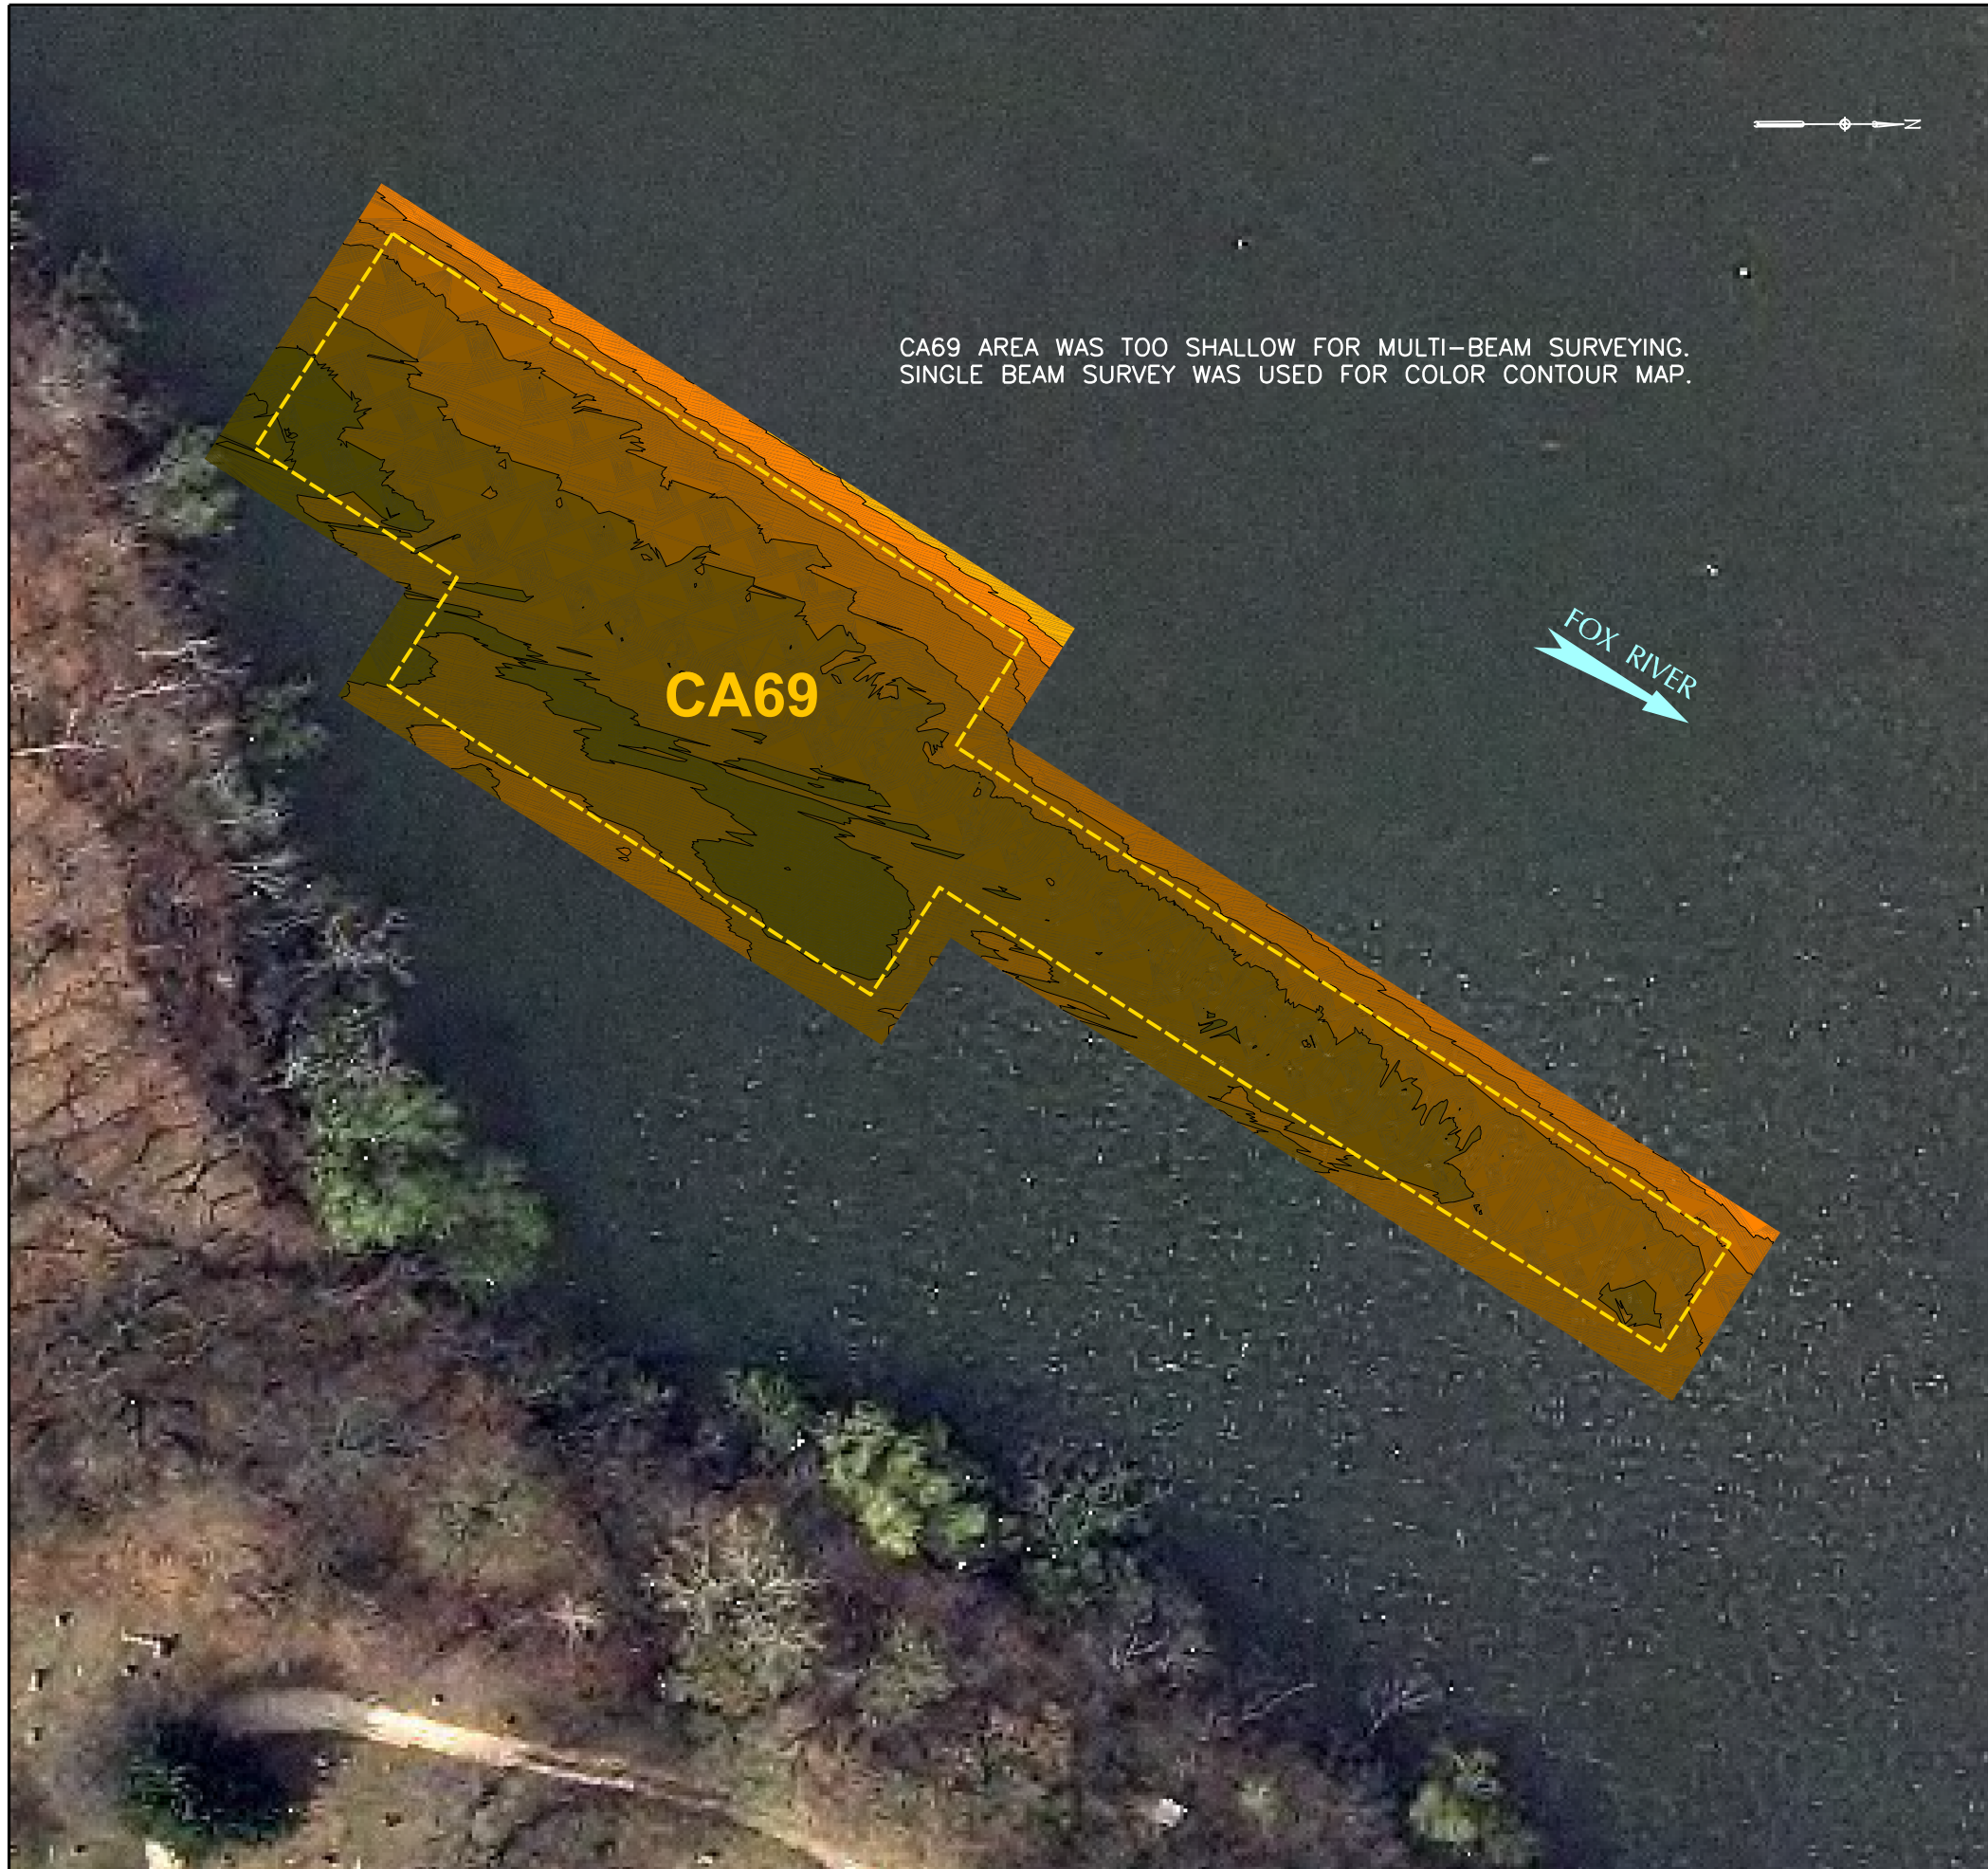
1. 200 KILOHERTZ (KHZ) SINGLE BEAM HYDROGRAPHIC SURVEY PERFORMED BY J.F. BRENNAN, CO. DATES OF SURVEY: NOVEMBER 2, 2011.
2. THE HORIZONTAL CONTROL IS REFERENCED TO THE NAD83 WISCONSIN STATE PLANE COORDINATE SYSTEM (WISCONSIN CENTRAL ZONE). THE VERTICAL CONTROL IS REFERENCED TO NAVD 88.
3. ORTHO PHOTO SUPPLIED BY BROWN COUNTY L.I.O. COMPILED IN NOVEMBER 2010.
4. DESIGN CAP PLACEMENT LIMITS DERIVED FROM DESIGN FILES PROVIDED BY TETRA TECH EC, INC.

As stated previously, CA 69 was not included in the multi-beam survey as water depths were not sufficient to allow for the multi-beam survey system to be utilized; however, a baseline survey was completed using single-beam equipment. Figure 15 shows the results of the CA 69 single-beam survey that will be used as the baseline information for future monitoring events.
