FINAL SUMMARY REPORT

**SEDIMENT MANAGEMENT UNIT 56/57 DEMONSTRATION PROJECT
FOX RIVER, GREEN BAY, WISCONSIN**

September 2001

**Prepared By:
Montgomery Watson**

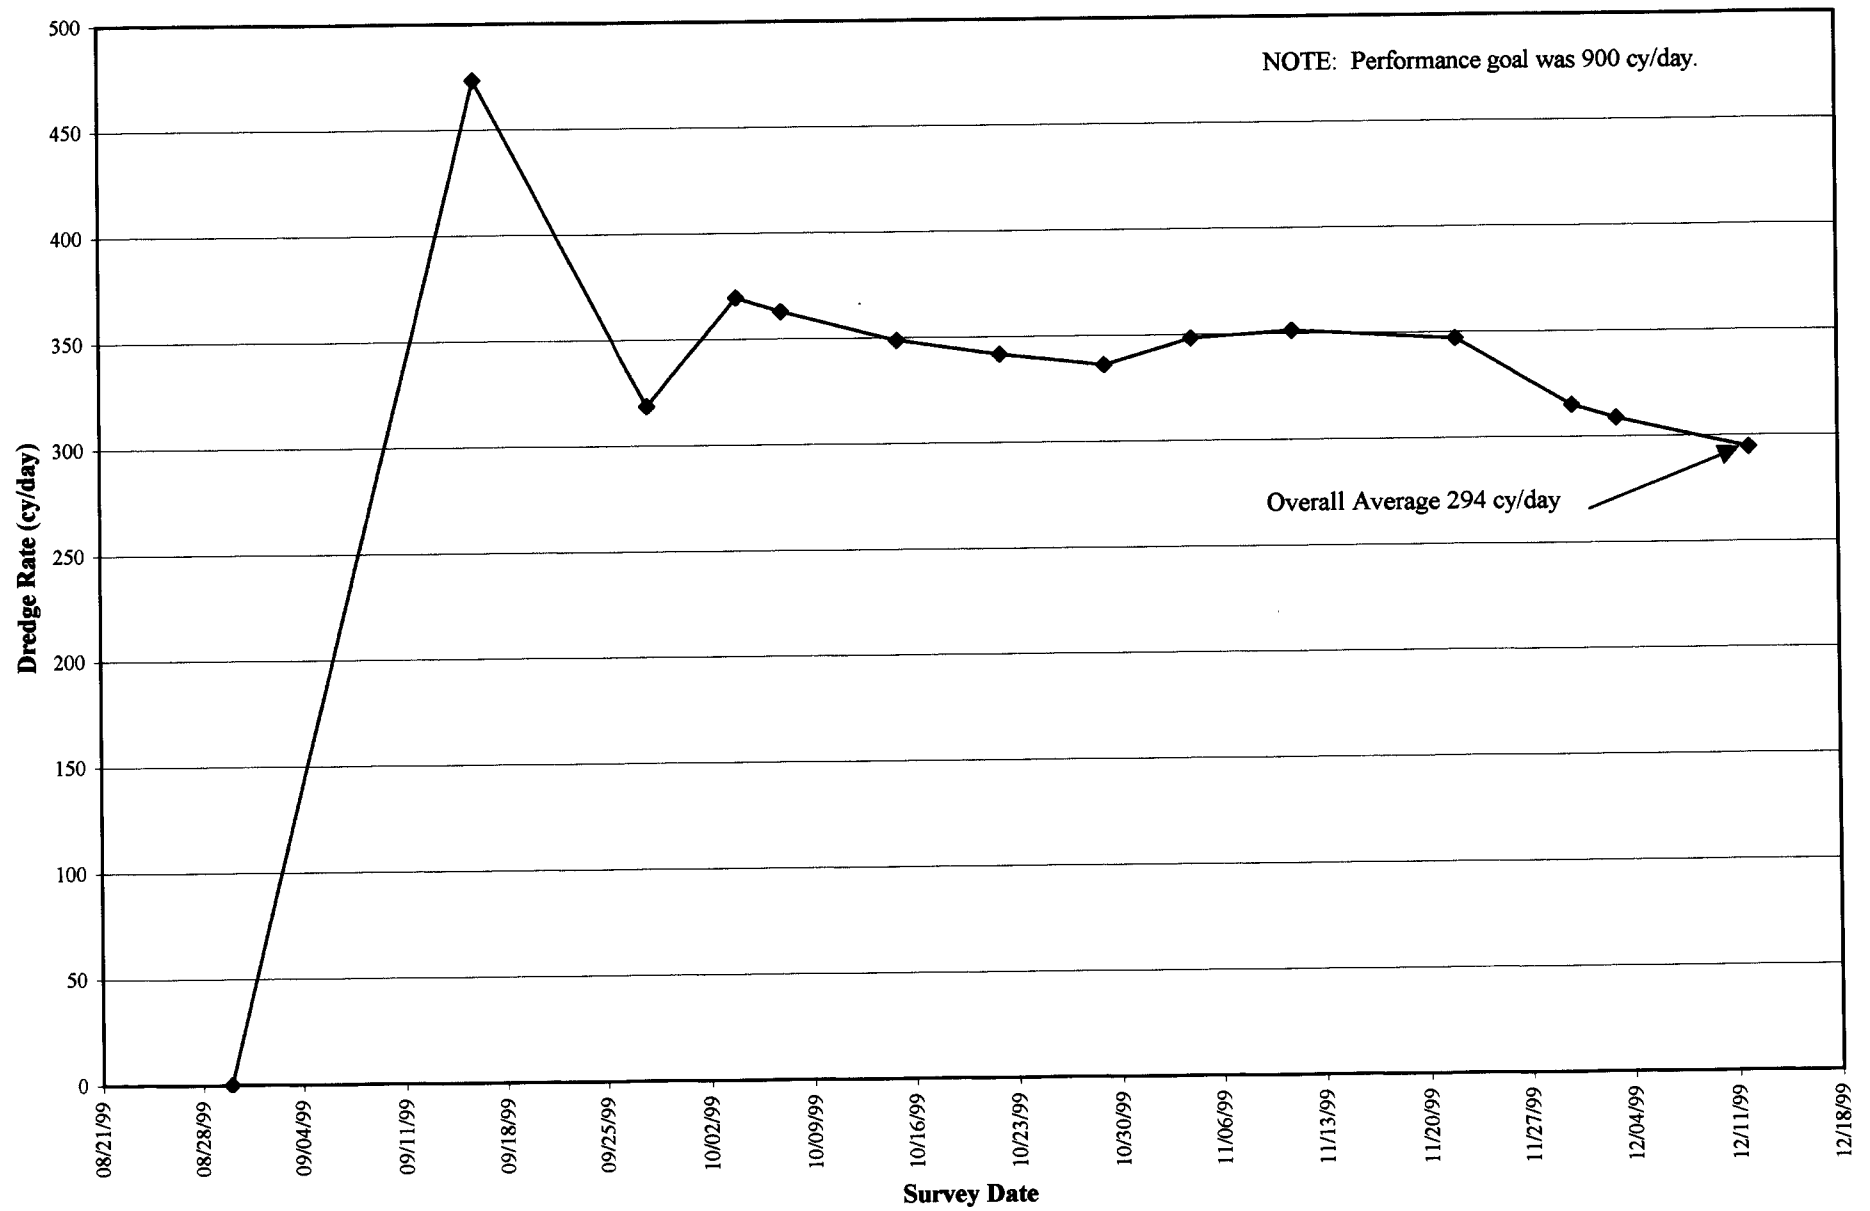
FIGURE 7 - DREDGING RATE - CUMULATIVE (CY/DAY)

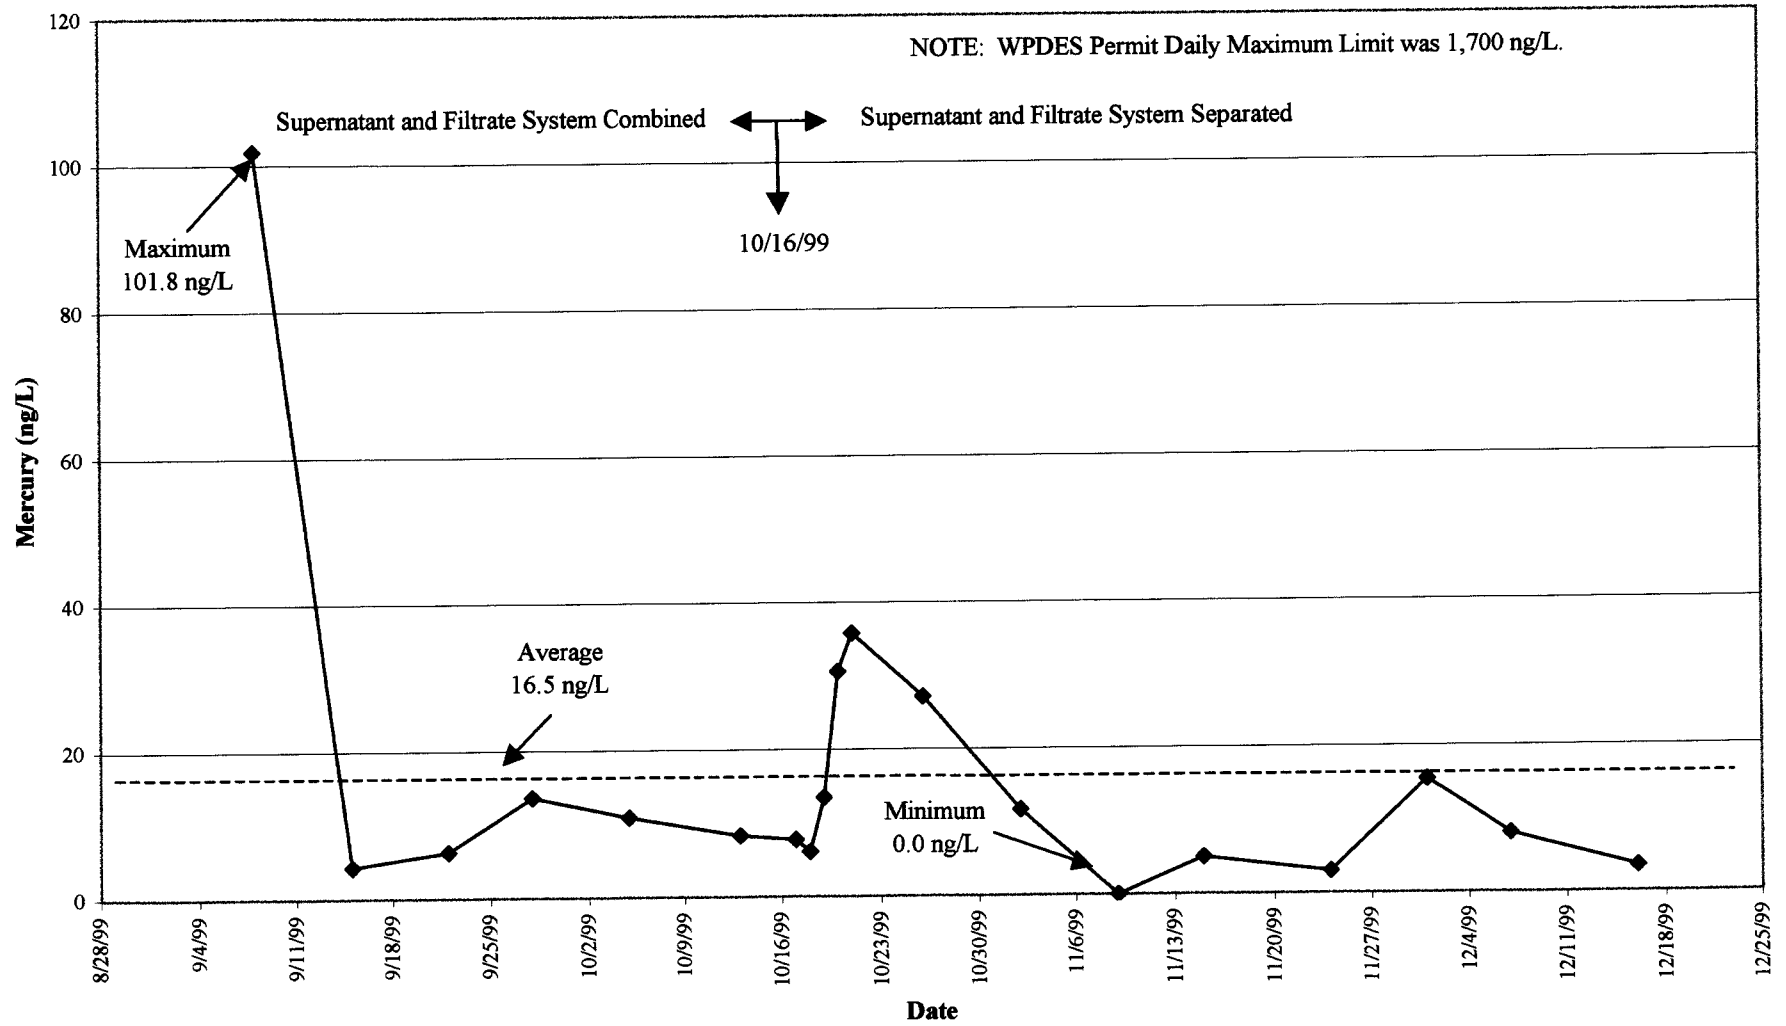
FIGURE 17 - EFFLUENT WATER (001) MERCURY

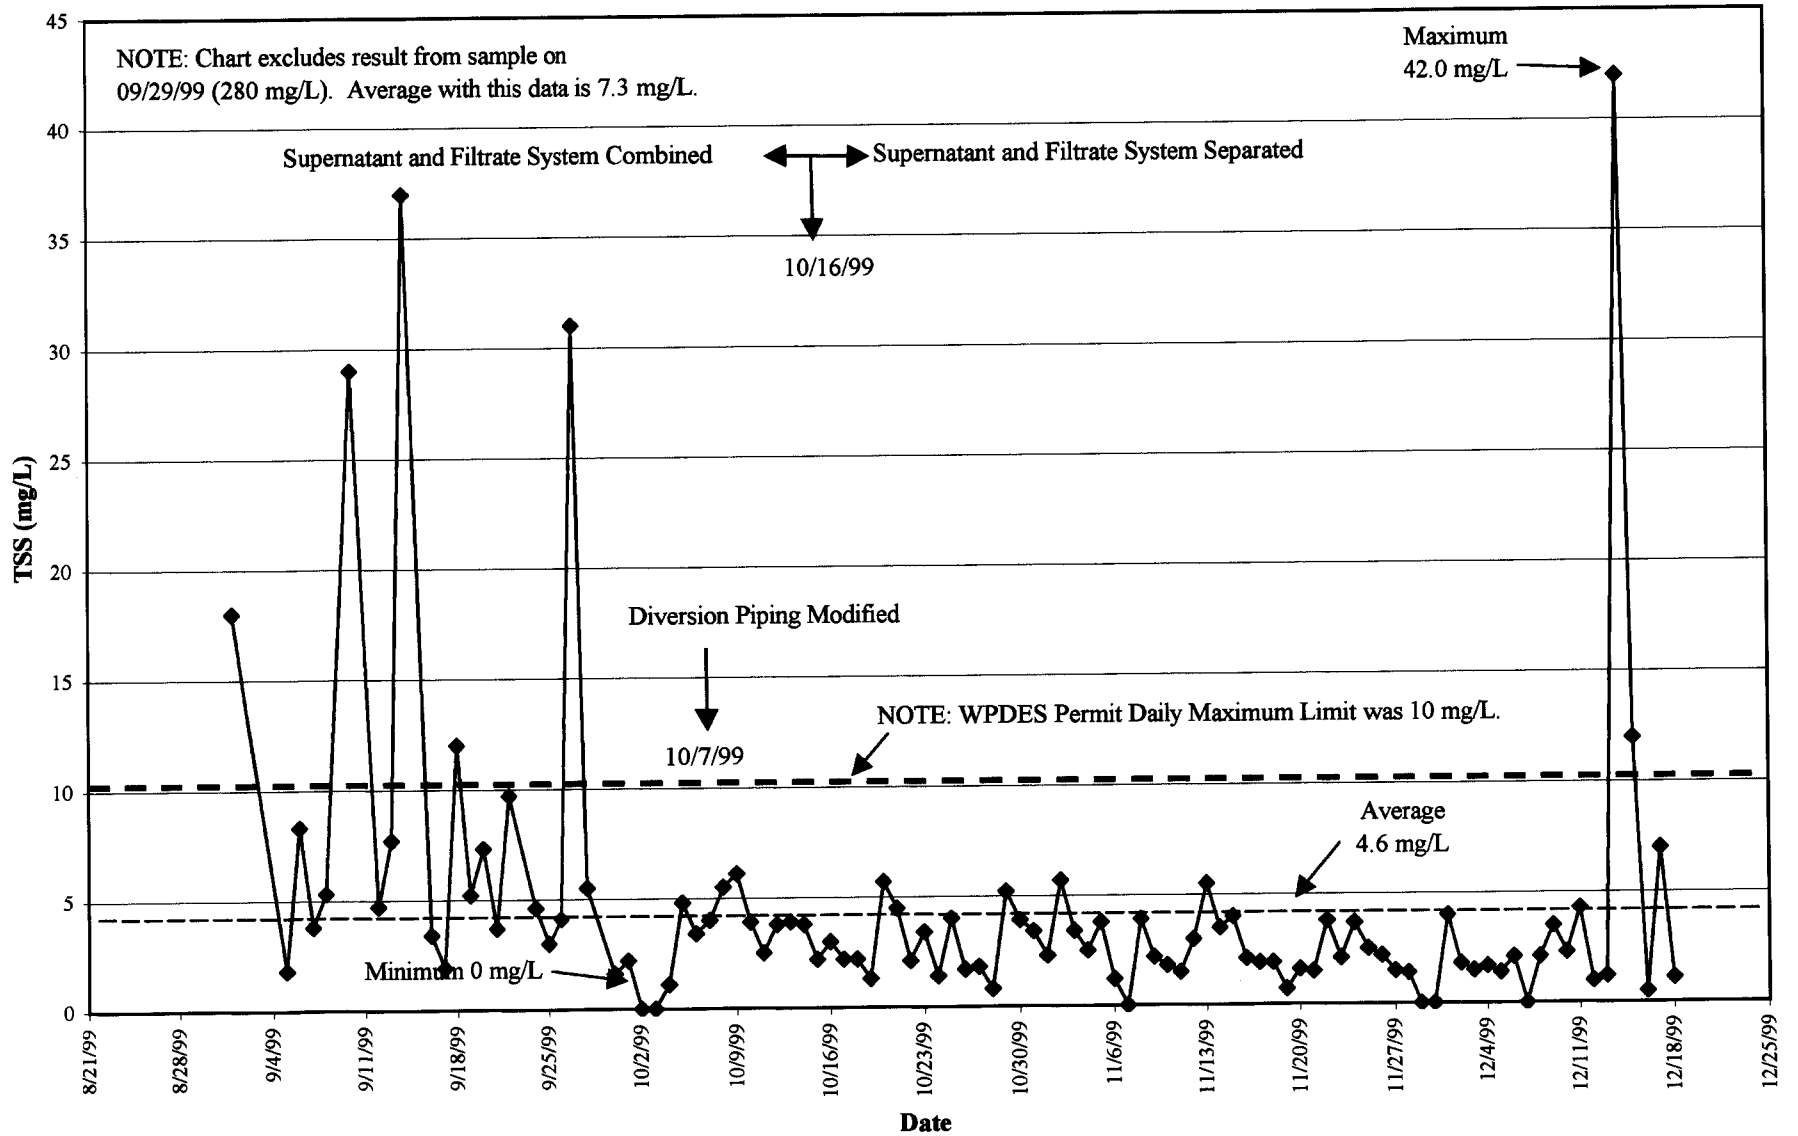
FIGURE 18 - EFFLUENT WATER (001) TOTAL SUSPENDED SOLIDS

The table above includes the total suspended solids (TSS) results of all daily samples. As noted, TSS concentrations shown on [Figure 18](#) exclude one result of 280 mg/L, which is anomalous compared to the other data. Without this value, the maximum measured concentration drops to 42 mg/L, and the average drops to 4.6 mg/L. Considering all results, the WPDES Permit daily maximum limit of 10 mg/L was exceeded six times in the first five weeks of operation. After learning of the results and diagnosing possible causes for periodic high values, the diversion valve and piping on the effluent line, used to circulate water back to the basins, was relocated upstream of the automatic sampler. Water was diverted back to the basins for re-treatment instead of to the river if the pH and/or

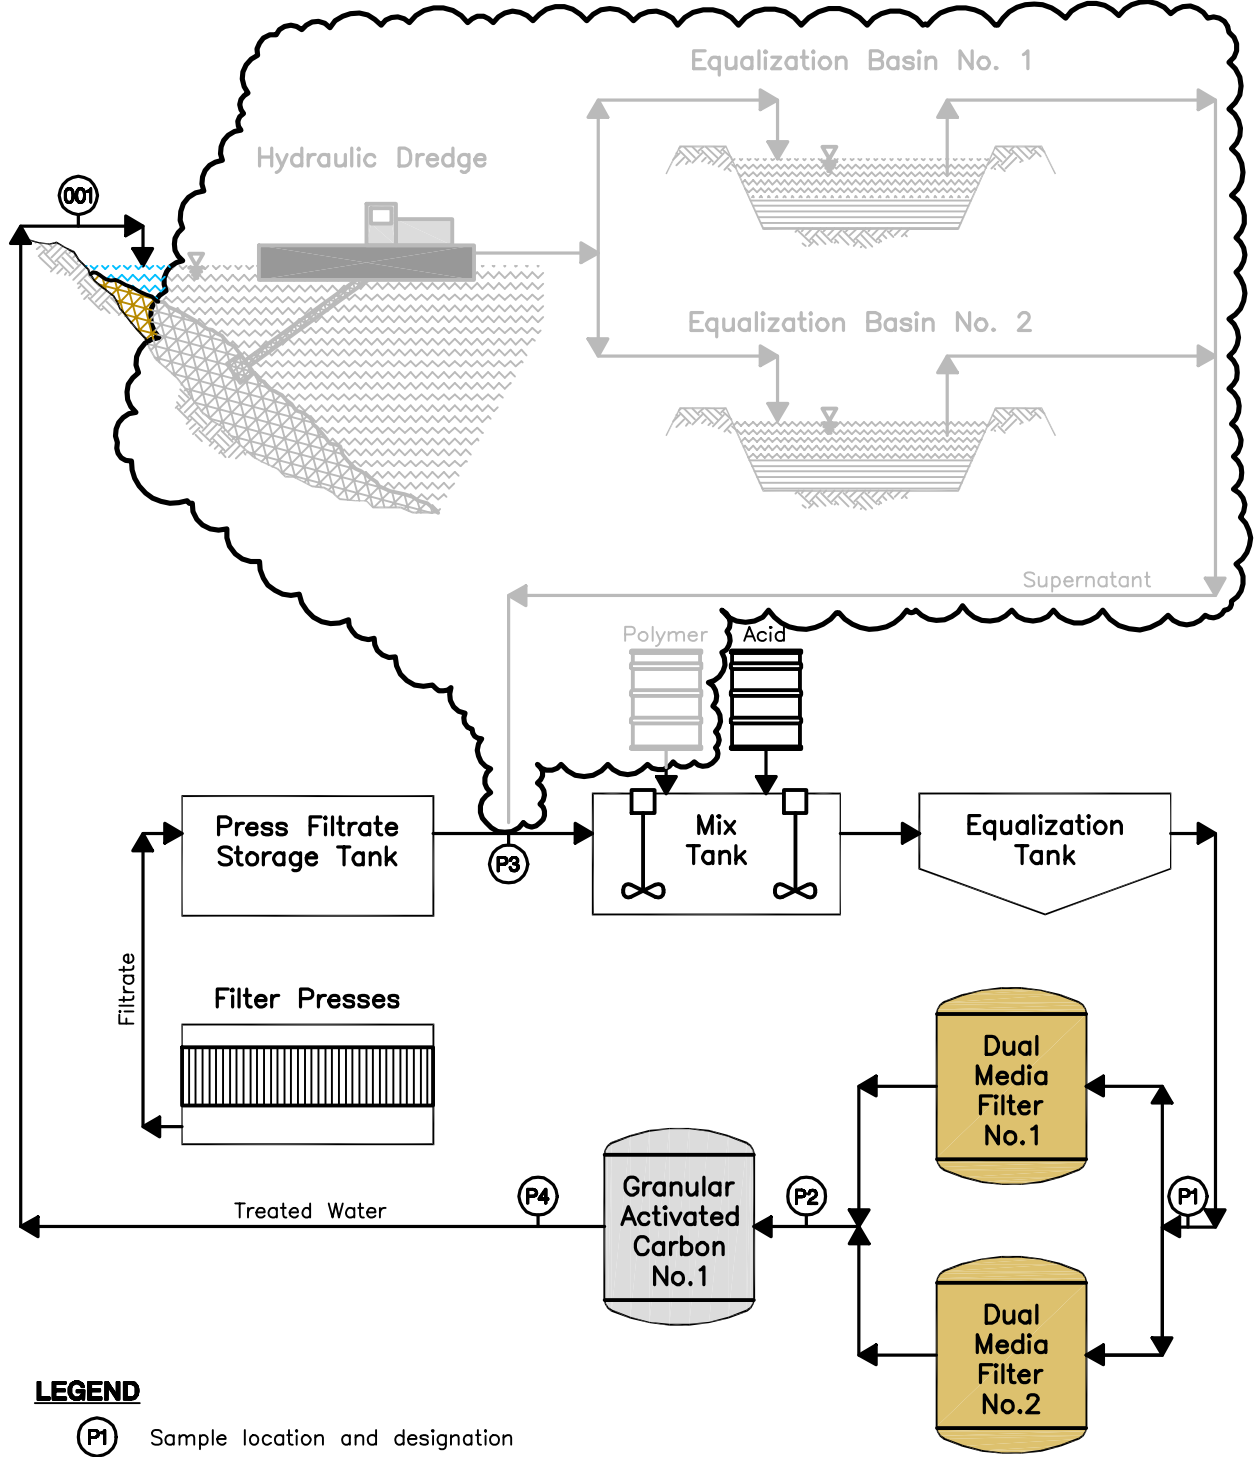
**PROCESS FLOW DIAGRAM
FILTRATE WATER TREATMENT SYSTEM**

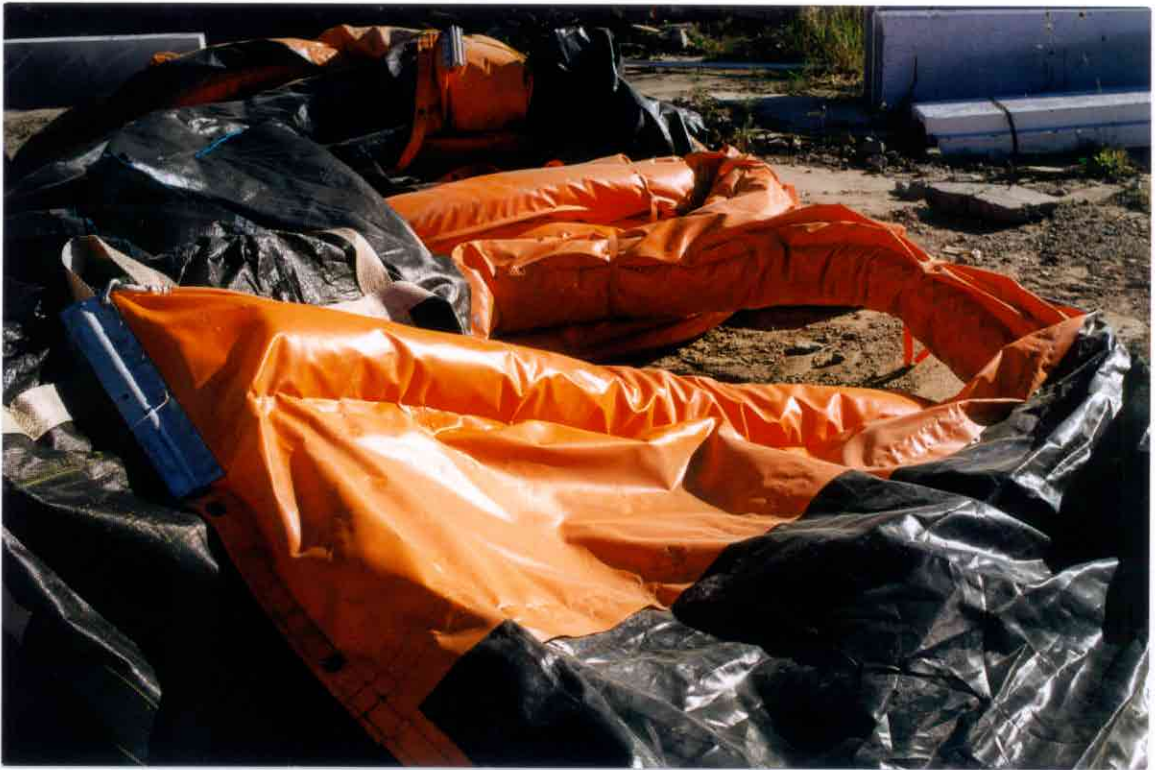
Photo No. 1: Spare silt curtain panel. Note orange floatation, black silt curtain skirt, and slide connector.

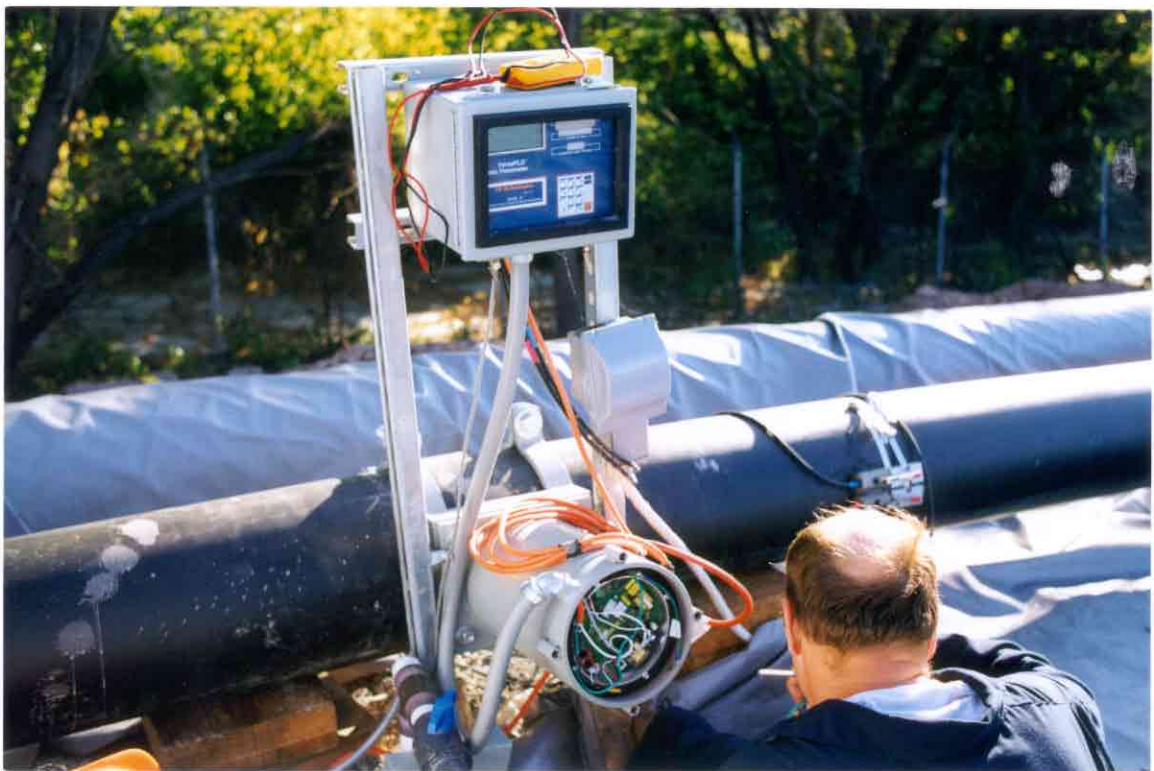
Photo No. 2: Dredge slurry flow meter.

A doppler flow meter was installed on the dredge slurry pipeline to measure slurry density, flow rate, and total flow. However, the dredging subcontractor experienced numerous problems maintaining and monitoring this meter throughout the Project. Examples of the problems included occasional loss of electric power to the instrument, and periodic and random stoppage of the flow meter operation for unknown reasons. This caused gaps in data acquisition, which led the subcontractor to often estimate results in his daily reports. Further, reported daily values for slurry density (in dry tons) consistently overstated the dredged mass removed, based on comparison to in-river dredge surveys and percent solids test results on slurry samples. For these reasons, Montgomery Watson considers the data to be unreliable and a discussion of the results is not included herein.

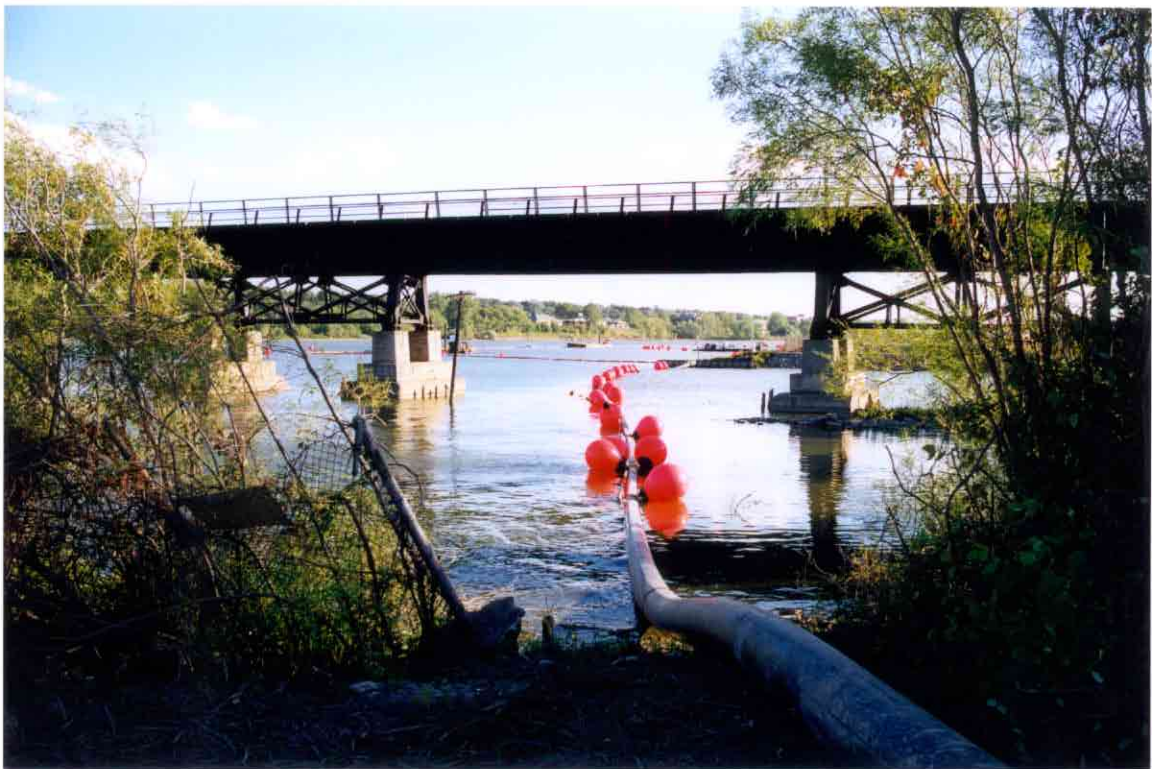
Photo No. 6: Dredge slurry pipeline across boat slip.

curtain between the on-shore booster pump and boat slip, was used to disconnect the slurry pipe for boat access. The slurry pipeline had the outer containment pipe between this coupling and the southeast corner of the east equalization basin. The slurry pipeline was a single pipe between the coupling and the dredge. Before the pipe was uncoupled to allow boat passage, it was cleared of dredged slurry by pumping river water from the dredge to the basins. Upon re-coupling, river water was again pumped to check for leaks before dredging was re-initiated.

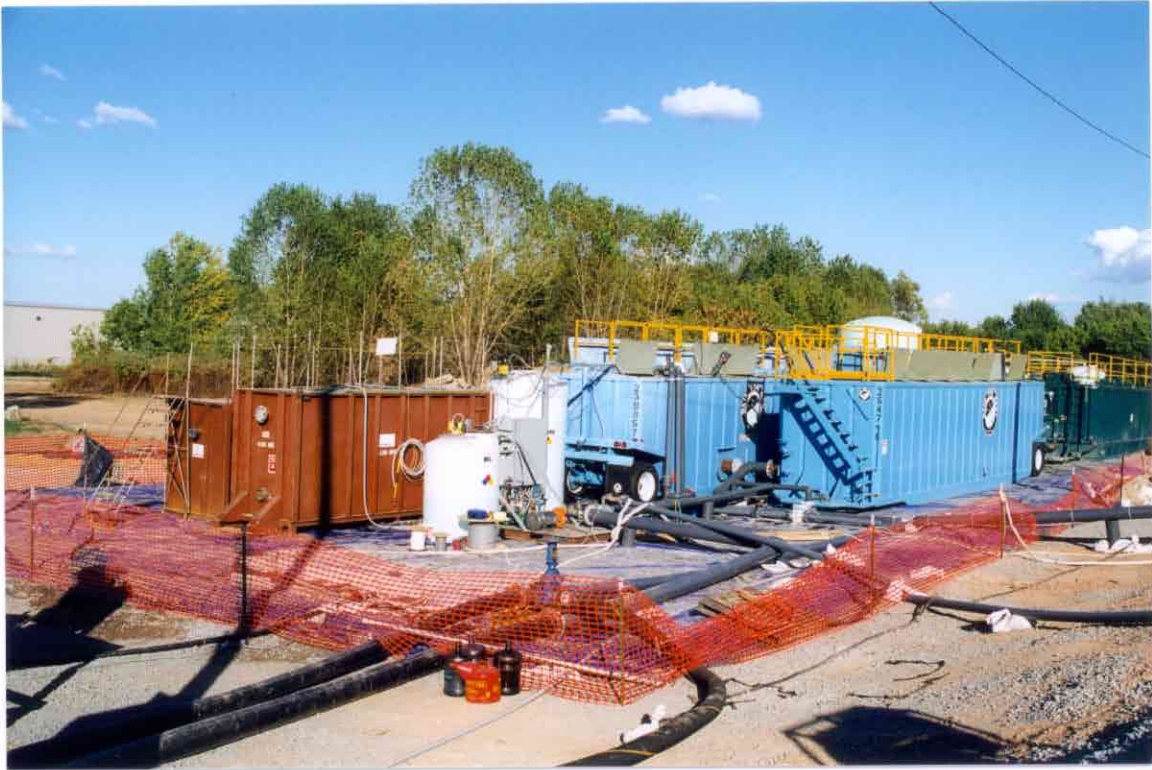
Photo No. 7: Water treatment - chemical addition and flocculation/equalization.

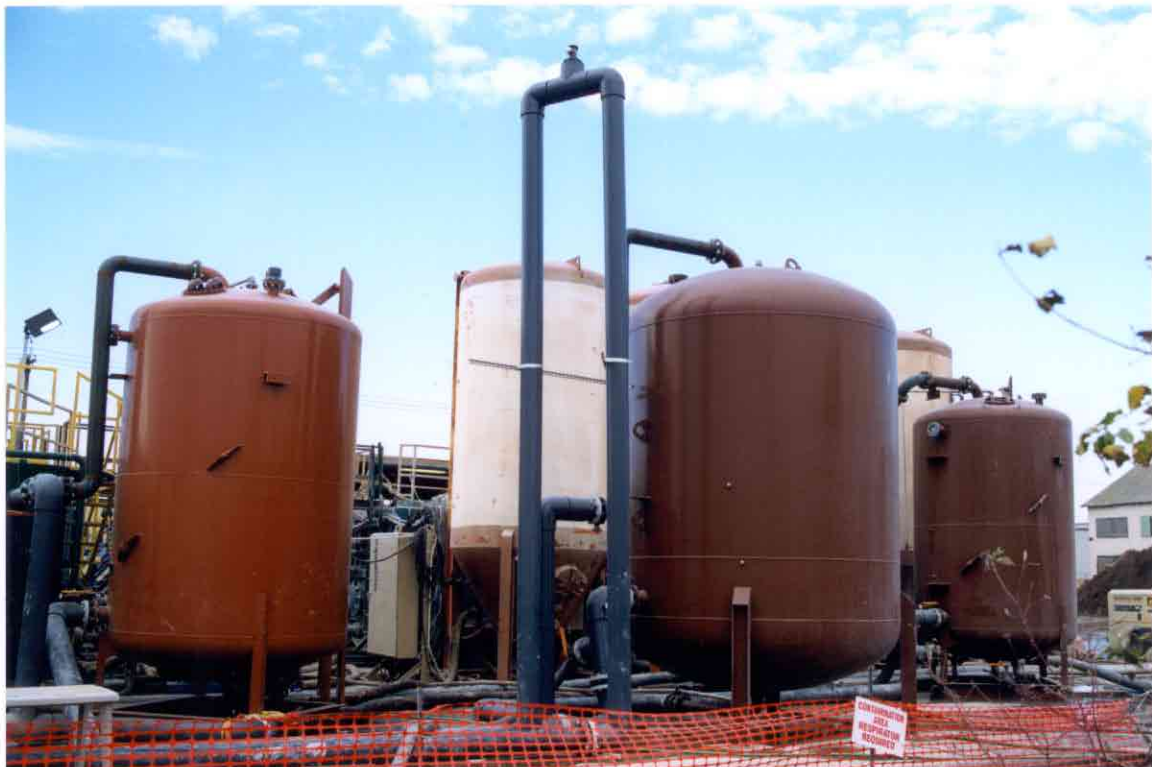
Photo No. 8: Water treatment - filtration and granular activated carbon.

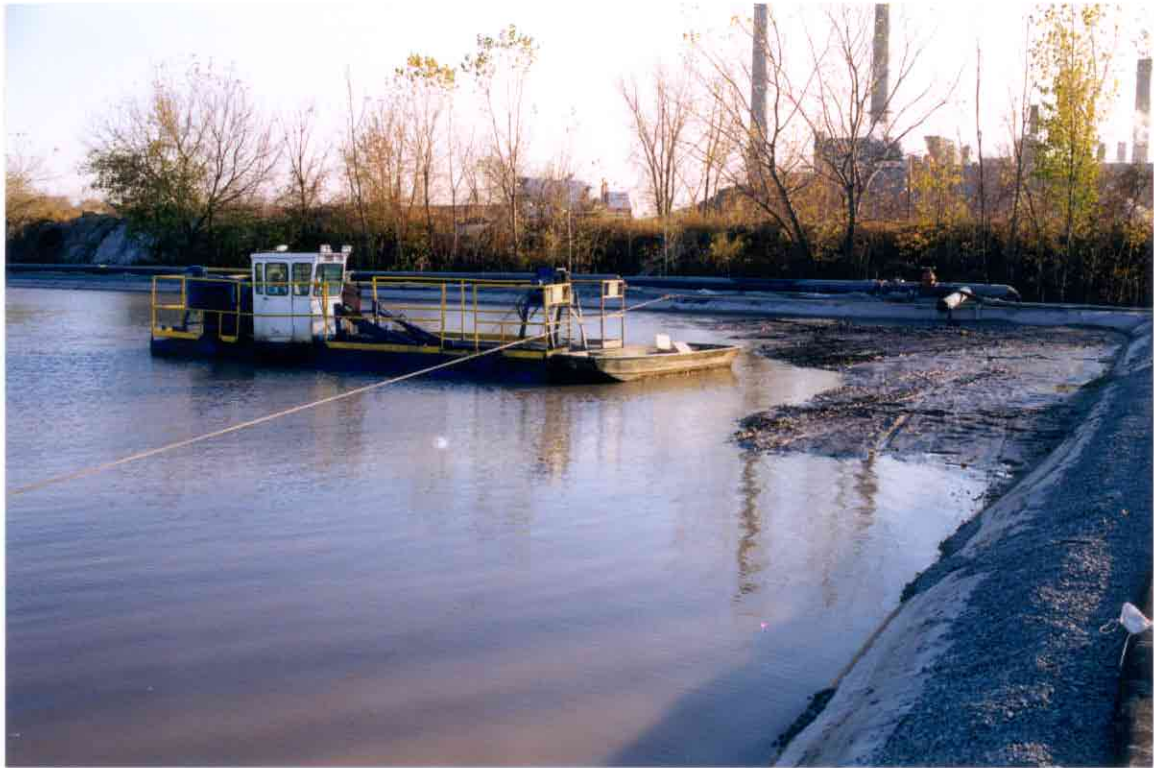
Photo No. 9: Small hydraulic dredge in west equalization basin. Note anchor and travel cables, and slurry discharge pipe.

The supernatant water and solids were removed from the east basin during the next two week period. Other cuts and tears in the HDPE liner were observed, determined to be caused by the steel shroud around the horizontal auger cutterhead of the small dredge. The wheels designed to keep the shroud off the bottom had apparently deflected, bending the axles connecting the wheels to the shroud, allowing the shroud to contact the liner.

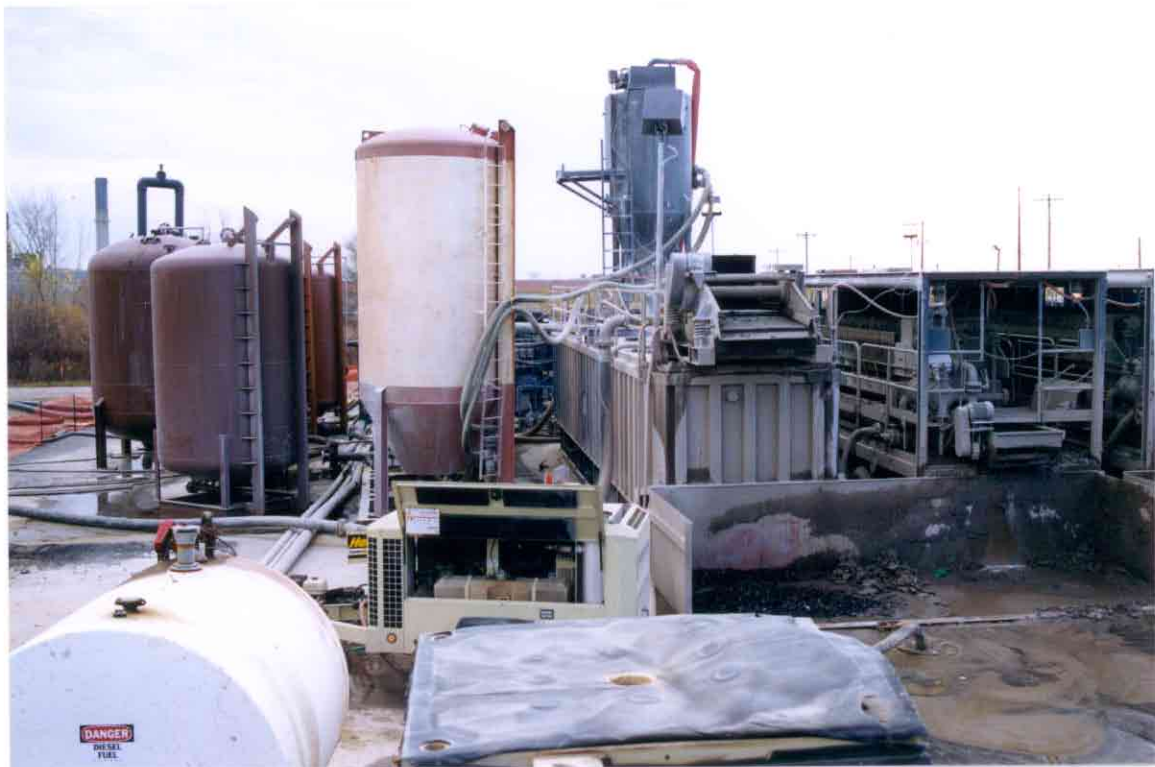
Photo No. 10: Slurry shaker mix tank, lime storage tanks, and lime feed system.

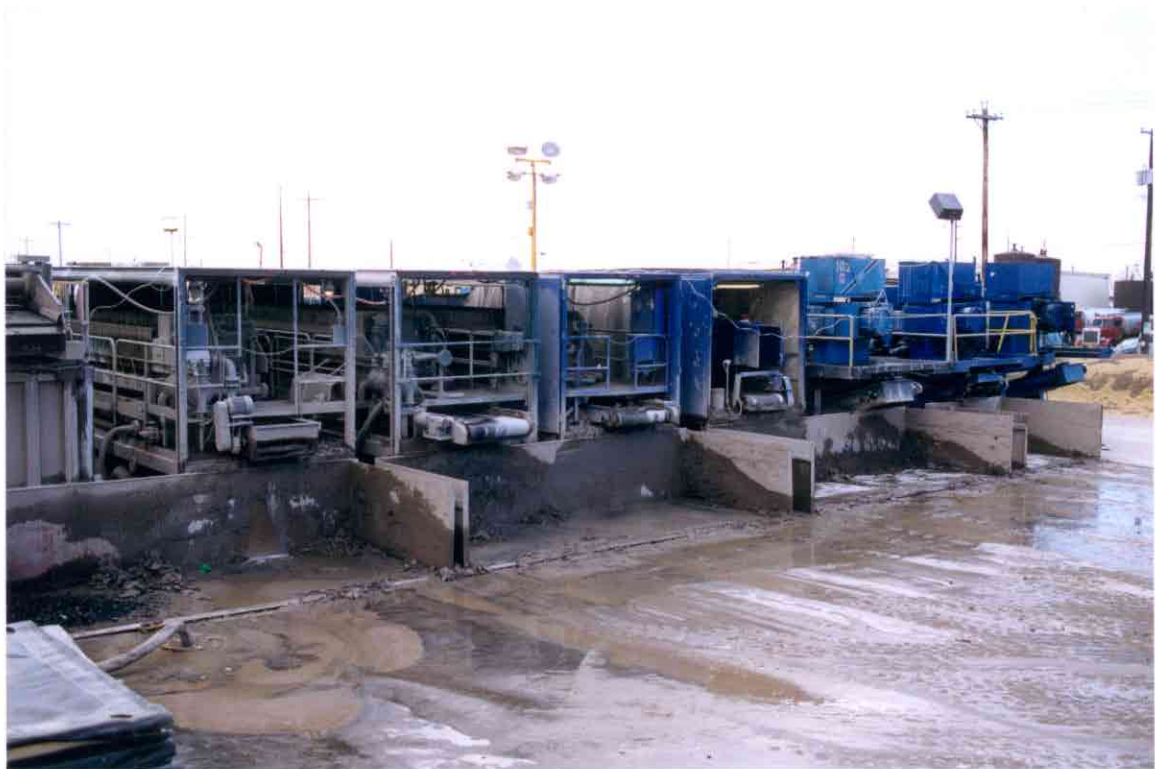
Photo No. 12: Filter presses. Note water collection sump in asphalt work pad on lower left corner.

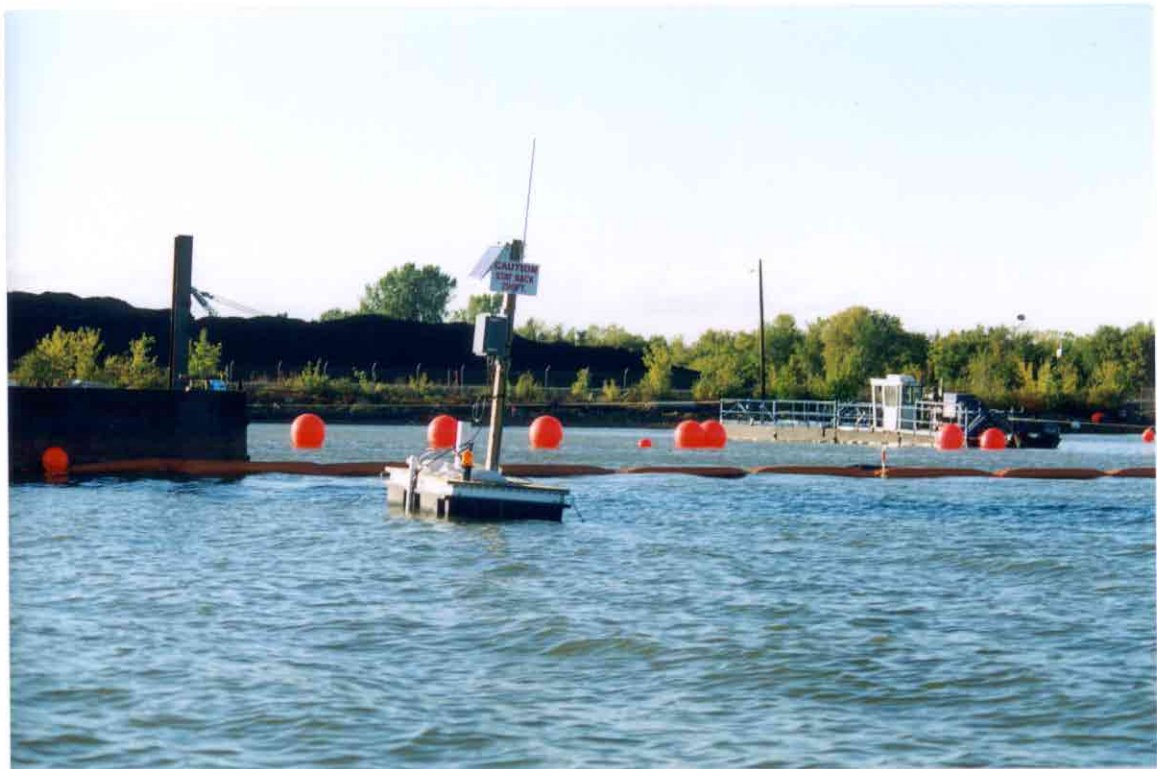
Photo No. 18: Real-time turbidity monitor on a float at the sidestream position outside the silt curtain. Also note the anchor barge, silt curtain, dredge pipeline floatation, and dredge.

The real-time turbidity monitors in the river (USO, USI, SSO, DSO, DSI) were initially installed on custom made floats approximately 4 ft by 5 ft in size (Photo No. 18), anchored at each corner with a rope tied to a concrete block. However, instability problems with the floats in rough water led Montgomery Watson to replace the floats with 6-in. or 8-in. diameter steel pipe piling (Photo No. 19), which were installed for us by McMullen & Pitz on October 5, 1999. A battery-powered, flashing amber beacon was installed at each river monitoring station. The turbidity monitor and transducer at FJI were installed on a wooden pole next to the water intake.

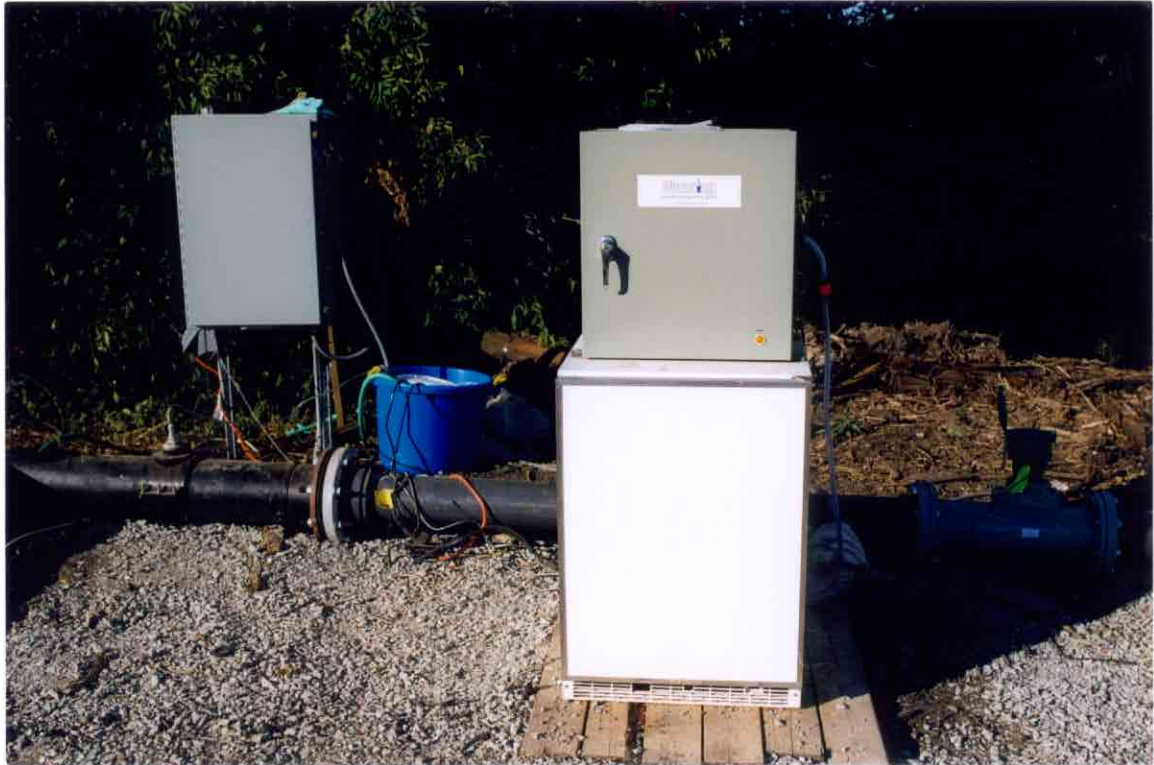
Photo No. 20: Automatic sampler on treated water discharge pipeline. Note flow meter on right side of sampler.

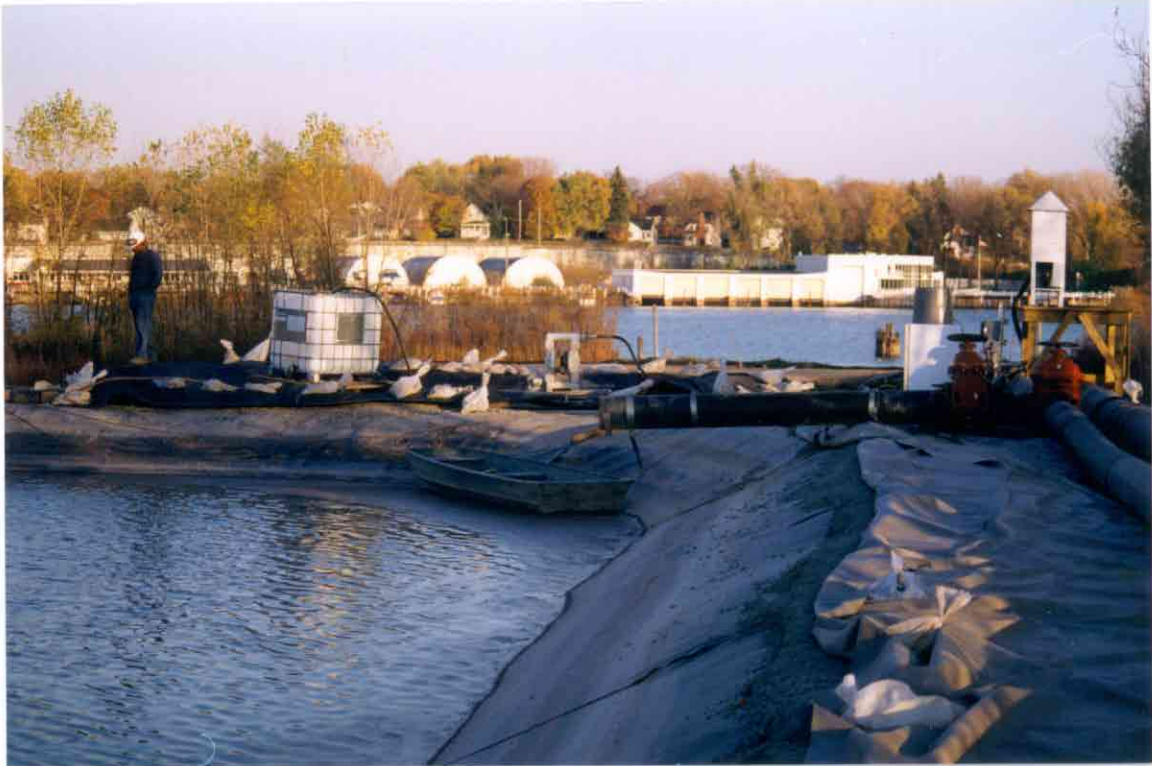
Photo No. 21: Dredge slurry sampling station at southeast corner of east equalization basin. Note valves on slurry pipe.

The sampler was wired to the slurry flow meter. The sampler was initially programmed to collect a representative aliquot of slurry for every 30 dry tons of sediment recorded by the mass flow meter (nuclear densometer). As noted previously, there were considerable problems maintaining the dredge slurry flow meter, and a consistent signal to the sampler was not able to be maintained. The sediment, and occasionally gravel and debris in the slurry, also regularly clogged the sampling hose and automatic sampler. Therefore, the FRRAT agreed that Montgomery Watson personnel would manually collect a dredge slurry sample periodically during dredging. As time allowed, the automatic sampler was manually turned on and off to collect an aliquot of dredge slurry in a 2.5-gal glass jar inside the refrigerated unit. The refrigerator held two glass jars, and generally a slurry sample was collected each day dredging was performed. USGS personnel came to the site throughout the week to pick up the slurry samples in the 2.5-gal jars. They processed each sample, and then returned the sample and cleaned jars. The slurry samples were submitted to EnChem with a chain of custody form for analyses.

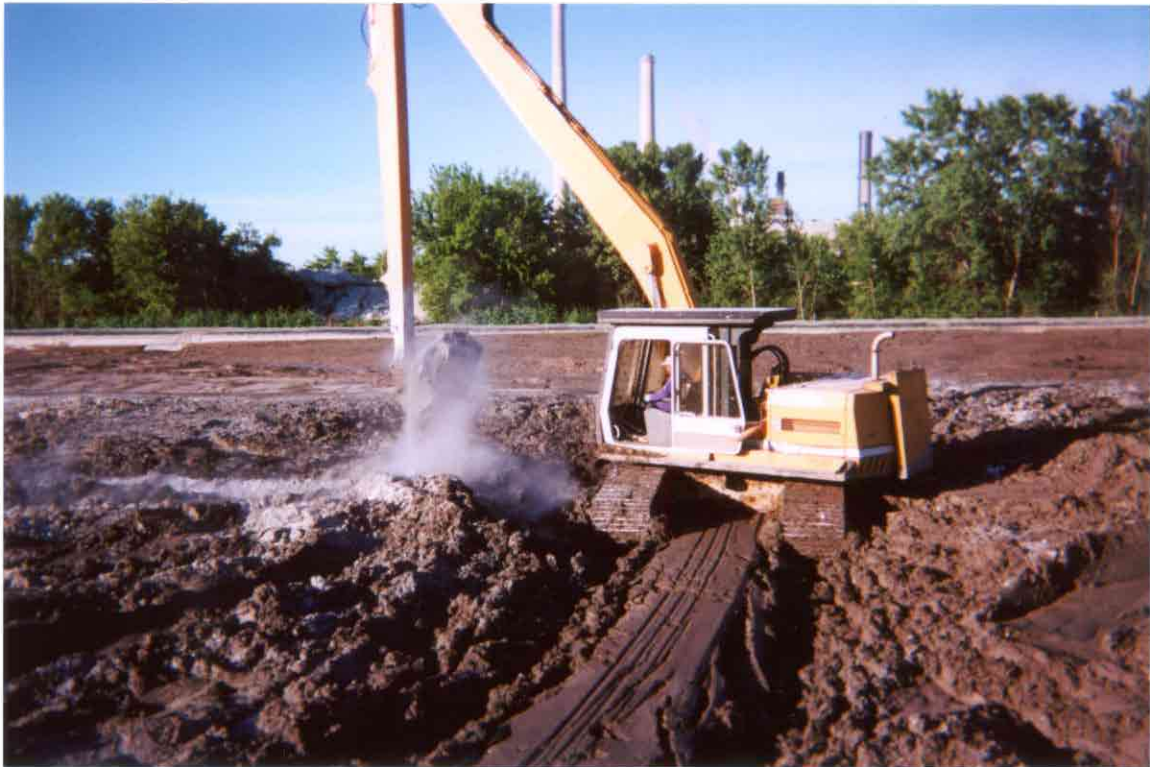
Photo No. 28 Solidification of sediment in the west equalization basin using hydrated lime.

- Treatment and river discharge of all but approximately 0.5 to 1.0 ft of water in the east and west equalization basins. Due to cold conditions, it was impractical to remove the last portion of dredged solids from the west equalization basin (rough estimate of 3,000 cy), and a thin layer of water treatment settled solids in the east basin. Therefore, both basins were then covered with a temporary polyethylene cover, weighted down at the top of the perimeter berm.
- Removal of the production river dredge, the cutterhead dredge used as an anchor barge, and the other anchor barge.
- Removal of the water treatment system, including tanks, pumps, controls and most of the filter media and carbon.
