2024 SPUR LAKE MANAGEMENT PLAN

Wisconsin Department of Natural Resources, 107 Sutliff Ave Rhinelander, WI 54501

April 2024

Spur Lake & Twin Lakes Creek Assessment Report

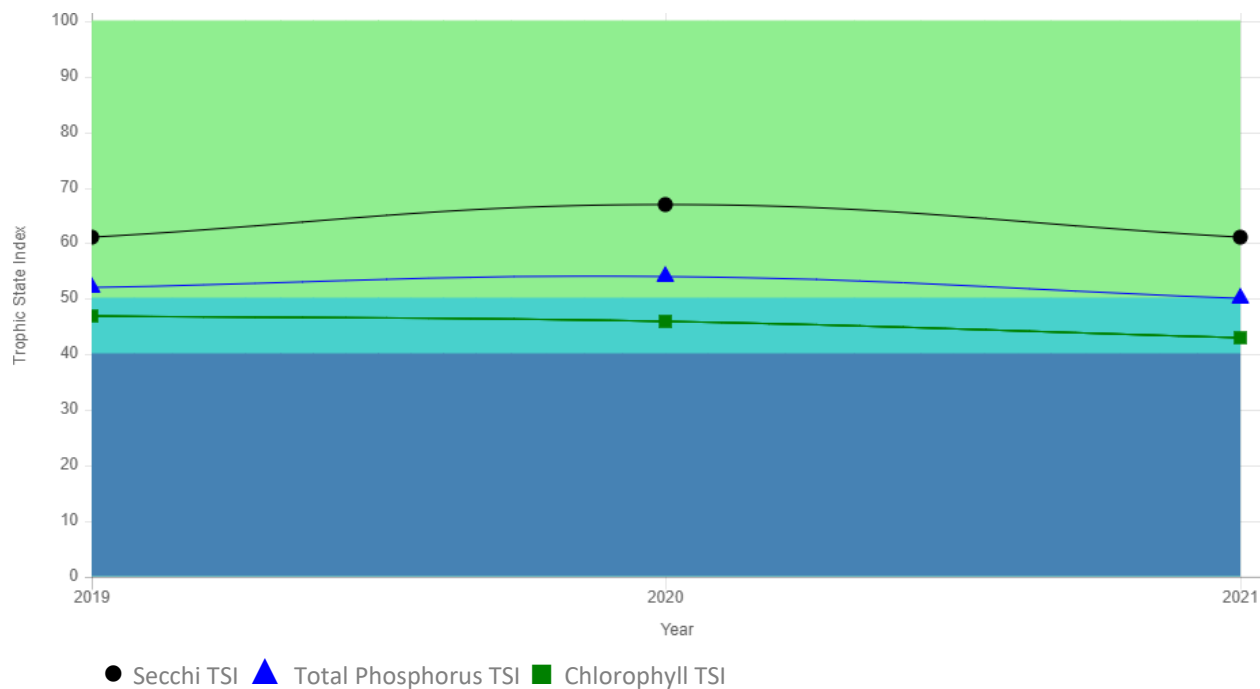
Figure 2. Trophic State Index Graph for Spur Lake. Displays average summer (July-August) Trophic State Index values for Secchi, total phosphorus, and chlorophyll a by year.

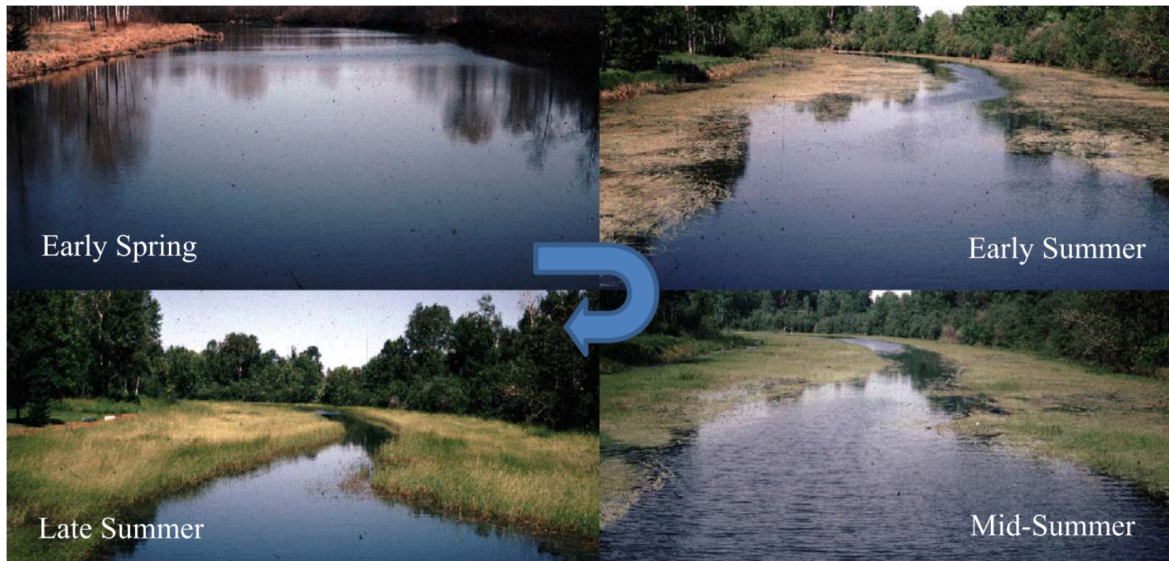
Figure 1. Life cycle of Manoomin reproduced from David et al. (2019).

Manoomin germinates in the early spring, reaches the water surface during the floating-leaf stage through June, emerges out of the water and flowers in mid-July, and reaches full maturation in September when it is consumed by waterfowl and harvesters (Aiken et al. 1988). Manoomin is wind-pollinated, with most cross-pollination occurring between nearby plants (Lu et al. 2005). In addition, Anishinaabe harvesting practices, waterfowl, and wind knock ripened seeds back into the water, reseeding the beds for the next year (Moyle 1944, Moodie 1991). Seed falling into the water near parent plants leads to generally short dispersal distances (Kjerland 2015), though waterfowl may contribute to longer-distance dispersal (Vivian-Smith and Stiles 1994, Diller et al. 2018). Together, short-distance pollination and dispersal limit gene flow between watersheds and give rise to unique, locally adapted genotypes, or strains, of Manoomin (Lu et al. 2005, Xu et al. 2015, but see Diller et al. 2018). The seeds require a period below or near freezing to induce germination (Atkins et al. 1987). Manoomin commonly exhibits an approximately 4-year cycle of abundance where years of low yield follow high ones (David et al. 2019). This has been attributed to microbial immobilization delaying availability of nitrogen from decaying Manoomin litter (Walker et al. 2010). However, other environmental factors, notably water levels, also influence abundance, leading to several consecutive good or bad

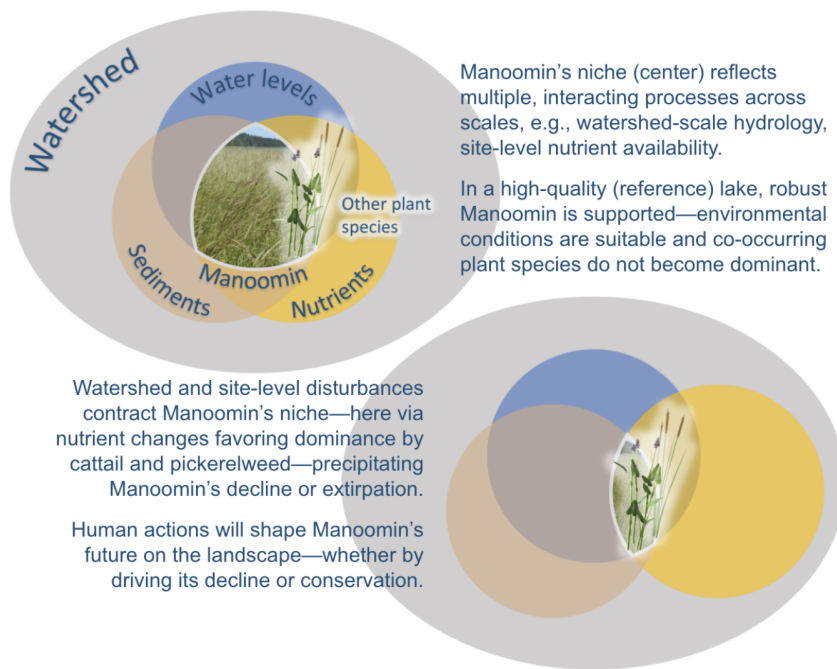
Figure 4. Manoomin niche model.

Our second conceptual model, seen in Figure 4, represents the dynamics surrounding the ecological niche in which Manoomin thrives. Specifically, we have conceptualized a Venn diagram of factors aligning or misaligning to determine the likelihood or abundance of Manoomin. Three of these factors on which we are currently focusing are water levels, sediment, and nutrients; however, these are not the only factors influencing Manoomin presence at any given site.

A project goal is to eventually move the Manoomin niche conceptual model (Figure 4) to include the interconnected relationship with people, as captured in the Manoomin socio-ecological systems model (Figure 3). During the 2020 December conference, Kate Hagsten, resource manager for the Leech Lake Band of Ojibwe, posed one particular hypothesis that brings these two ways of looking at the Manoomin community together. She proposed that the decline in Manoomin harvesting may have increased the likelihood of brown spot disease and presence of rice worm, because with less harvesting, more seeds germinate, increasing stem density and stand humidity, factors that correspond with brown spot disease (David et al. 2019) and rice worm abundance (Dahlberg and Pastor 2014).

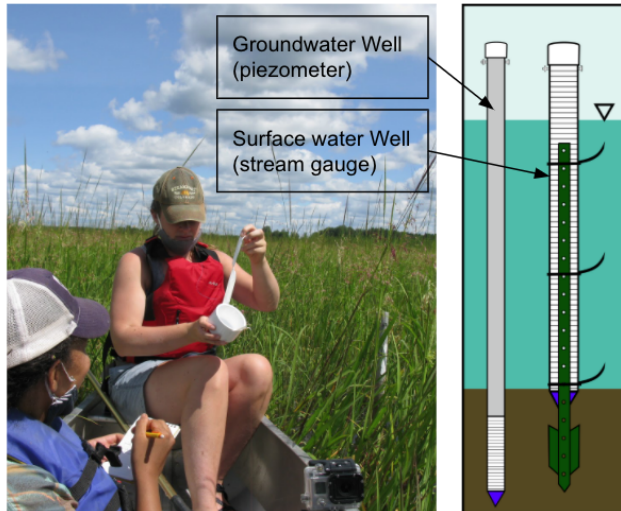
Figure 6. Maddy and Hannah Jo checking sensors in a Perch Lake groundwater well in July 2020. Groundwater wells (piezometers) were constructed from PVC pipe with open screening below the lake bottom. Water filling this well reflects the groundwater level (groundwater hydraulic head). Surface water wells (stream gauges, pipe diagram on the right) were constructed from PVC pipes with screening throughout their length, so the water level within these wells reflects the surface water level (surface water hydraulic head).

Automated water level sensors called “pressure transducers” (sometimes referred to as “data loggers”) were deployed in groundwater wells (or “piezometers”) and surface water gauges. The sensors were commercial units (Schlumberger Barologger or Solinst Levelogger Jr. Edge). Measurements were made at regular sub-hourly intervals (15 minutes or 30 minutes) in both surface water and groundwater wells.

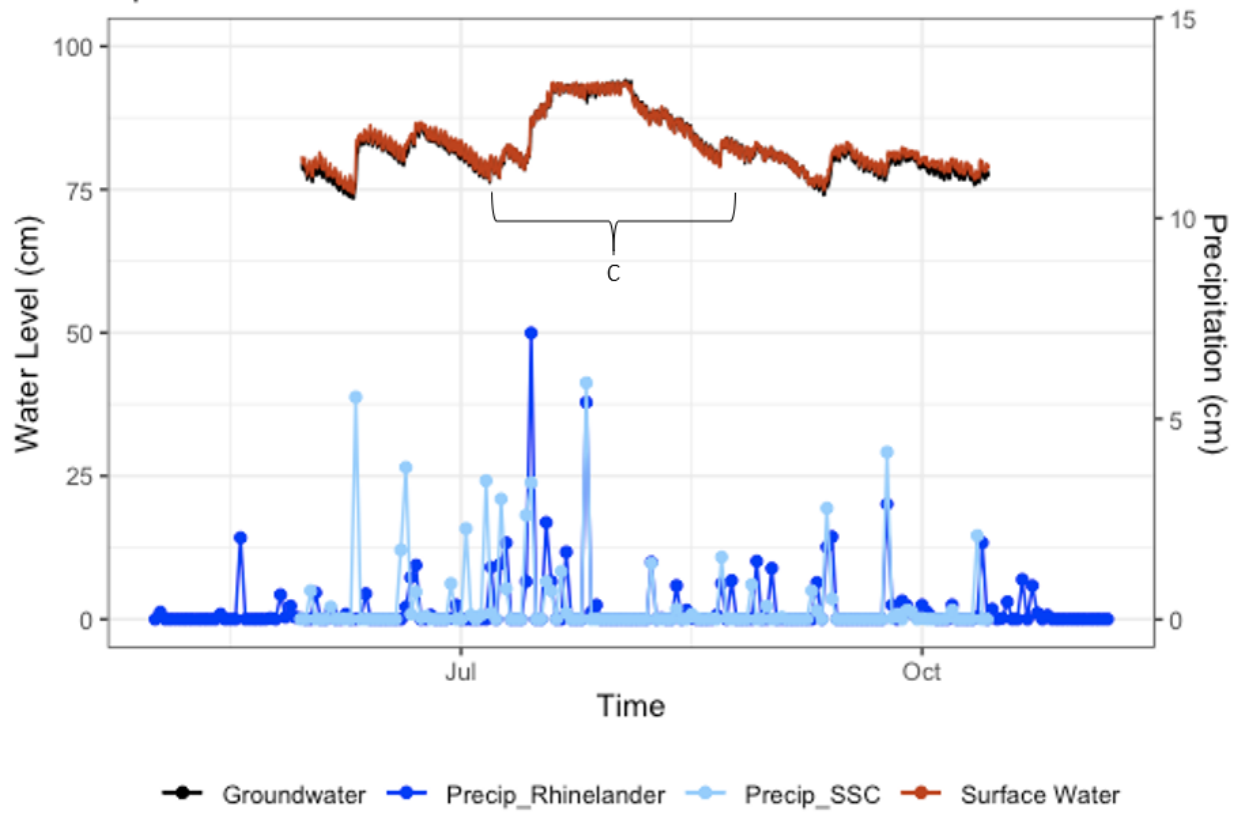
Figure 7. 2018-2021 surface water levels, groundwater levels (2019-2021), and precipitation for Spur Lake. Groundwater and surface water levels (hydraulic head) are plotted in centimeters above the lake bed. The precipitation record was collected from the nearest station Rhineland-Oneida County Airport Station (~25 miles west) (obtained from weatherunderground.com (2018-2020) and Midwest Regional Climate Center’s CliMATE dataset (2021)), and from the Sokaogon Chippewa Community (SCC) rain gauge (~30 miles to the south). Arrows indicate management actions undertaken during 2018-2021: a) riffle structure removed from outlet channel, b) spillover dam, beaver dams, and vegetation and sediments in Twin Lakes Creek removed, c) vegetation and sediments removed from Twin Lakes Creek multiple times in July and August, d) vegetation removed from stream channel downstream of Spur Lake, e/f) old beaver dams removed from Twin Lakes Creek. [Note we will switch all precipitation data to data from the Midwest Regional Climate Center’s CliMATE dataset in the future]

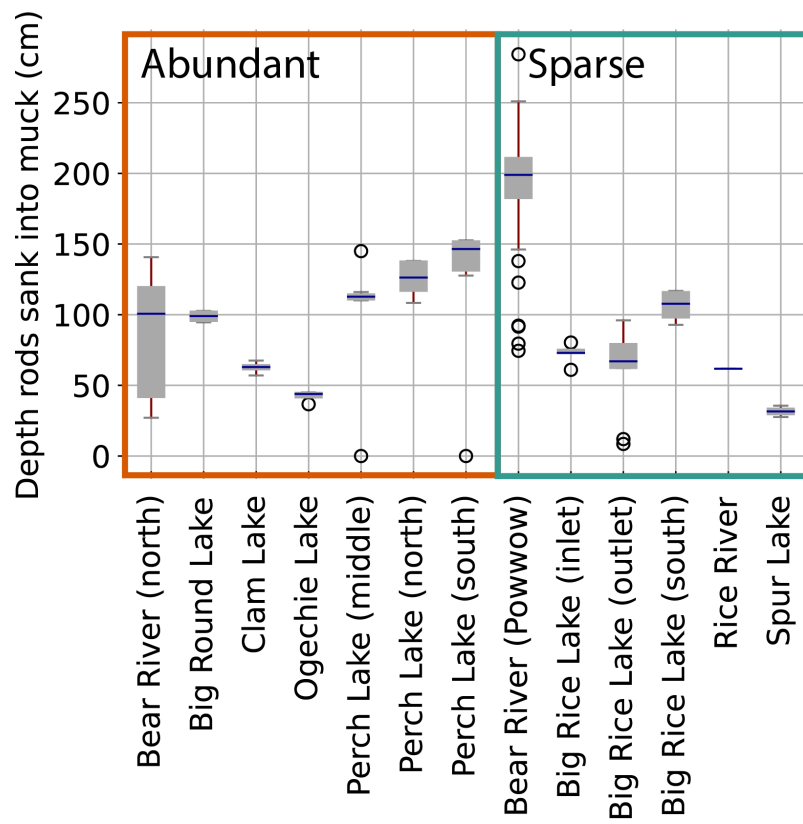
Figure 8. 2021 Depth that a 4m drive rod sank to across field sites, including abundant and sparse sites.

Sediment density matters to Manoomin health. Manoomin does not grow well in very loose sediments. This is a concern at some of our field sites, so we decided to take measurements across all of our sampling locations. We recorded the depth that two different instruments sunk into the sediment: a Secchi disk and a 4-m drive rod. Both the drive rod and the Secchi disk were placed into the water and allowed to sink until they stopped moving. We specifically chose not to push in the drive rod and instead let it sink itself in order to standardize the measurement. (We found in the past that different people were able to push in the drive rod with different forces, so it was not a consistent measurement.)

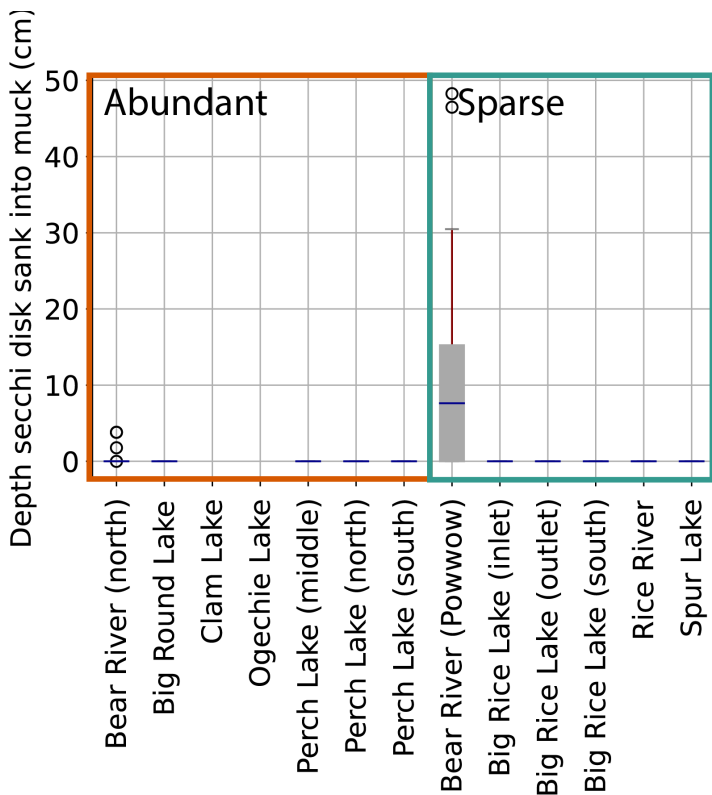
Figure 8. 2021 Depth that a secchi disk sank to across field sites, including abundant and sparse sites. This measurement reflects how much the muck compacted.

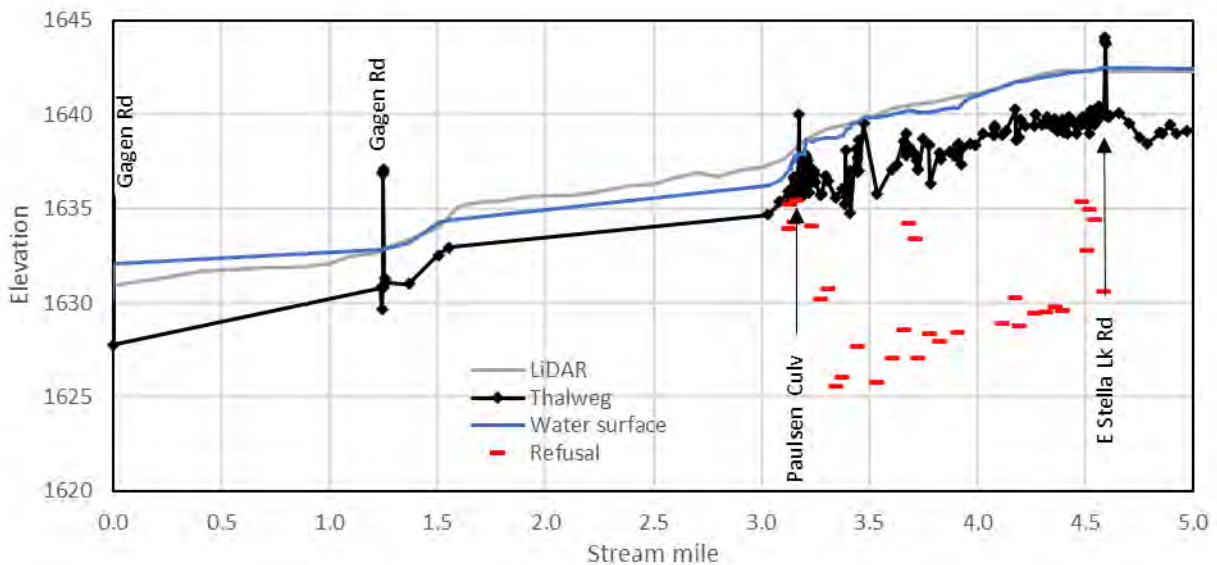
Figure 3. Longitudinal profile of Twin Lakes Creek between Gagen Road and Spur Lake.

In some cases where Twin Lakes Creek traverses coarse meltwater deposits, there is no substantial change in stream elevation. At stream mile (SM) 3.7, the channel dissects an esker deposit (Figure 4). The wetland peat surface that filled upstream and downstream from the esker is nearly the same elevation. Nevertheless, the sand and gravel sediment are locally present on the stream bed. The coarse channel bed material is a stark contrast to the silt and peat channel bed that is extensive in the adjacent reaches. Refusal probing data indicate that the peat channel bed is soft and does not provide grade control.

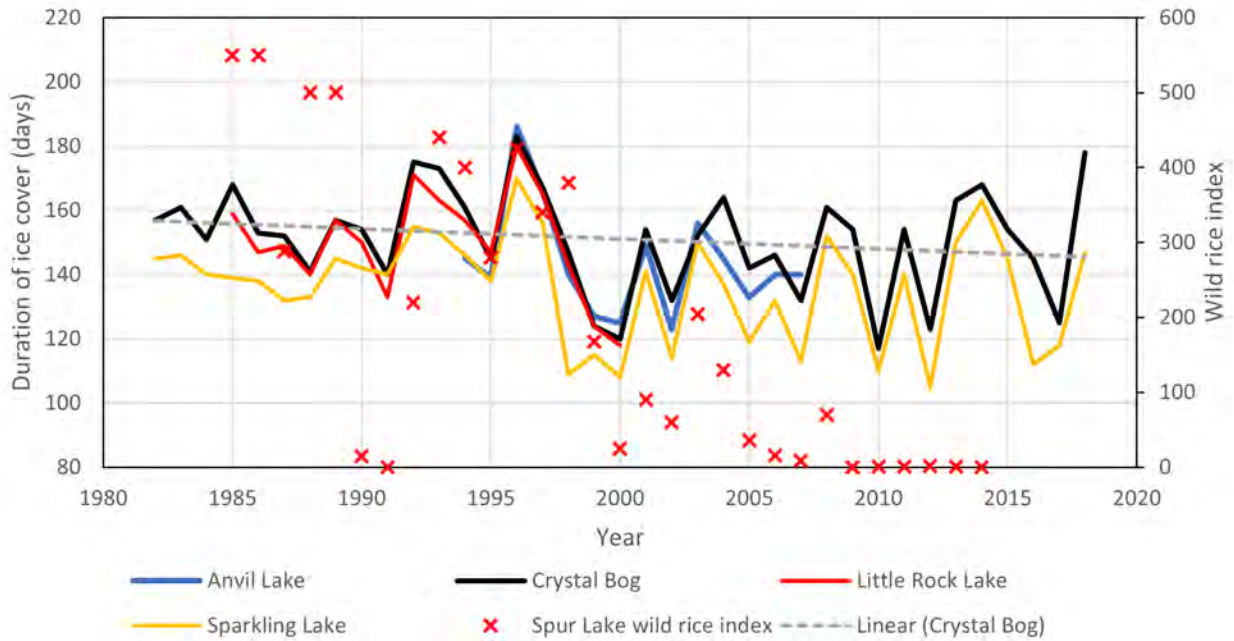
Figure 8. Duration of ice cover at the Trout Lake Research Station lakes (Magnuson et al., 2021) and the wild rice index at Spur Lake (David, 2020).

Although there were some correlations, there were many years without any apparent influence by ice. For example, the duration of ice cover was relatively consistent between 1985 and 1990; however, the wild rice index fluctuated greatly. After 2008, wild rice was practically absent from Spur Lake even though the greatest ice thickness on record was measured in 2014.

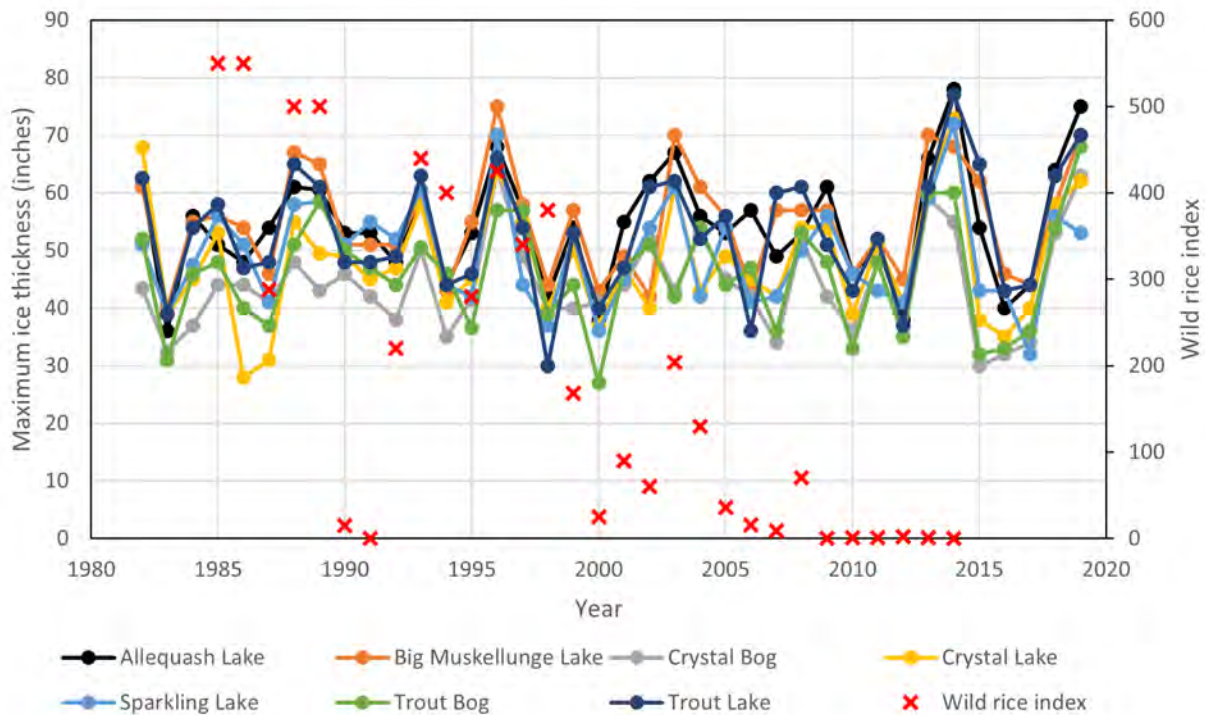
Figure 9. Maximum ice thickness at the Trout Lake Research Station lakes (Magnuson et al., 2021) and the wild rice index at Spur Lake (David, 2020).

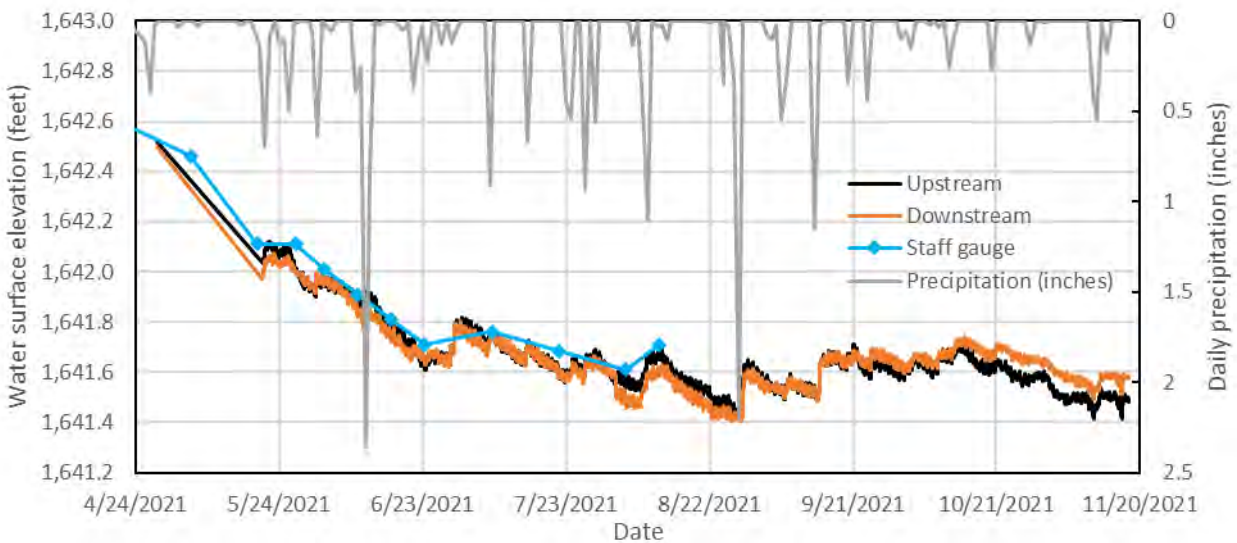
Figure 10. Water levels upstream and downstream from East Stella Lake Road. Periodic staff gage measurements are shown in blue. Precipitation is shown for reference on the secondary axis. Note the lack of difference in water level on either side of the road even during the larger 2-inch rainstorms.

The water level dataset indicates that there was no substantial difference on either side of East Stella Lake Road. During precipitation events, the water surfaces increased about 0.1 feet on the upstream side. The water level receded after a couple of days to match the downstream side of the culverts. The 0.1-foot increase probably has no major effect on water depth suitability for wild rice in Spur Lake. The lack of water level change also indicates that there is little potential energy to drive water downstream through the culverts. Over multiple field visits in 2021, very little water velocity was observed, confirming the lack of flow.

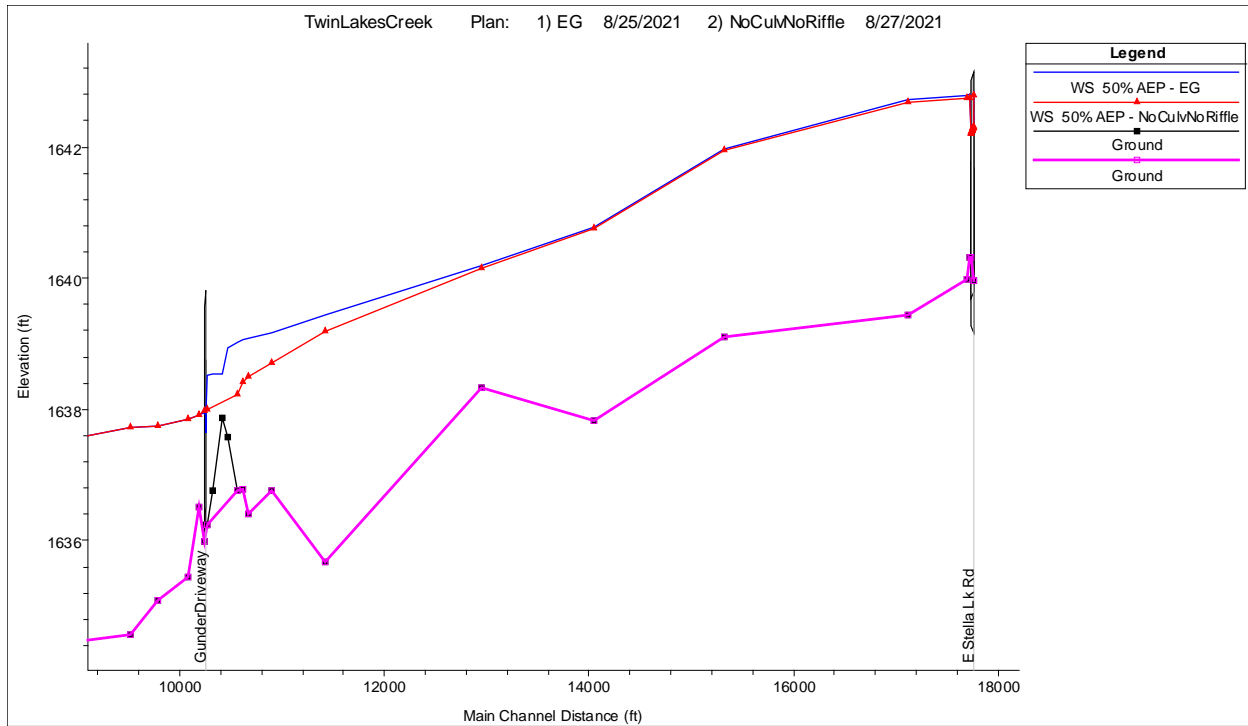
Figure 14. Water surface profile during the 50% AEP under existing conditions (blue line) and with the culvert and artificial riffle removed from Gunder Paulsen's property (red line).

Water surface elevations drop throughout a longer reach with both the culvert and the artificial riffle eliminated on Gunder Paulsen’s property. During the 50% AEP flood, the water levels decrease an average of about 0.27 feet between the riffle and the esker crossing at SM 3.7. Shear stresses in the reach increase by about 20% indicating that the loose channel bed silts may mobilize more readily. Similar drops in water surface were predicted during larger floods up to the 1% AEP.
