Memorandum

RE: Lower Fox River OU4/5 *COMMP* Cap Integrity Assessment - Year 0 (Caps Completed 2018-2020)

Background

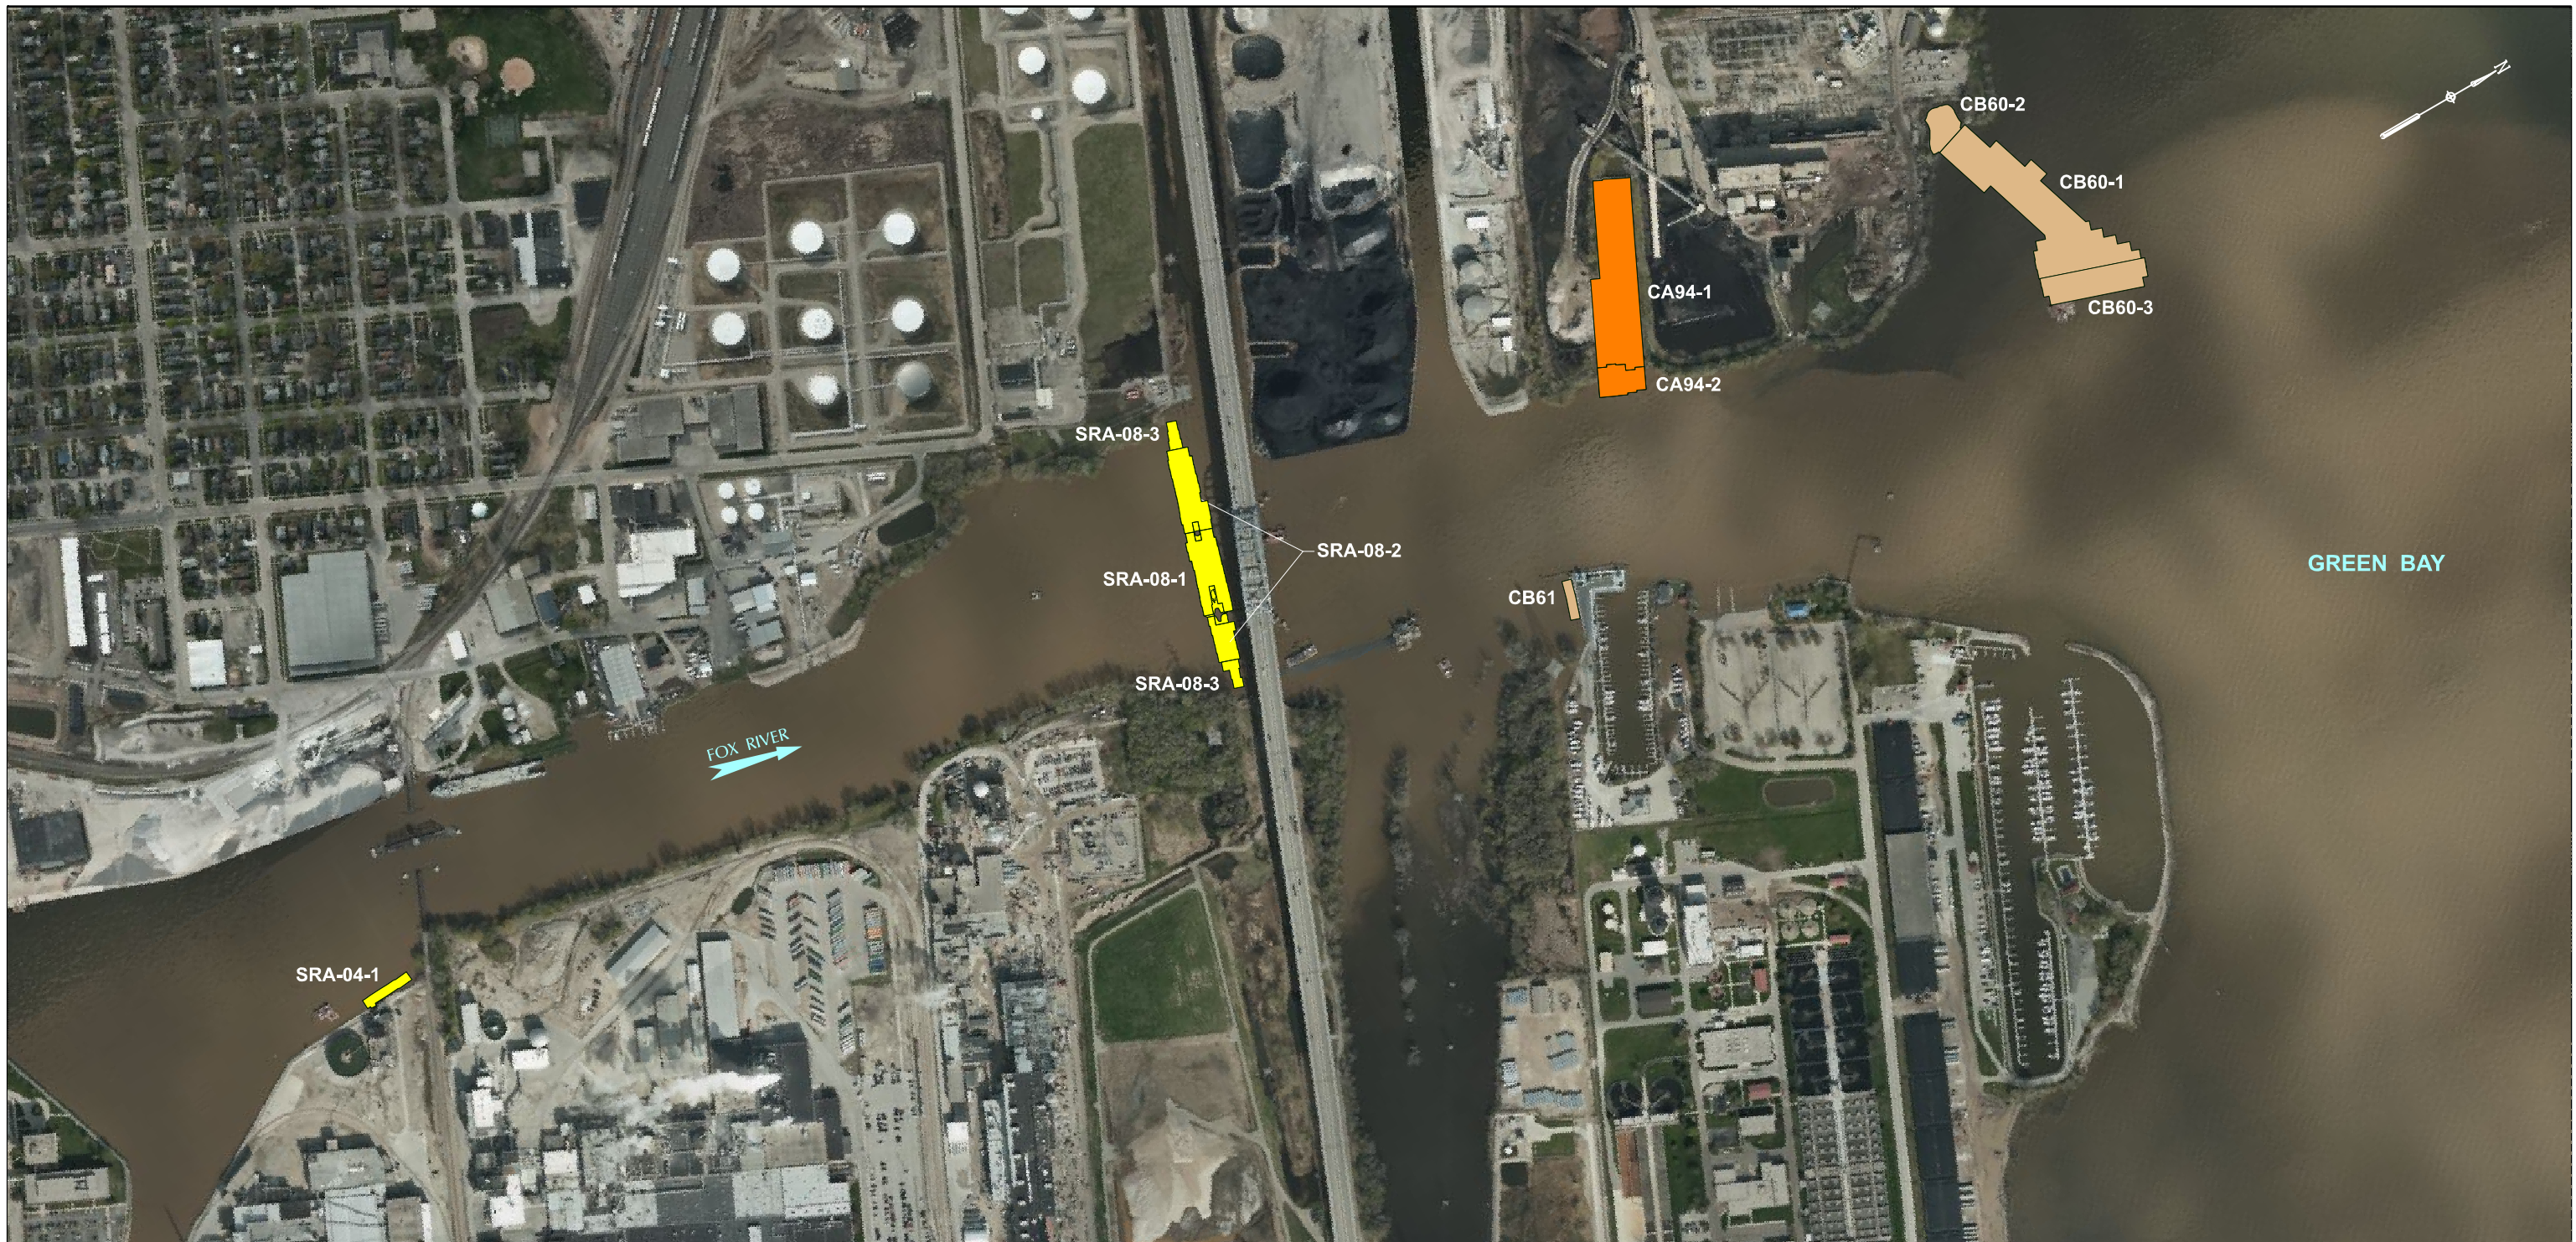
GEORGIA-PACIFIC CORP. / P.H. GLATFELTER COMPANY			
FIGURE 1			
YEAR ZERO - OU4 CAP LOCATIONS (FORT HOWARD TURNING BASIN TO MAIN STREET) LOWER FOX RIVER			
Date: JANUARY 2021		Revision Date:	
Drawn By: JRB2	Checked By: TMK1	Project: LFR LTM & COMMP

In order to evaluate the change in top of cap elevation over time, a baseline or reference point needs to be established. Baseline cap elevations were initially established by conducting a survey in the year each cap was constructed/completed for the OU4/5 caps completed in 2018-2020 (Figures 1 and 2). The surveys documenting the baseline conditions are termed the “Year 0” surveys.

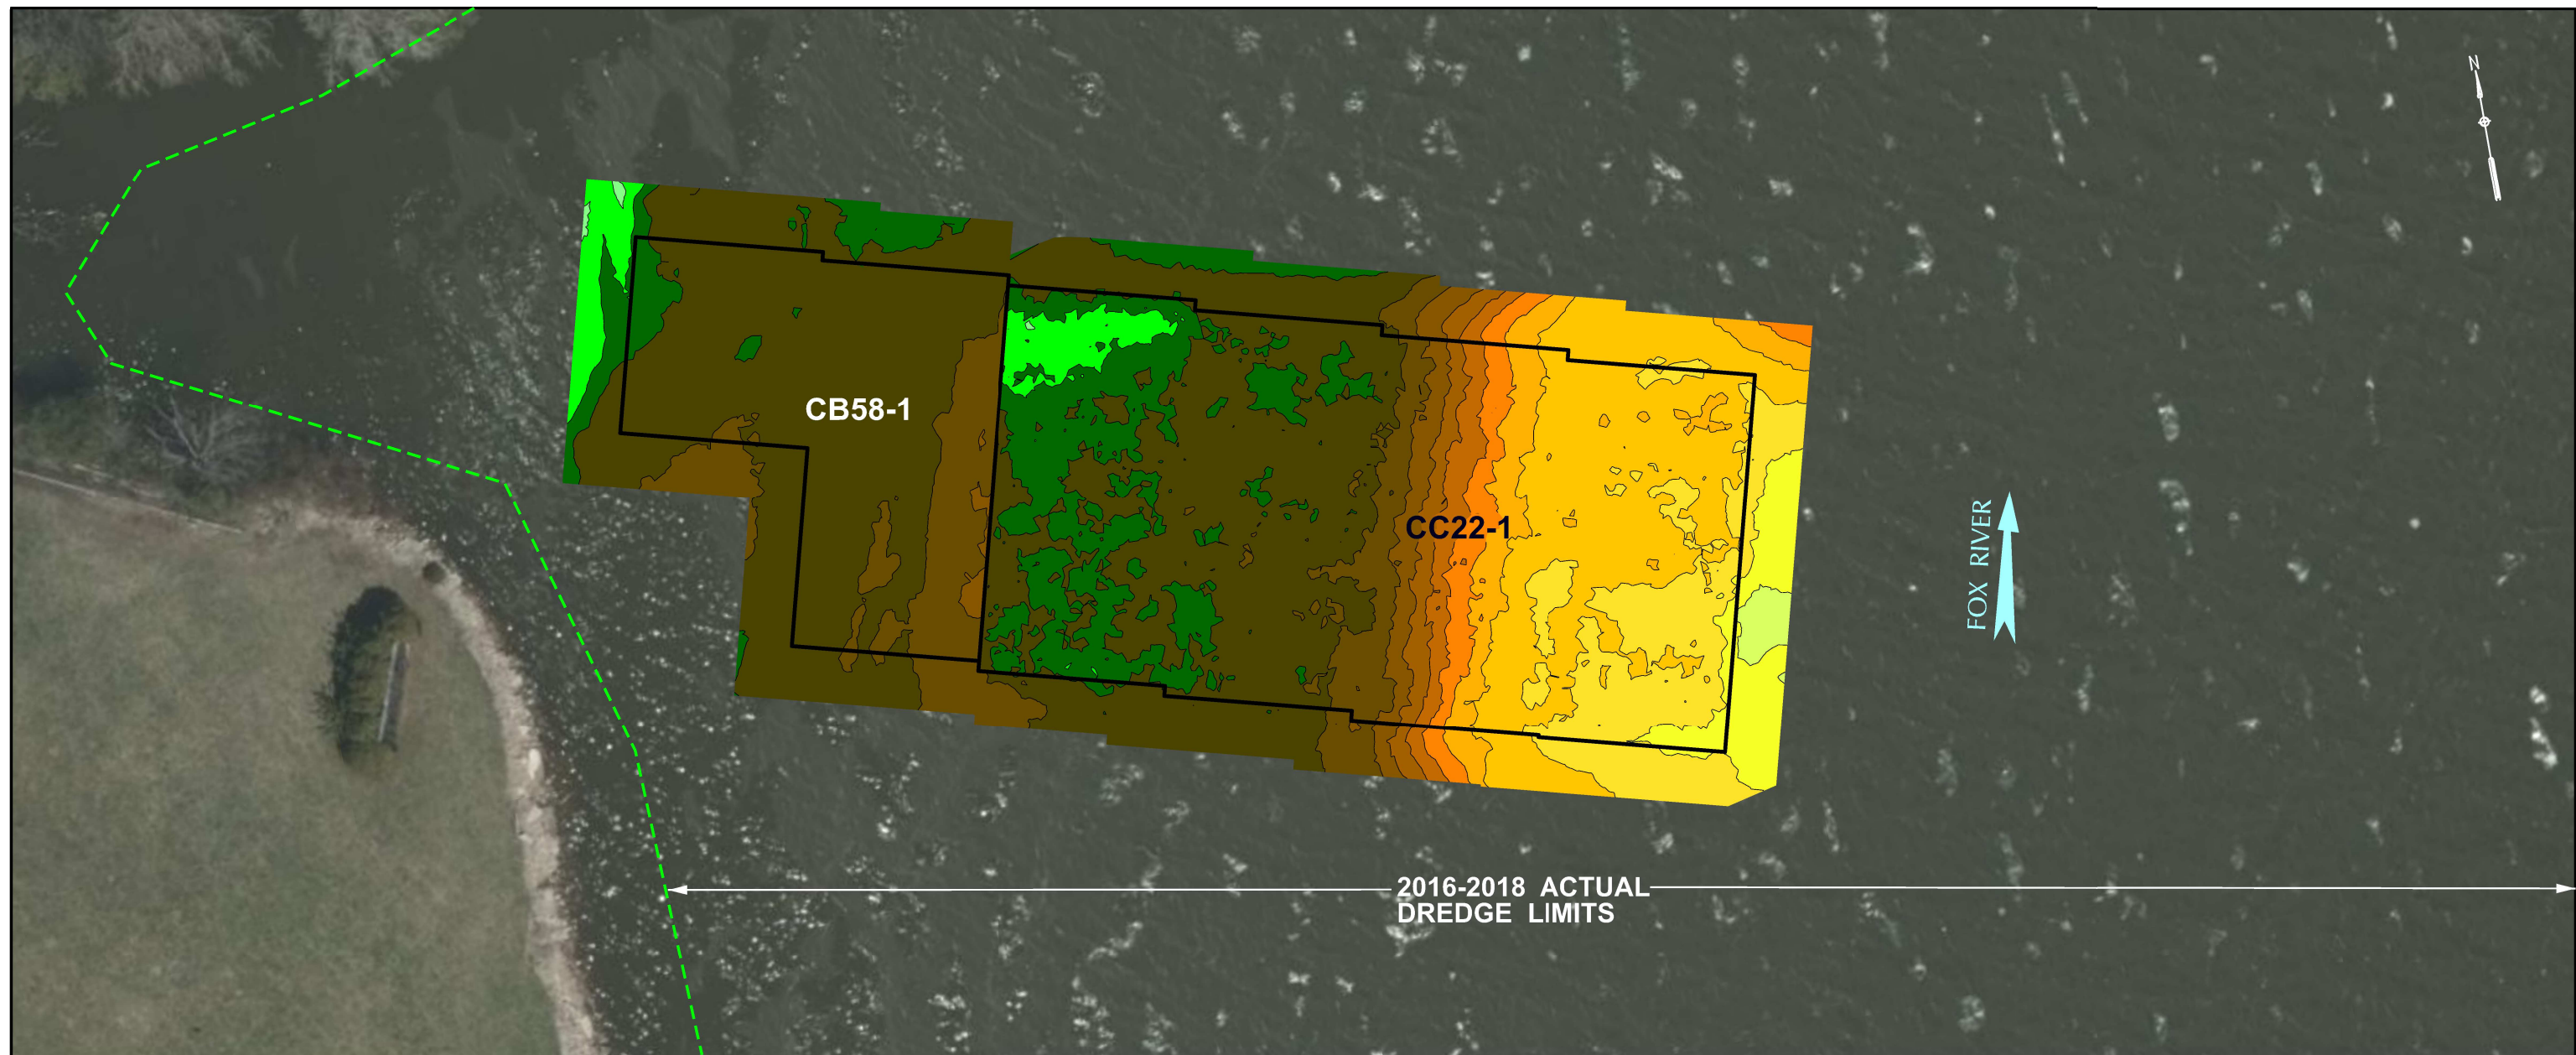
GEORGIA-PACIFIC CORP. / P.H. GLATFELTER COMPANY			
FIGURE 6A			
LOWER FOX RIVER - OU4 CB58-1 / CC22-1 CAP ELEVATIONS PLAN VIEW			
Date: JANUARY 2021	Revision Date:		
Drawn By: JRB2	Checked By: TMK1	Project: LFR LTM & COMMP

COLOR ELEVATION CHART
 COLOR CONTOURS SHOWN REPRESENTS THE
 NOVEMBER 8, 2018 OR SEPTEMBER 20, 2019
 TOP OF ENGINEERED CAP ELEVATIONS

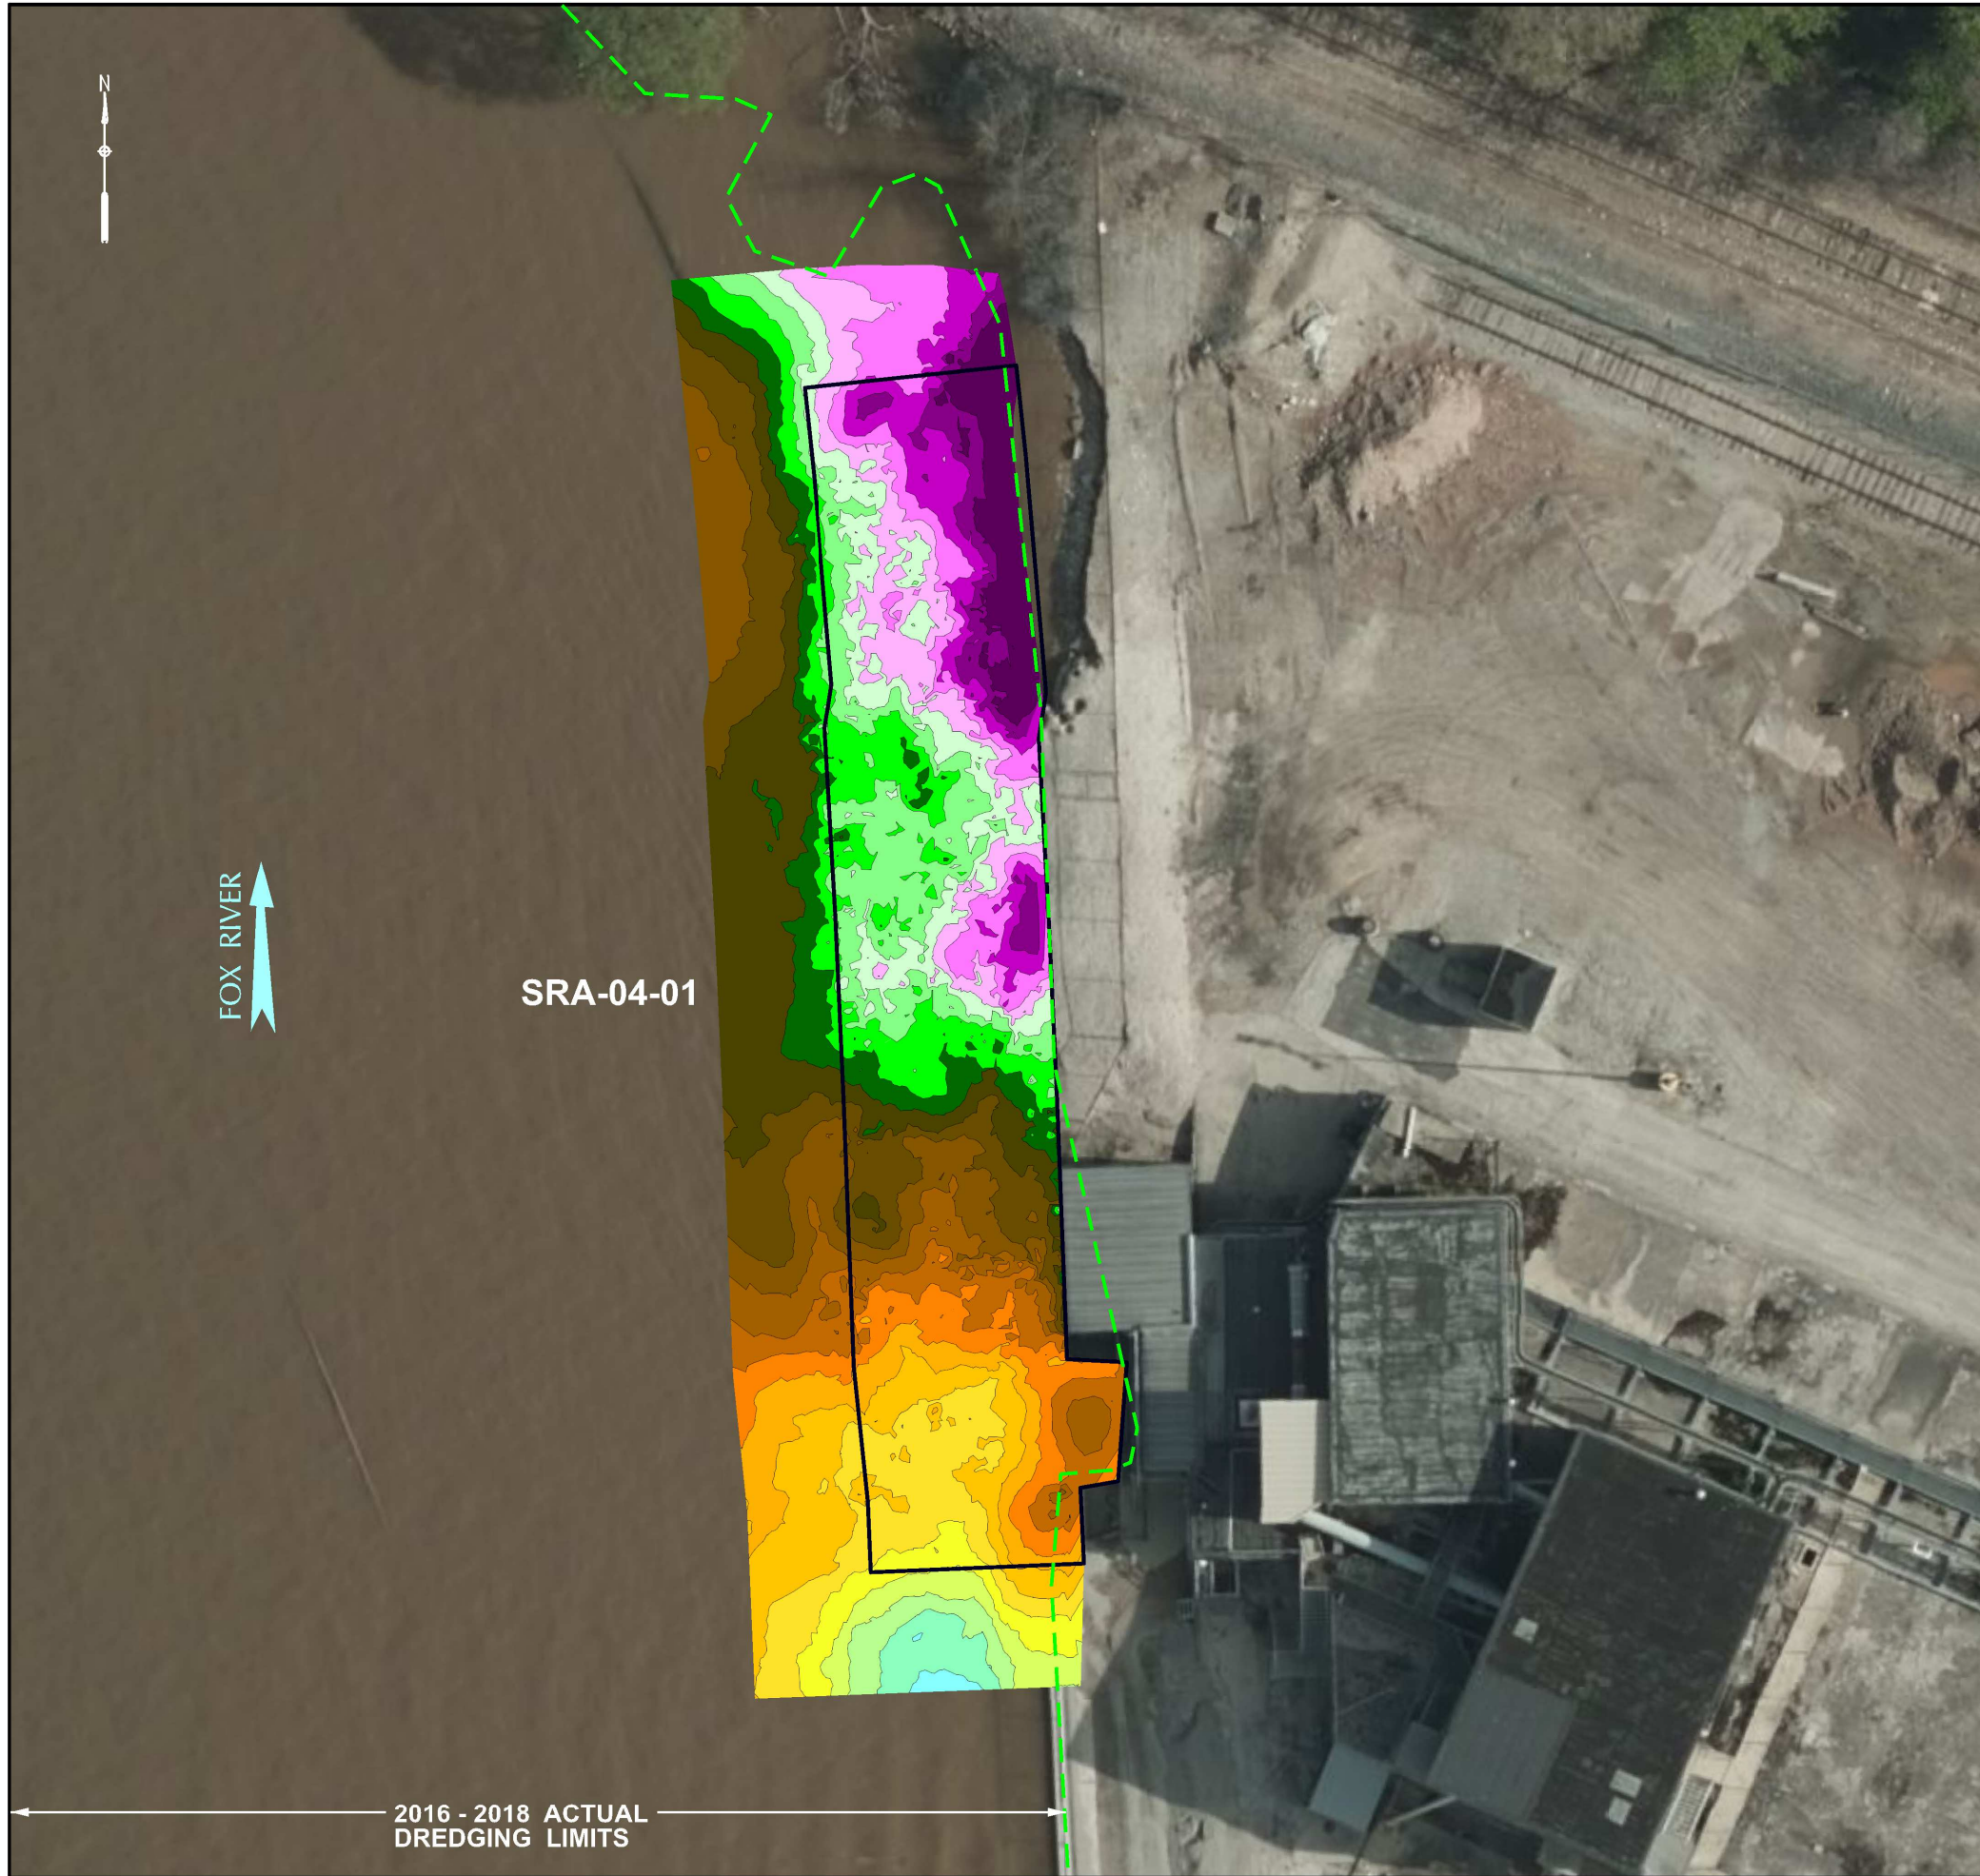
GEORGIA-PACIFIC CORP. / P.H. GLATFELTER COMPANY		
FIGURE 9C		
LOWER FOX RIVER - OU4 CBD157-3 & CBD35NOP-DCA45-7 CAP CROSS - SECTIONS B - B' & C - C'		
Date: JANUARY 2021	Revision Date:	
Drawn By: JRB2	Checked By: TMK1	Project: LFR LTM & COMMP

- ◆ CBD35NOP-DCA45-7 is a cap area. Though irregularity in the top of cap elevations was anticipated in this area due to the bridge foundations (Figure 9B2), a cross-section (C-C’) was cut through the area and the top of cap elevations were compared to the 2020 pre-cap placement bathymetry (Figure 9C) for confirmation. The two surveys followed a similar profile indicating a reflection of the river bottom topography rather than the cap having been eroded or undergone significant differential settlement.

CA94-2	0.41	2020	Year 0 (2020)	No irregularities noted.	Cap maintenance not required.	N/A
CB60-2	0.36	2020	Year 0 (2020)	No irregularities noted.	Cap maintenance not required.	N/A
CBD35NOP-DCA45-7	0.15	2020	Year 0 (2020)	To assess the steep slope and irregularity of the top of cap surface elevations, a cross-section was cut through the area and the top of cap elevations were compared to the 2020 pre-cap placement bathymetry. The two surveys followed a similar profile indicating a reflection of the river bottom topography rather than the cap having been eroded or undergone significant differential settlement.	Cap maintenance not required.	N/A

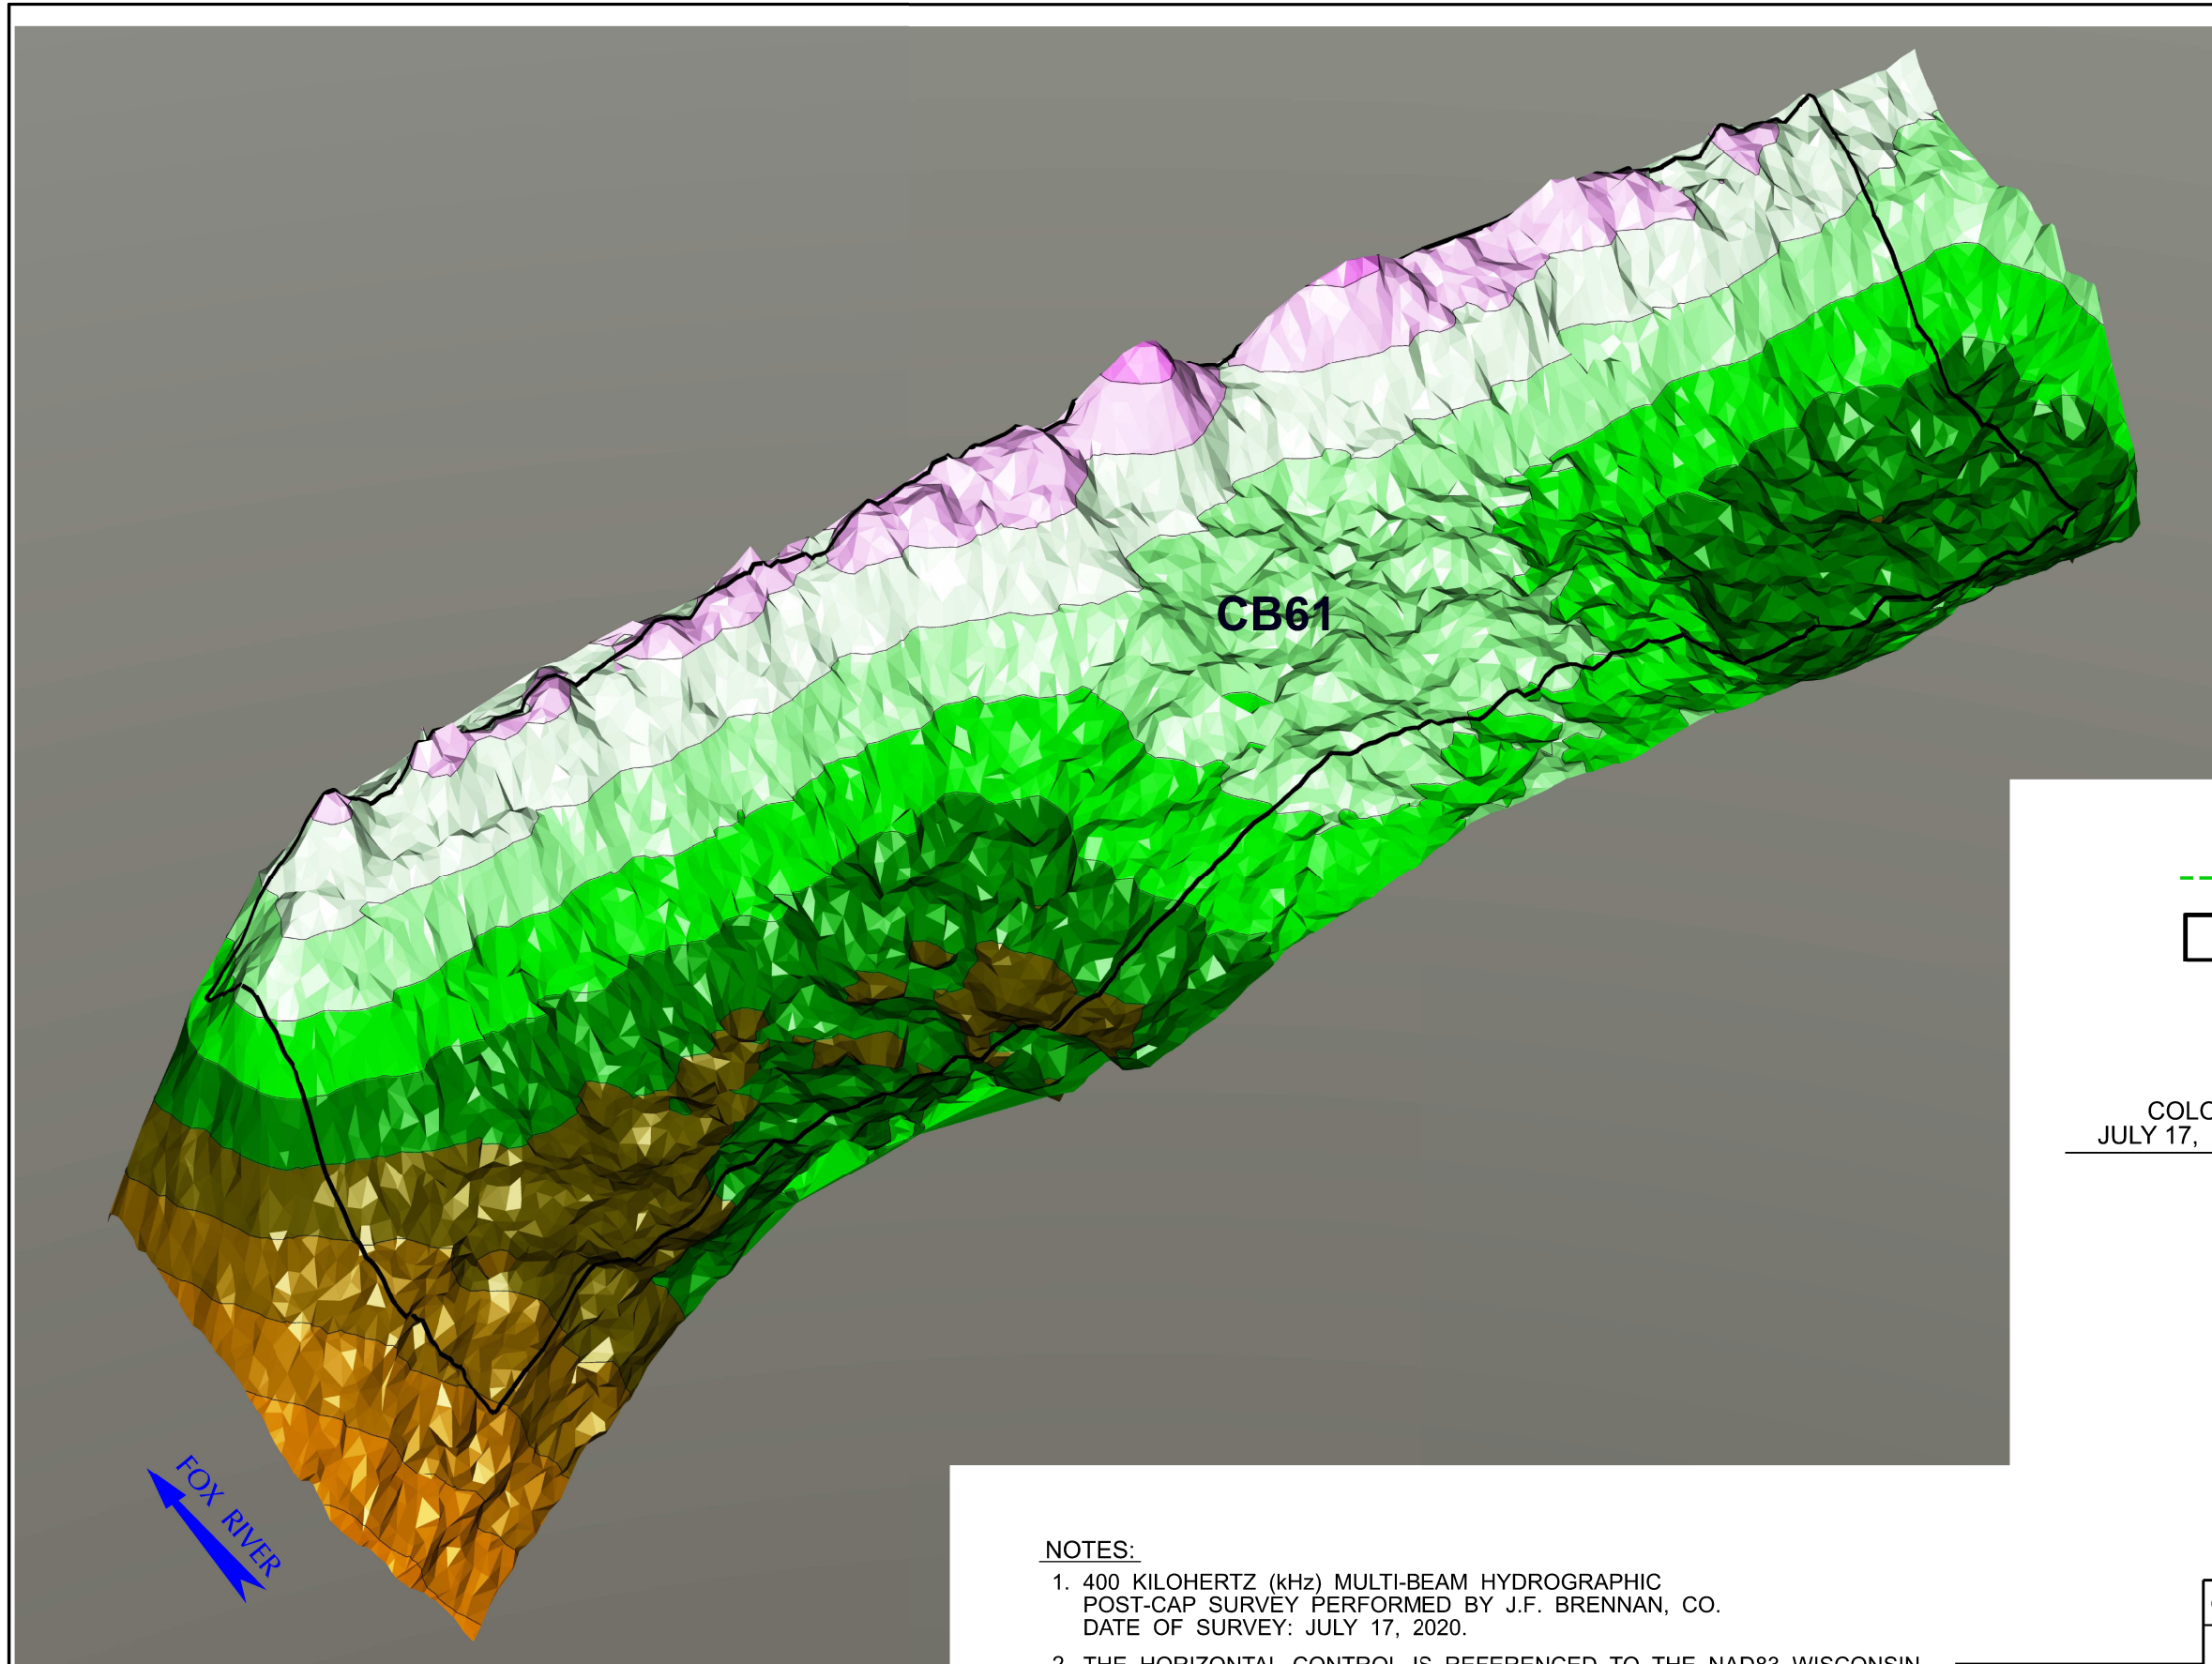
GEORGIA-PACIFIC CORP. / P.H. GLATFELTER COMPANY	
FIGURE 15A	
LOWER FOX RIVER - OU4 CB61 CAP ELEVATIONS PLAN VIEW	
Date: JANUARY 2021	Revision Date:
Drawn By: JRB2	Checked By: TMK1
Project: LFR LTM & COMMP

CB61

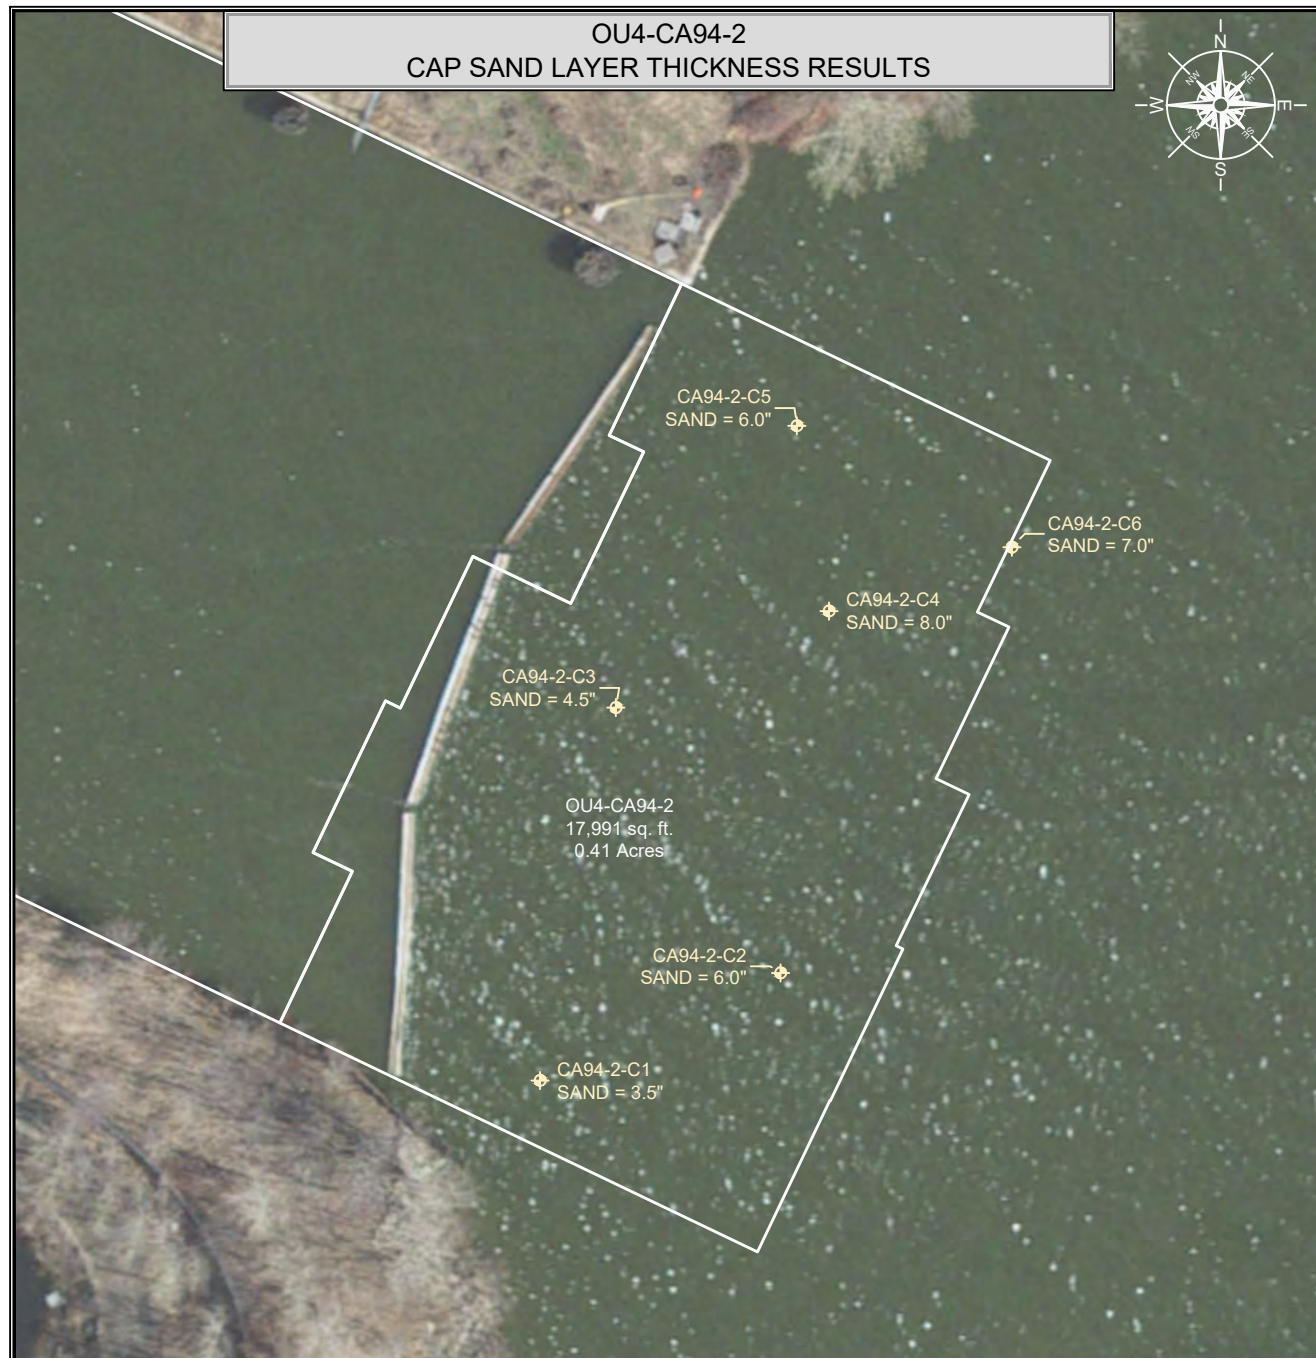
**OU4-CA94-2
CAP SAND LAYER THICKNESS RESULTS**

<10 PPM SURFICIAL	
MINIMUM SAND LAYER THICKNESS	3.0"
ASSUMED SAND OVERPLACEMENT THICKNESS	3.0"
MINIMUM ARMOR LAYER THICKNESS	6.0"
ASSUMED ARMOR OVERPLACEMENT THICKNESS	6.0"
MINIMUM QUARRY SPALL ARMOR THICKNESS	28.0"
QUARRY SPALL OVERPLACEMENT THICKNESS	24.0"
MINIMUM CAP THICKNESS	37.0"
ASSUMED AVERAGE CAP THICKNESS	70.0"
FILTER LAYER D50 STONE = 3.0"	
QUARRY SPALL = 14.0"

NUMBER OF SAND COVER THICKNESS VERIFICATION CORES COLLECTED	6
NUMBER OF SAND COVER THICKNESS VERIFICATION CORES SATISFYING CRITERIA	6
NUMBER OF ARMOR THICKNESS VERIFICATION SAMPLES COLLECTED	4
NUMBER OF ARMOR THICKNESS VERIFICATION SAMPLES SATISFYING CRITERIA	4
NUMBER OF QUARRY SPALL THICKNESS VERIFICATION SAMPLES COLLECTED	4
NUMBER OF QUARRY SPALL THICKNESS VERIFICATION SAMPLES SATISFYING CRITERIA	2

Quarry Spall/Heavy Rip Rap D50=14" was placed and surveyed within OU4-CA94-2. The quarry spall/heavy rip rap thicknesses based on barge survey meet or exceed the minimum thickness requirement of 20-inches. Furthermore, thickness verification poling was conducted at 4 locations. 2 of 4 samples meet or exceed the minimum thickness requirement of 20-inches. Tetra Tech recommends accepting this area on an exception basis.

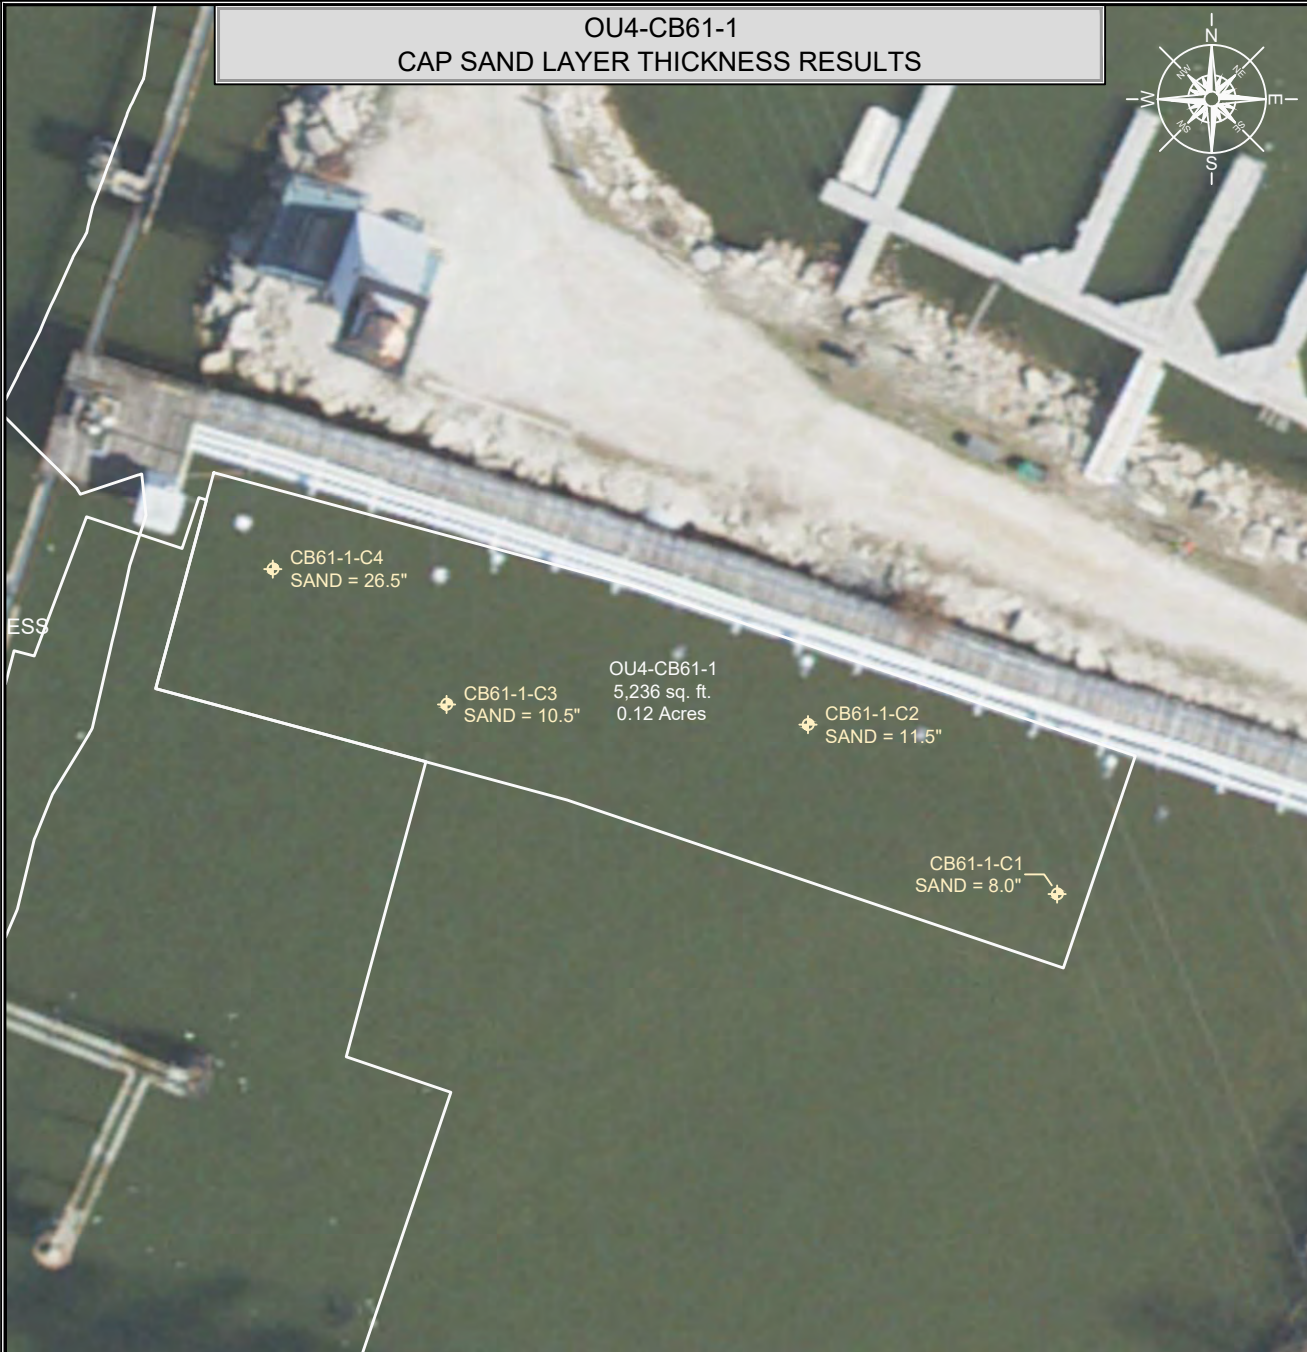
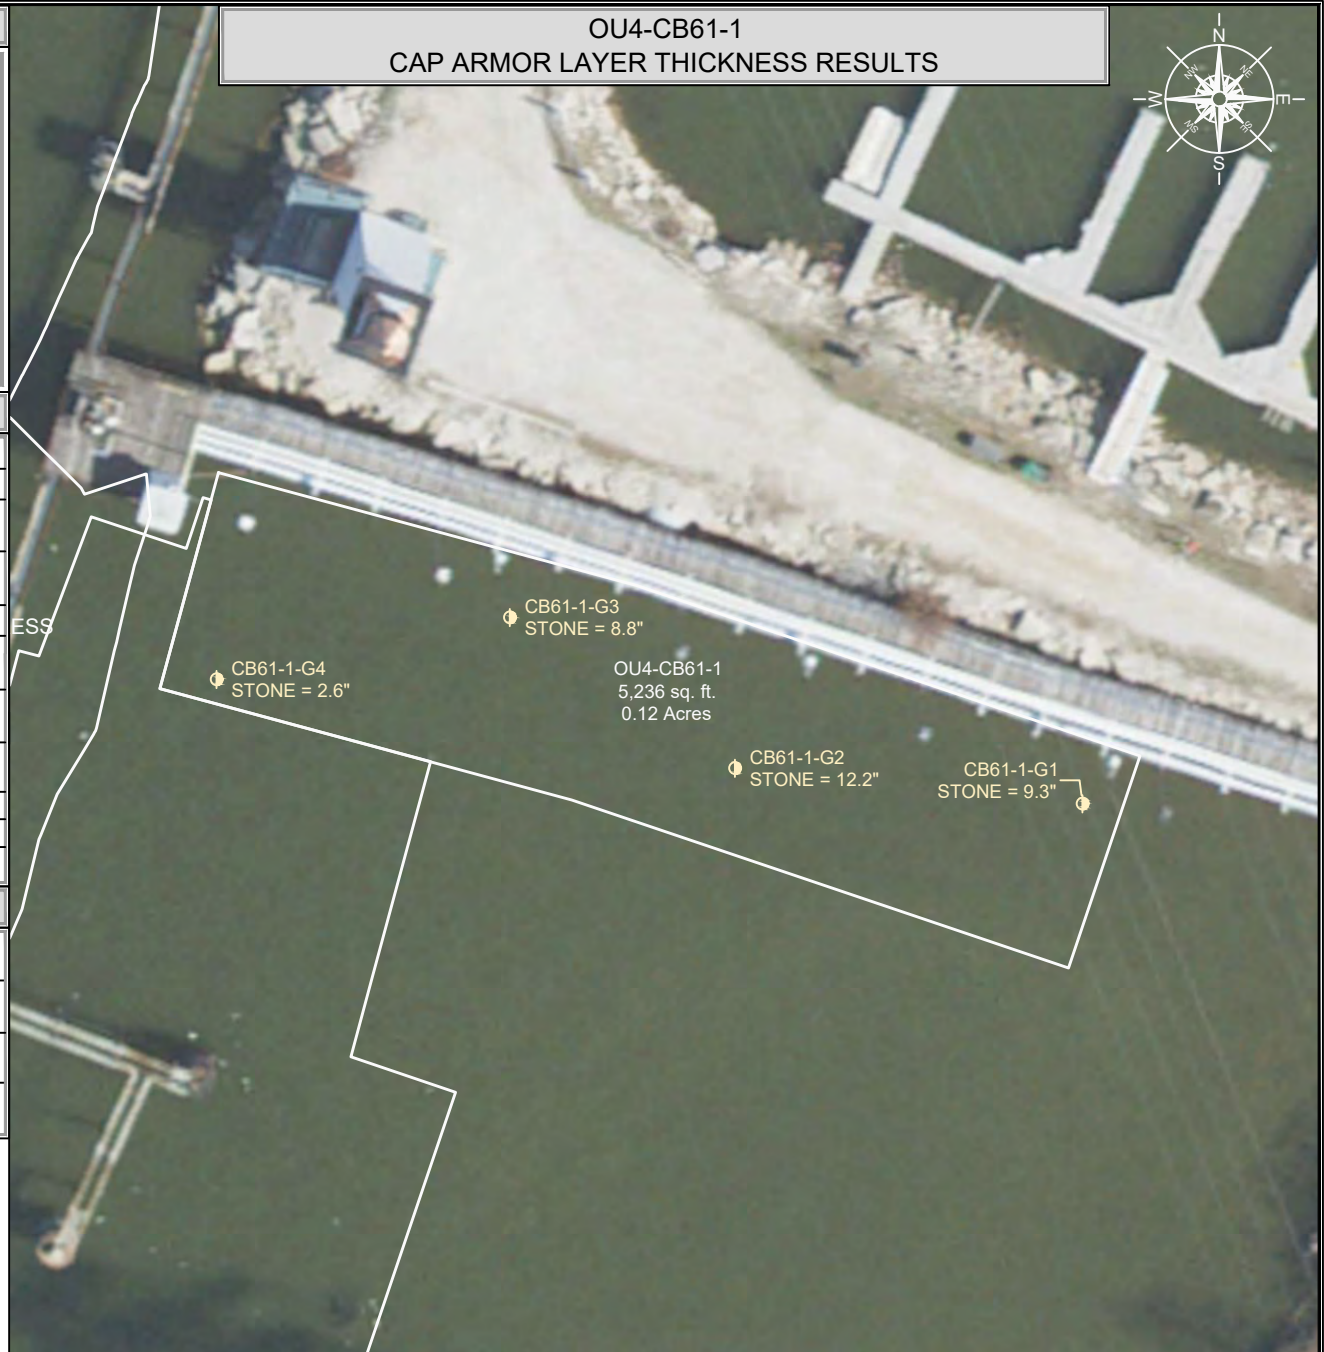
OU4-CB61-1
CAP ARMOR LAYER THICKNESS RESULTS

>10 and <50 PPM SURFICIAL	
ASSUMED SAND MIXING LAYER THICKNESS	3.0"
SAND CHEMICAL ISOLATION LAYER THICKNESS	3.0"
ASSUMED SAND OVERPLACEMENT THICKNESS	3.0"
MINIMUM ARMOR LAYER THICKNESS	4.0"
ASSUMED ARMOR OVERPLACEMENT THICKNESS	3.0"
MINIMUM QUARRY SPALL ARMOR THICKNESS	NA
QUARRY SPALL OVERPLACEMENT THICKNESS	NA
MINIMUM CAP THICKNESS	10.0"
ASSUMED AVERAGE CAP THICKNESS	16.0"
D50 STONE = 1.5"

NUMBER OF SAND COVER THICKNESS VERIFICATION CORES COLLECTED	4
NUMBER OF SAND COVER THICKNESS VERIFICATION CORES SATISFYING CRITERIA	4
NUMBER OF ARMOR THICKNESS VERIFICATION SAMPLES COLLECTED	4
NUMBER OF ARMOR THICKNESS VERIFICATION SAMPLES SATISFYING CRITERIA	3

OU4-CB61-1 (D50=1.5")									
ID	Date Sampled	Average Thickness (Inches)	Required Thickness (Inches)	Mudline	Pre-Placement Coordinates		Survey Coordinates		Comments
					Northing	Easting	Northing	Easting	
CB61-1-G1	7/21/2020	9.3	4.0	573.0	262521.37	2488695.26	262520.15	2488697.68	Bucket not found; Poling method used
CB61-1-G2	7/21/2020	12.2	4.0	573.8	262523.46	2488643.72	262525.69	2488643.42	Bucket not found; Poling method used
CB61-1-G3	7/21/2020	8.8	4.0	573.4	262548.98	2488609.34	262549.26	2488608.28	Bucket not found; Poling method used
CB61-1-G4	7/21/2020	2.6	4.0	570.2	262541.42	2488563.63	262539.56	2488562.46	Bucket not found; Poling method used

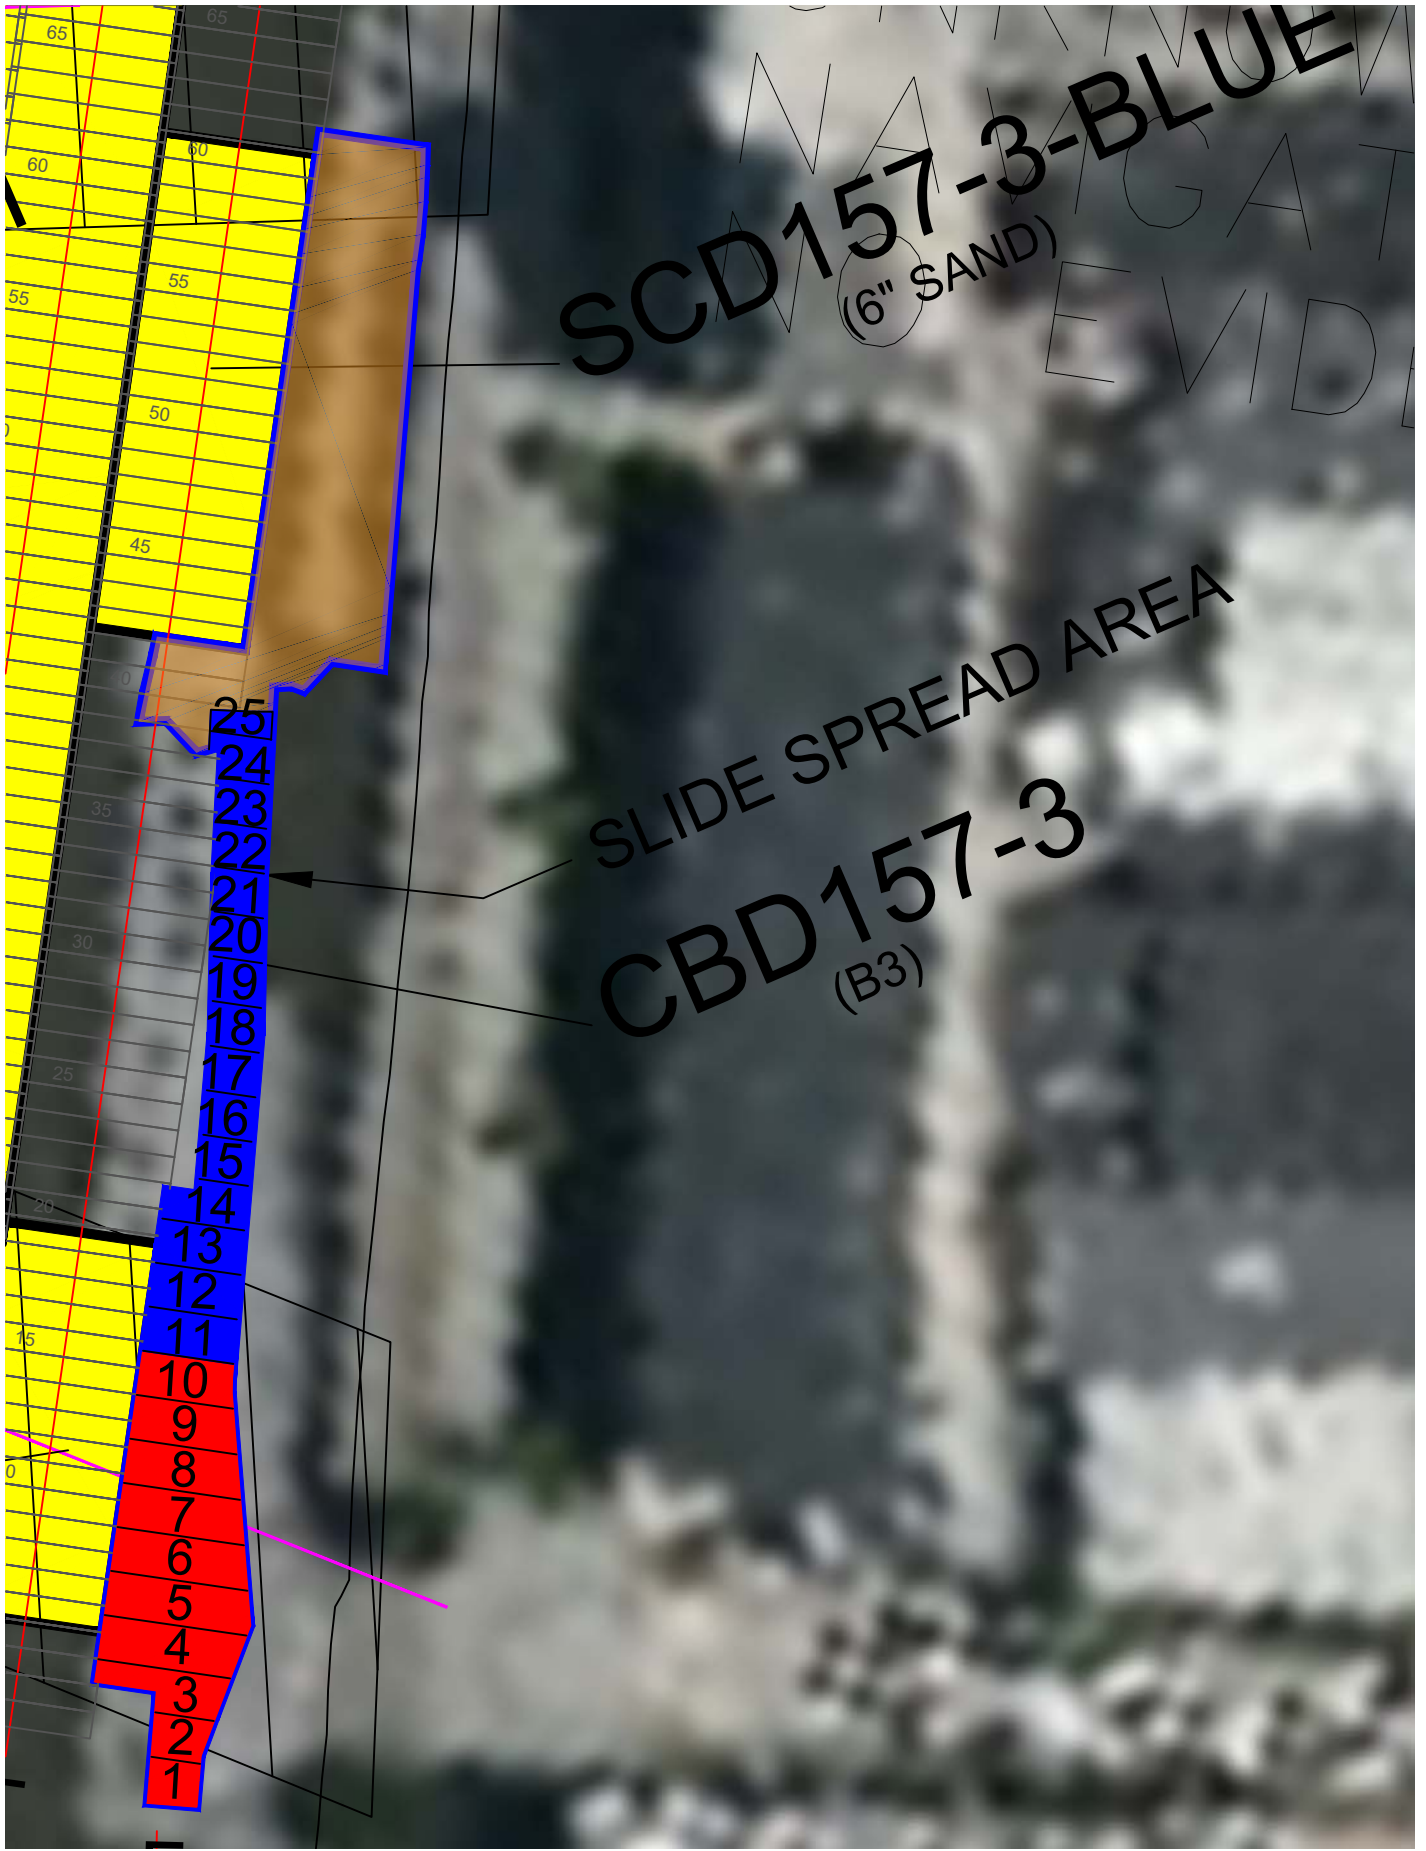
SCD157-3-BLUE
(6" SAND)

Step Start Date	Step Start Time	Area	SMU/CMU	Lane	Step Number	Duration (min)	Northing	Easting	Density (#/cu.ft.)	Weight (tons)	Cubic Yards	Area (ft ²)	Calculated Thickness (in.)	Remarks
4/17/2020	14:55:33		CBD157-3		0	25.63	255060.43	2485775.75	112.00	25.00	16.34			Upstream of area, placed to ensure upstream limit acquired sand
4/17/2020	15:27:22		CBD157-3		1	4.48	255077.13	2485781.25	112.00	4.80	3.14	110.20	9.22	
4/17/2020	15:40:52		CBD157-3		2	4.67	255085.48	2485782.57	112.00	5.20	3.40	119.80	9.19	
4/17/2020	15:47:33		CBD157-3		3	5.92	255094.74	2485782.49	112.00	9.40	6.14	218.80	9.10	
4/17/2020	16:00:47		CBD157-3		4	6.18	255103.70	2485792.82	112.00	13.30	8.69	310.70	9.06	
4/17/2020	16:13:33		CBD157-3		5	6.25	255112.64	2485796.95	112.00	13.70	8.95	319.80	9.07	
4/17/2020	16:24:18		CBD157-3		6	5.77	255120.45	2485801.37	112.00	12.80	8.37	298.30	9.09	
4/17/2020	16:35:46		CBD157-3		6	5.55	255131.36	2485807.20	112.00	11.80	7.71	275.50	9.07

4/17/2020	16:46:26		CBD157-3		8	5.48	255138.36	2485810.12	112.00	10.80	7.06	252.70	9.05	
4/17/2020	16:57:13		CBD157-3		9	4.50	255149.52	2485817.17	112.00	9.80	6.41	230.00	9.02	
4/17/2020	17:06:03		CBD157-3		10	6.98	255158.34	2485819.75	112.00	15.90	10.39	209.80	16.05	
Averages						7.40				12.05	7.87			
Totals						81.41				132.50	86.60
