Memorandum

RE: Lower Fox River OU4/5 *COMMP* Cap Integrity Assessment - Year 0 (Caps Completed 2018-2020)

Background

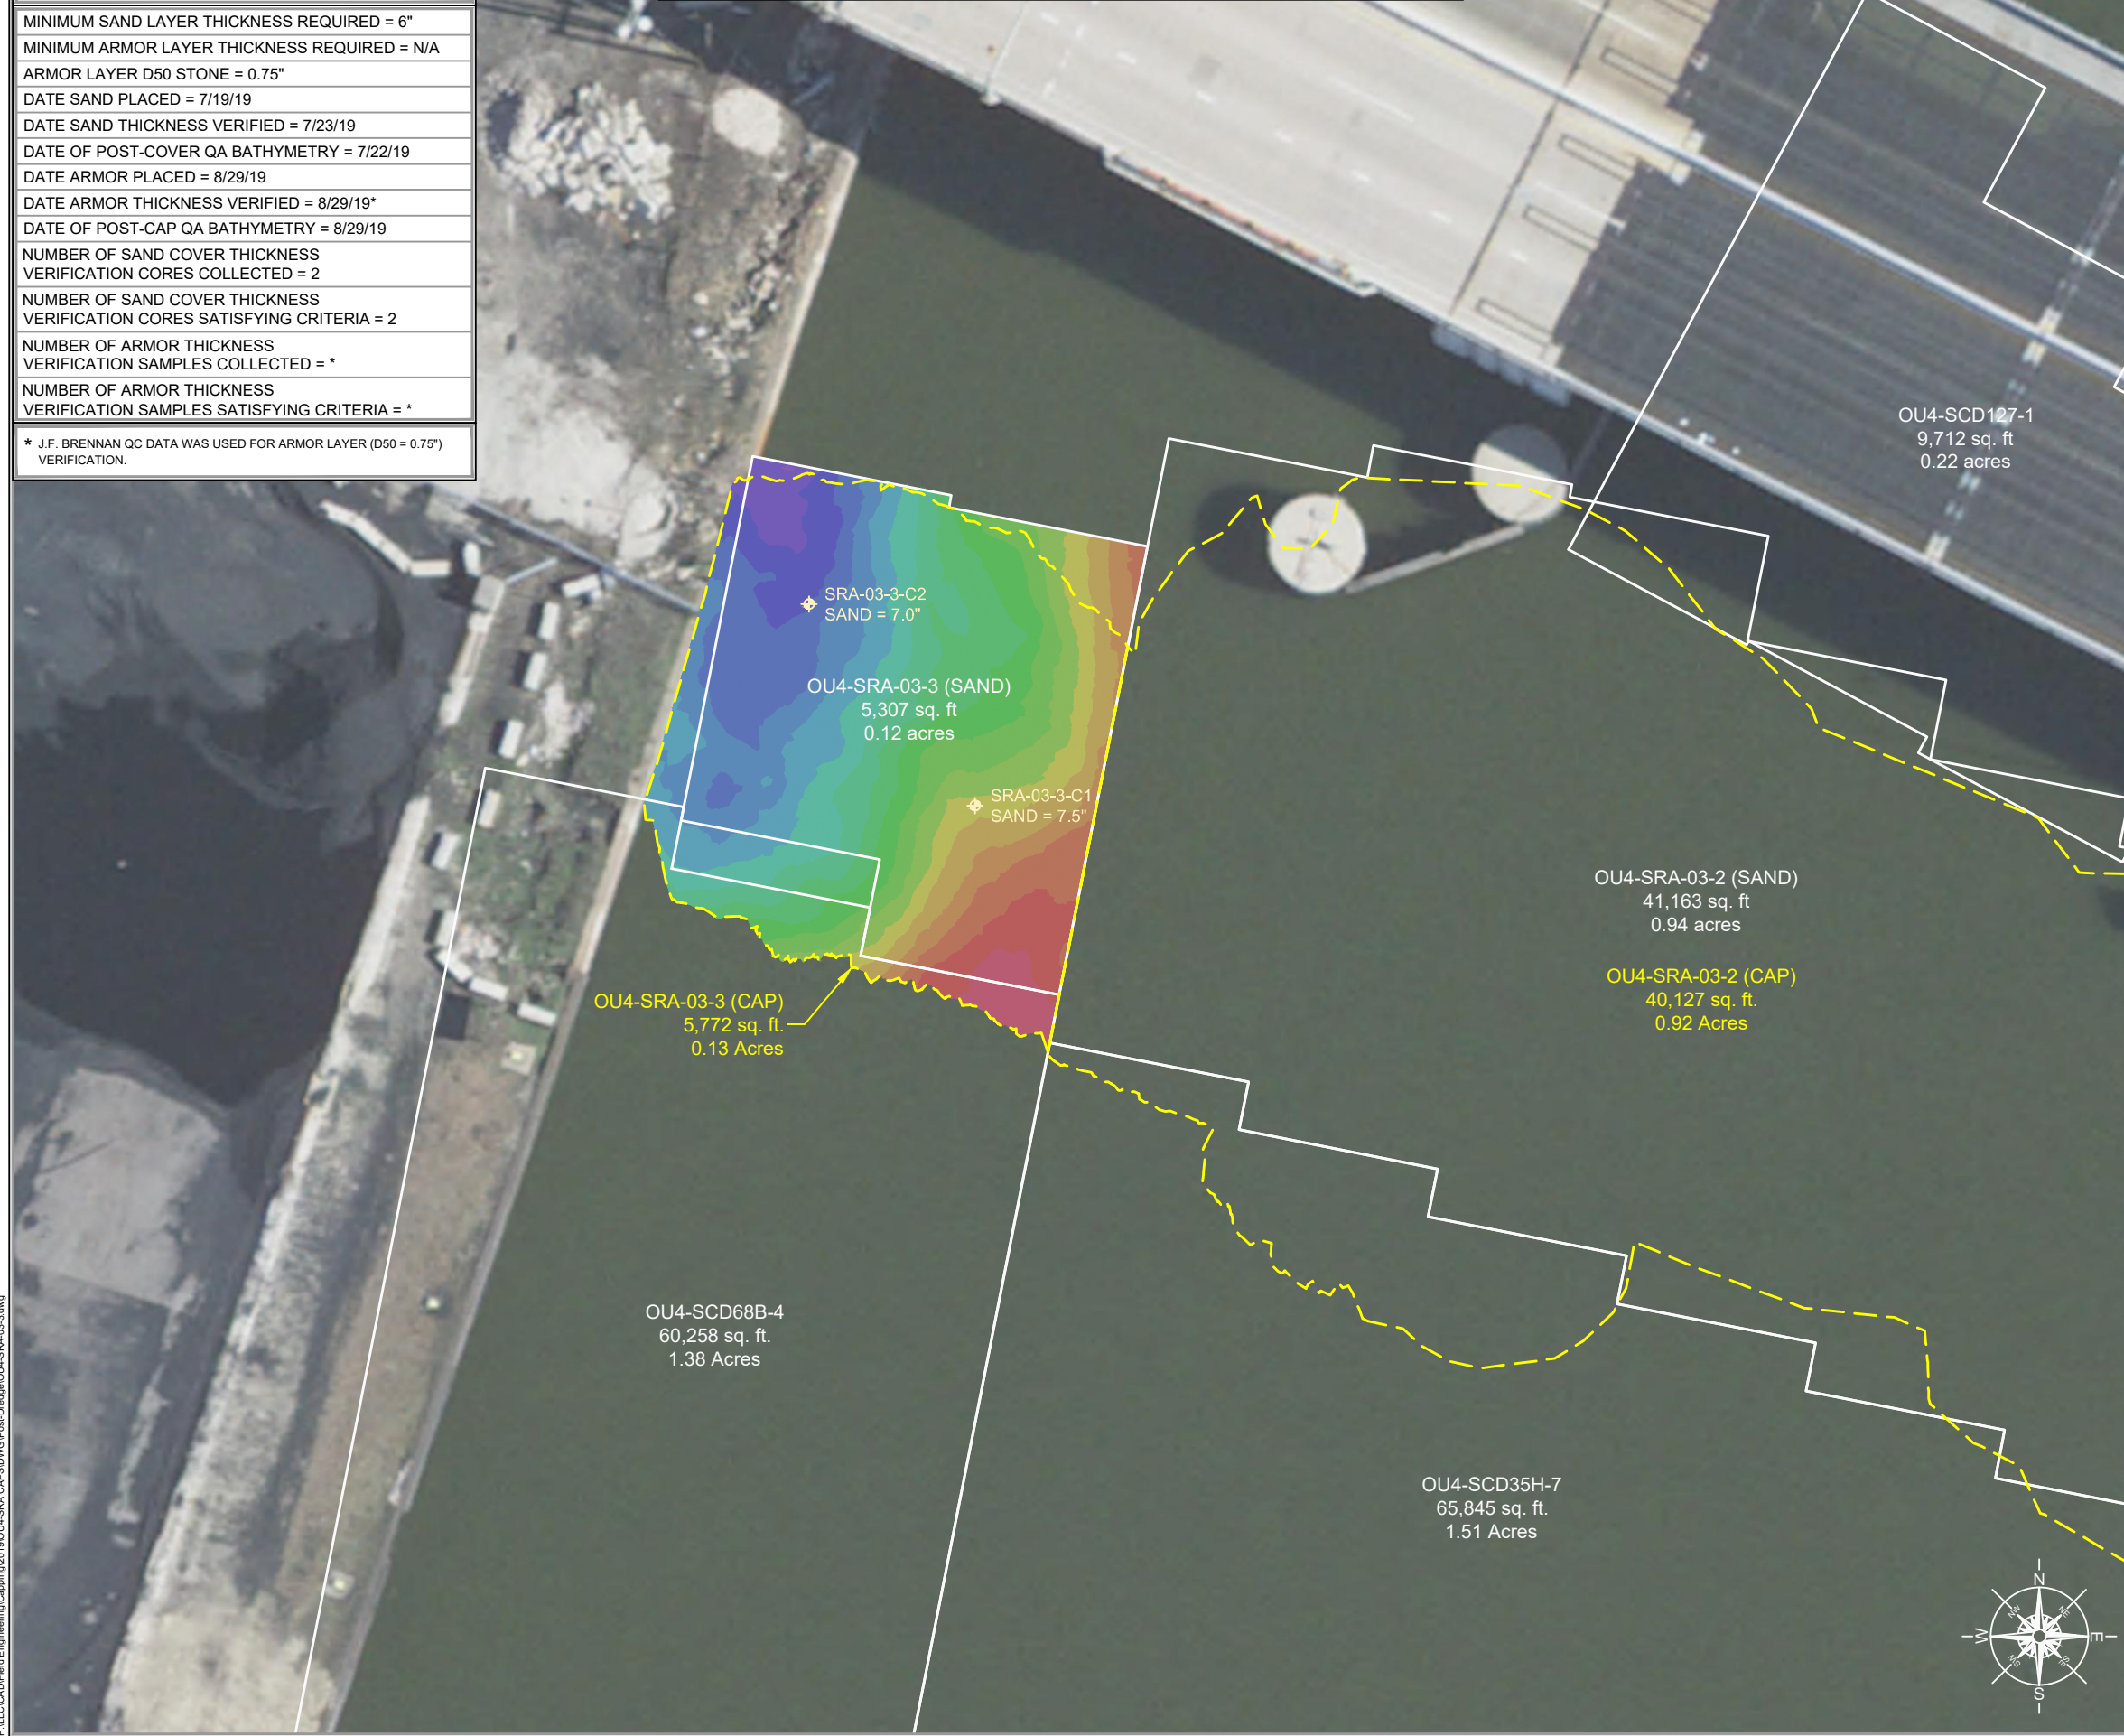
OU4-SRA-03-3
POST-CAP AS-BUILT ELEVATIONS/SAND & ARMOR LAYER THICKNESS RESULTS

LEGEND	
MIN. EL.	MAX. EL.
549.00'	550.00'
550.00'	551.00'
551.00'	552.00'
552.00'	553.00'
553.00'	554.00'
554.00'	555.00'
555.00'	556.00'
556.00'	557.00'
557.00'	558.00'
558.00'	559.00'
559.00'	560.00'
560.00'	561.00'
561.00'	562.00'
562.00'	563.00'
563.00'	564.00'
564.00'	565.00'
565.00'	566.00'
566.00'	567.00'
