Intended for
Wisconsin Public Service Corporation

Date
June 26, 2020

NORTH FOCUS AREA REMEDIAL ACTION SUMMARY REPORT REVISION 2

FORMER GREEN BAY MANUFACTURED GAS PLANT SITE

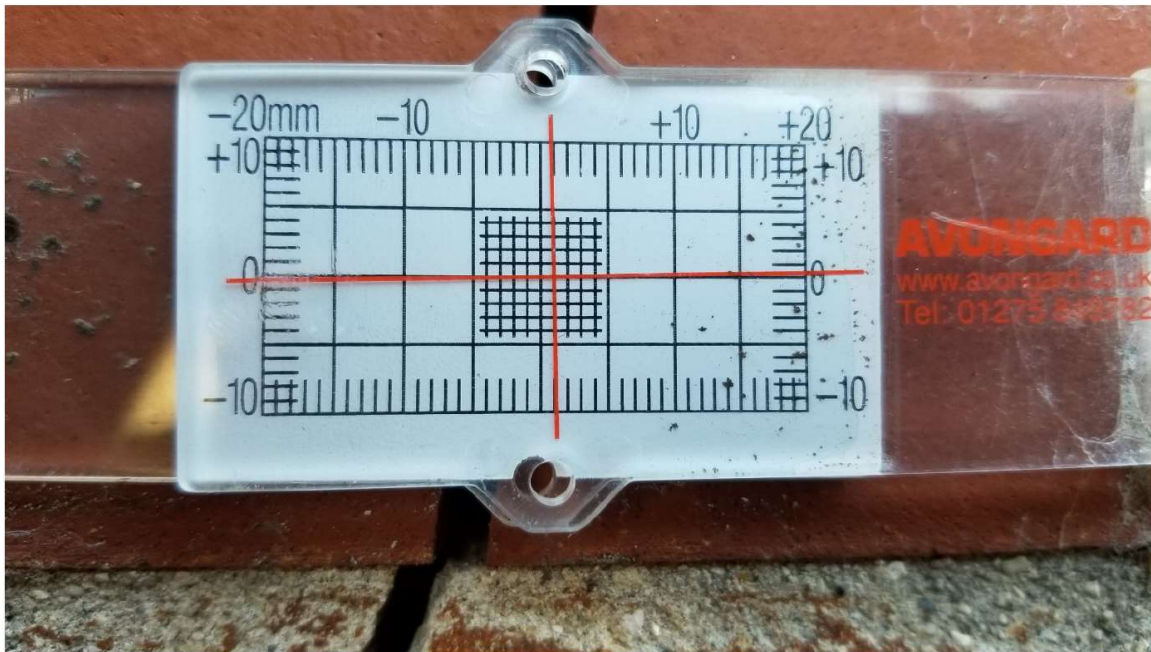
1. Crack Monitor #1 – North Side of Intake Building, April 2019

Wall monitoring during the RA was performed by AET at the GP Day Street Mill Site also at the request of GP. Two crack monitors were installed by AET at the GP clarifier intake building in 2018, as shown on Figure 5. Monitoring by AET continued into 2019 during the RA, concurrent with GP's building demolition near the bulkhead, with no significant movement observed on either monitor. Photos taken before and after the monitoring period are shown for reference.

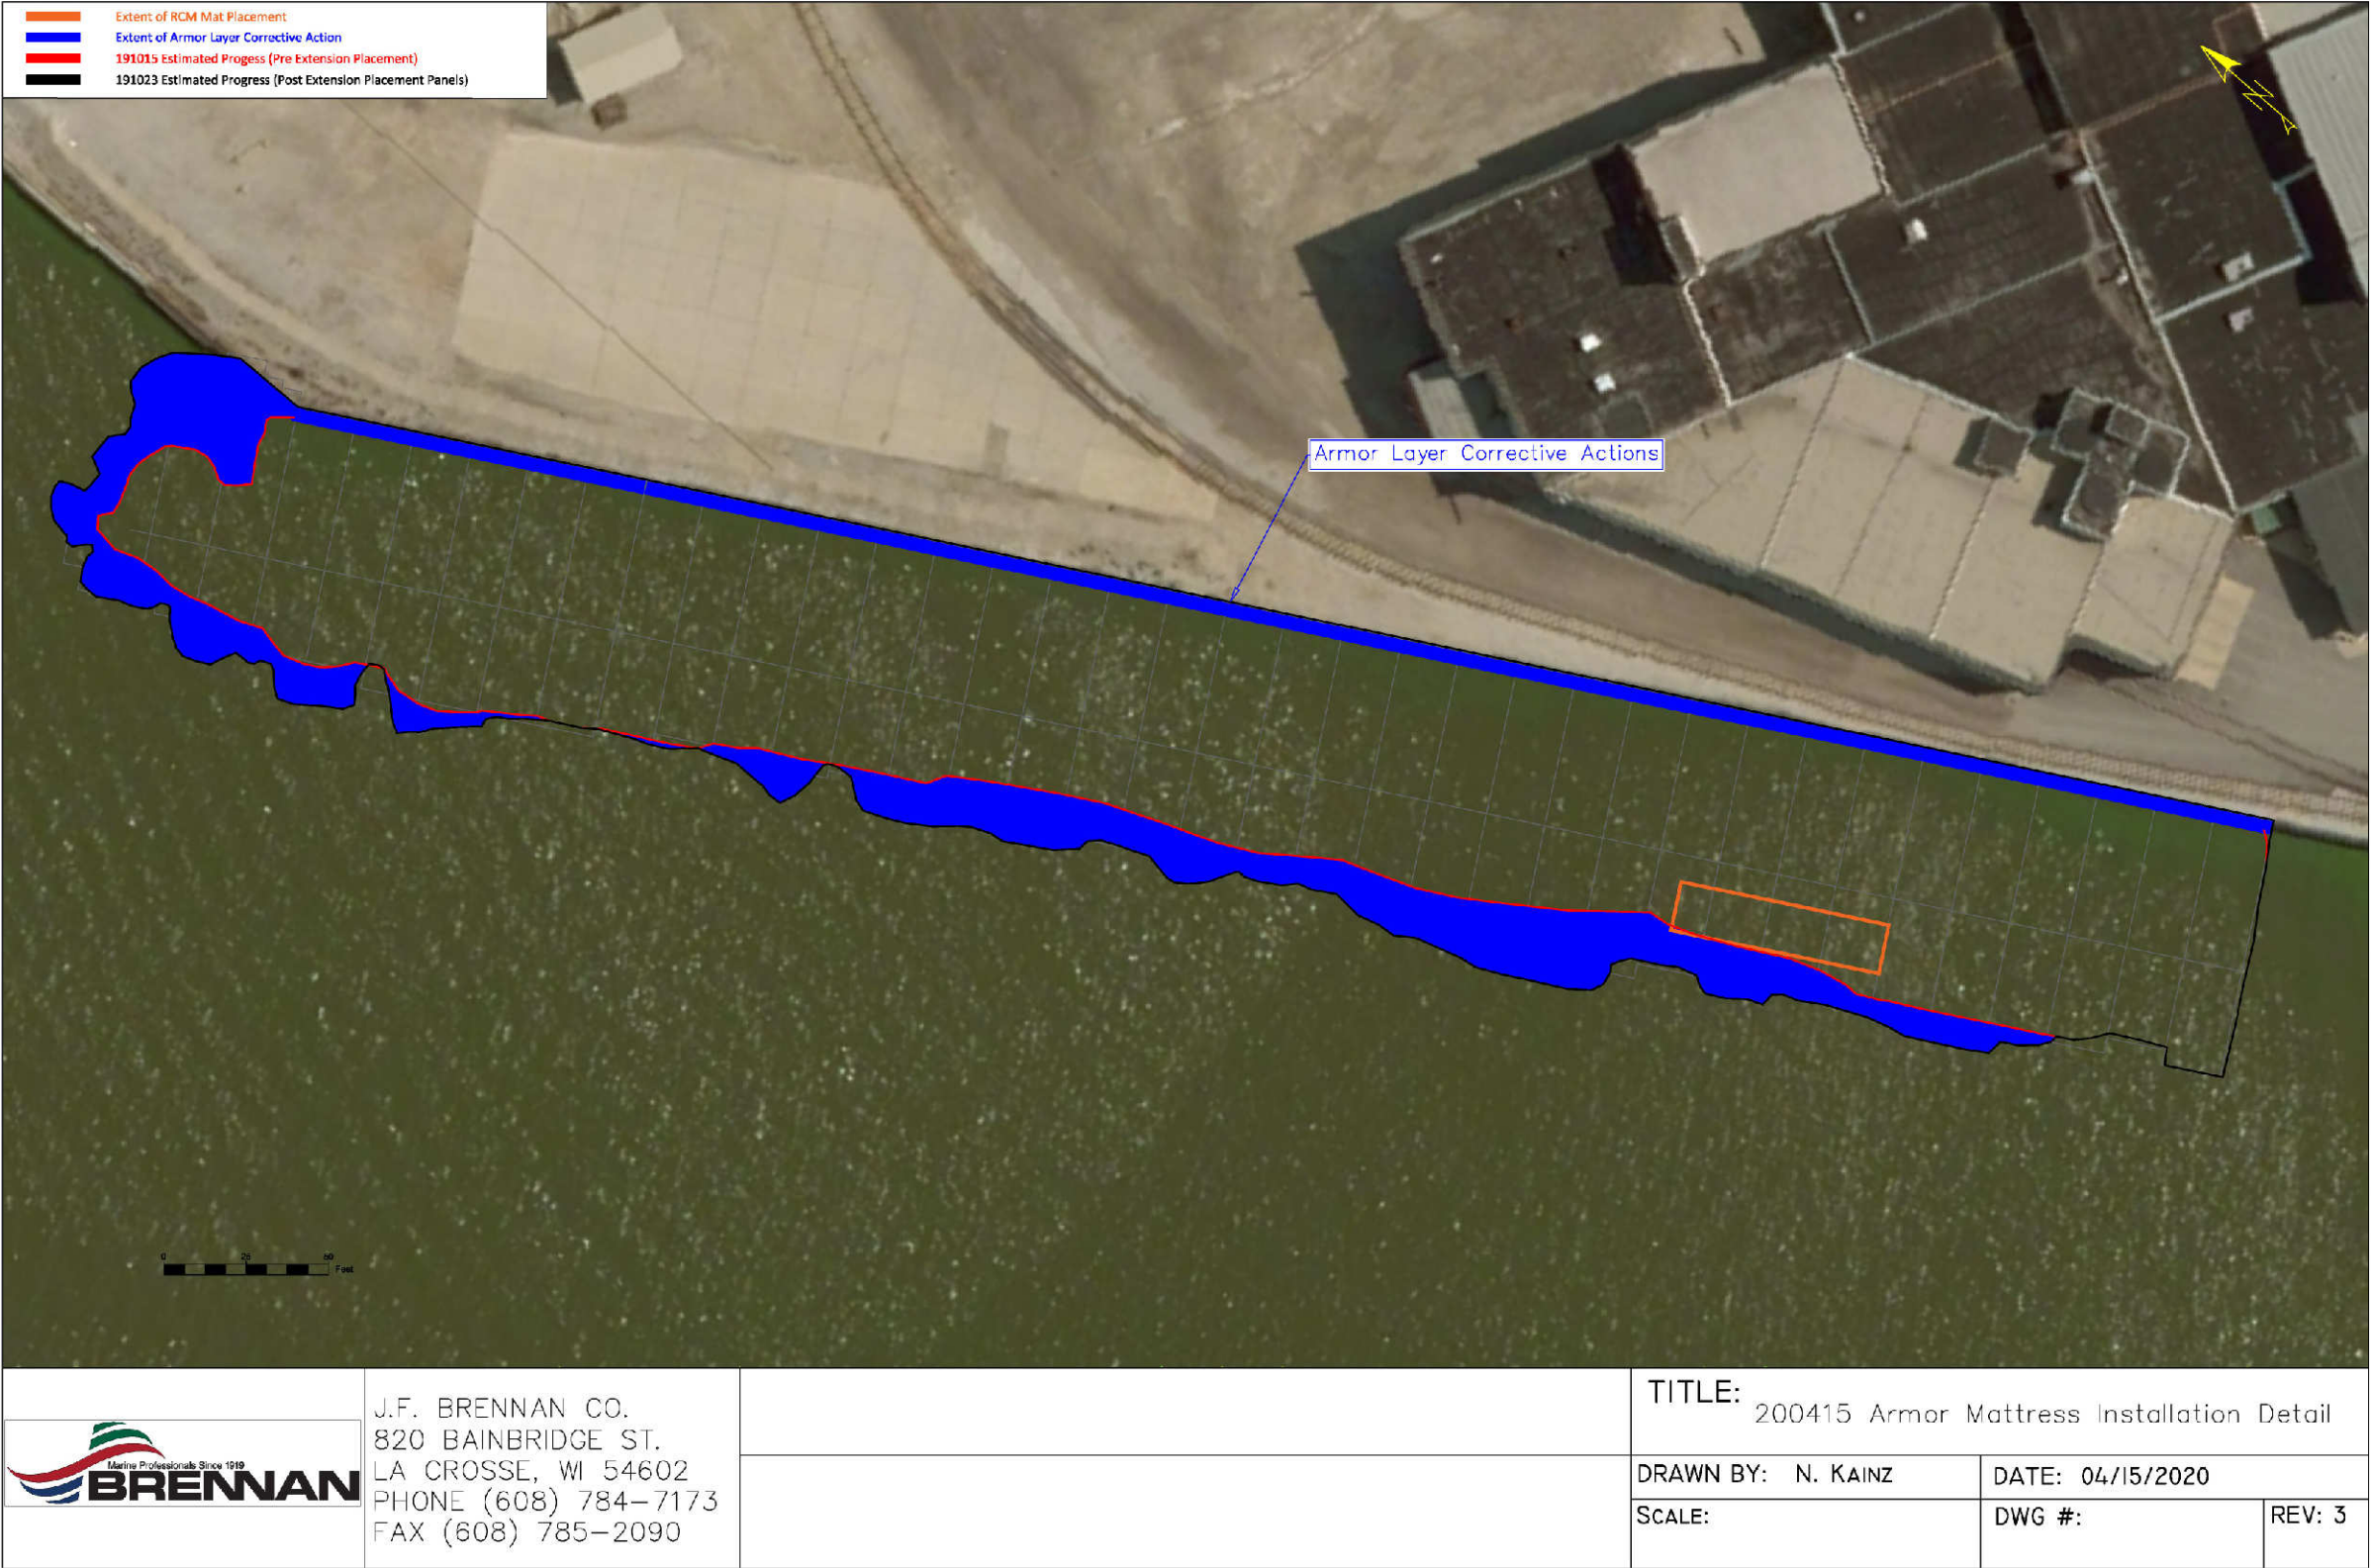
FIGURE 7

ARMORED MATTRESS INSTALLATION DETAIL

Anchor QEA evaluated the portion of the grouted mattress that had been placed to date, with the understanding that the as-built mattress thickness was less in some areas than the design thickness of 12 inches. Conservatively assuming that the mattresses installed to date averaged 8-inch thickness, the as-built grouted mattress with anchors exceeded design requirements for resistance to flows. Although the as-built conditions exceeded design requirements, the team worked with Synthetex to improve grout filling outcomes. An adjustment to the sequence of grout filling, connecting with neighboring mattresses, and anchoring facilitated subsequently filled mattresses to substantially achieve the design thickness of 12 inches. Divers recorded mattress thicknesses to document for QA progress reports.

Divers visually inspected the mats from September 18 to October 21, 2019 for consistent filling of the grout chambers and general conditions of the mats (i.e., mats were installed flat on post-dredge surface with no folds or wrinkles). QC thickness progress charts are provided in Appendix F. The A/OT accepted armor layer installation results on November 8, 2019.

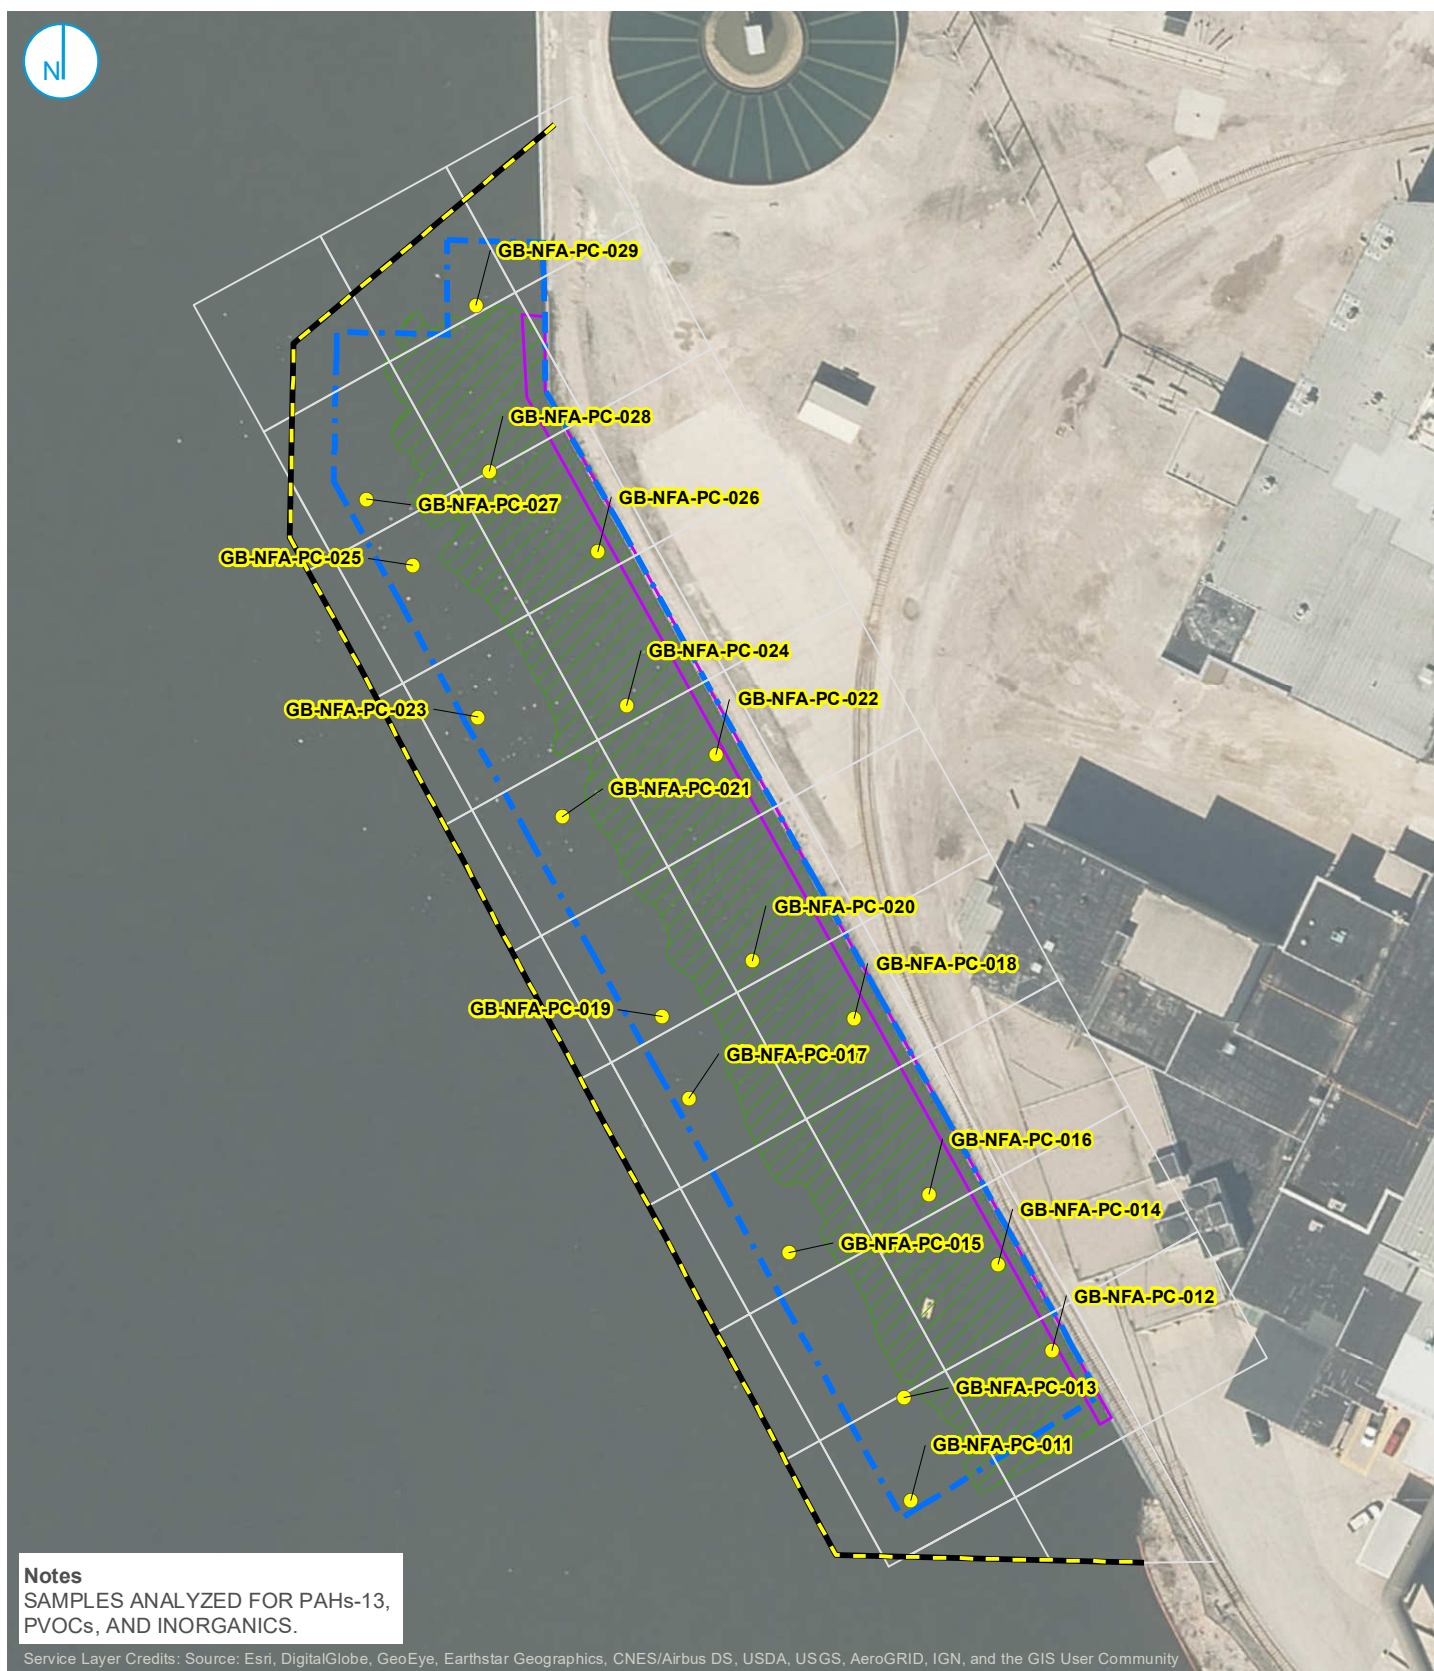
FIGURE 8

POST-REMOVAL SAMPLE LOCATIONS - AUGUST 2019

Geotechnical samples were collected at selected verification locations inside the SDE footprint from August 6 through August 9, 2019 to characterize the sediments beneath the CIL and armor cap layers. Geotechnical results are presented in Table 4. Moisture content was highly variable, ranging from 33.0% to 171.1%. Regardless of texture (grain size), the coefficients of permeability were quite low, on the order of 10^{-8} centimeters per second (cm/s).

Locations GB-NFA-PC-014 through 26 (even numbered) had visual observations of DNAPL noted during core characterization.

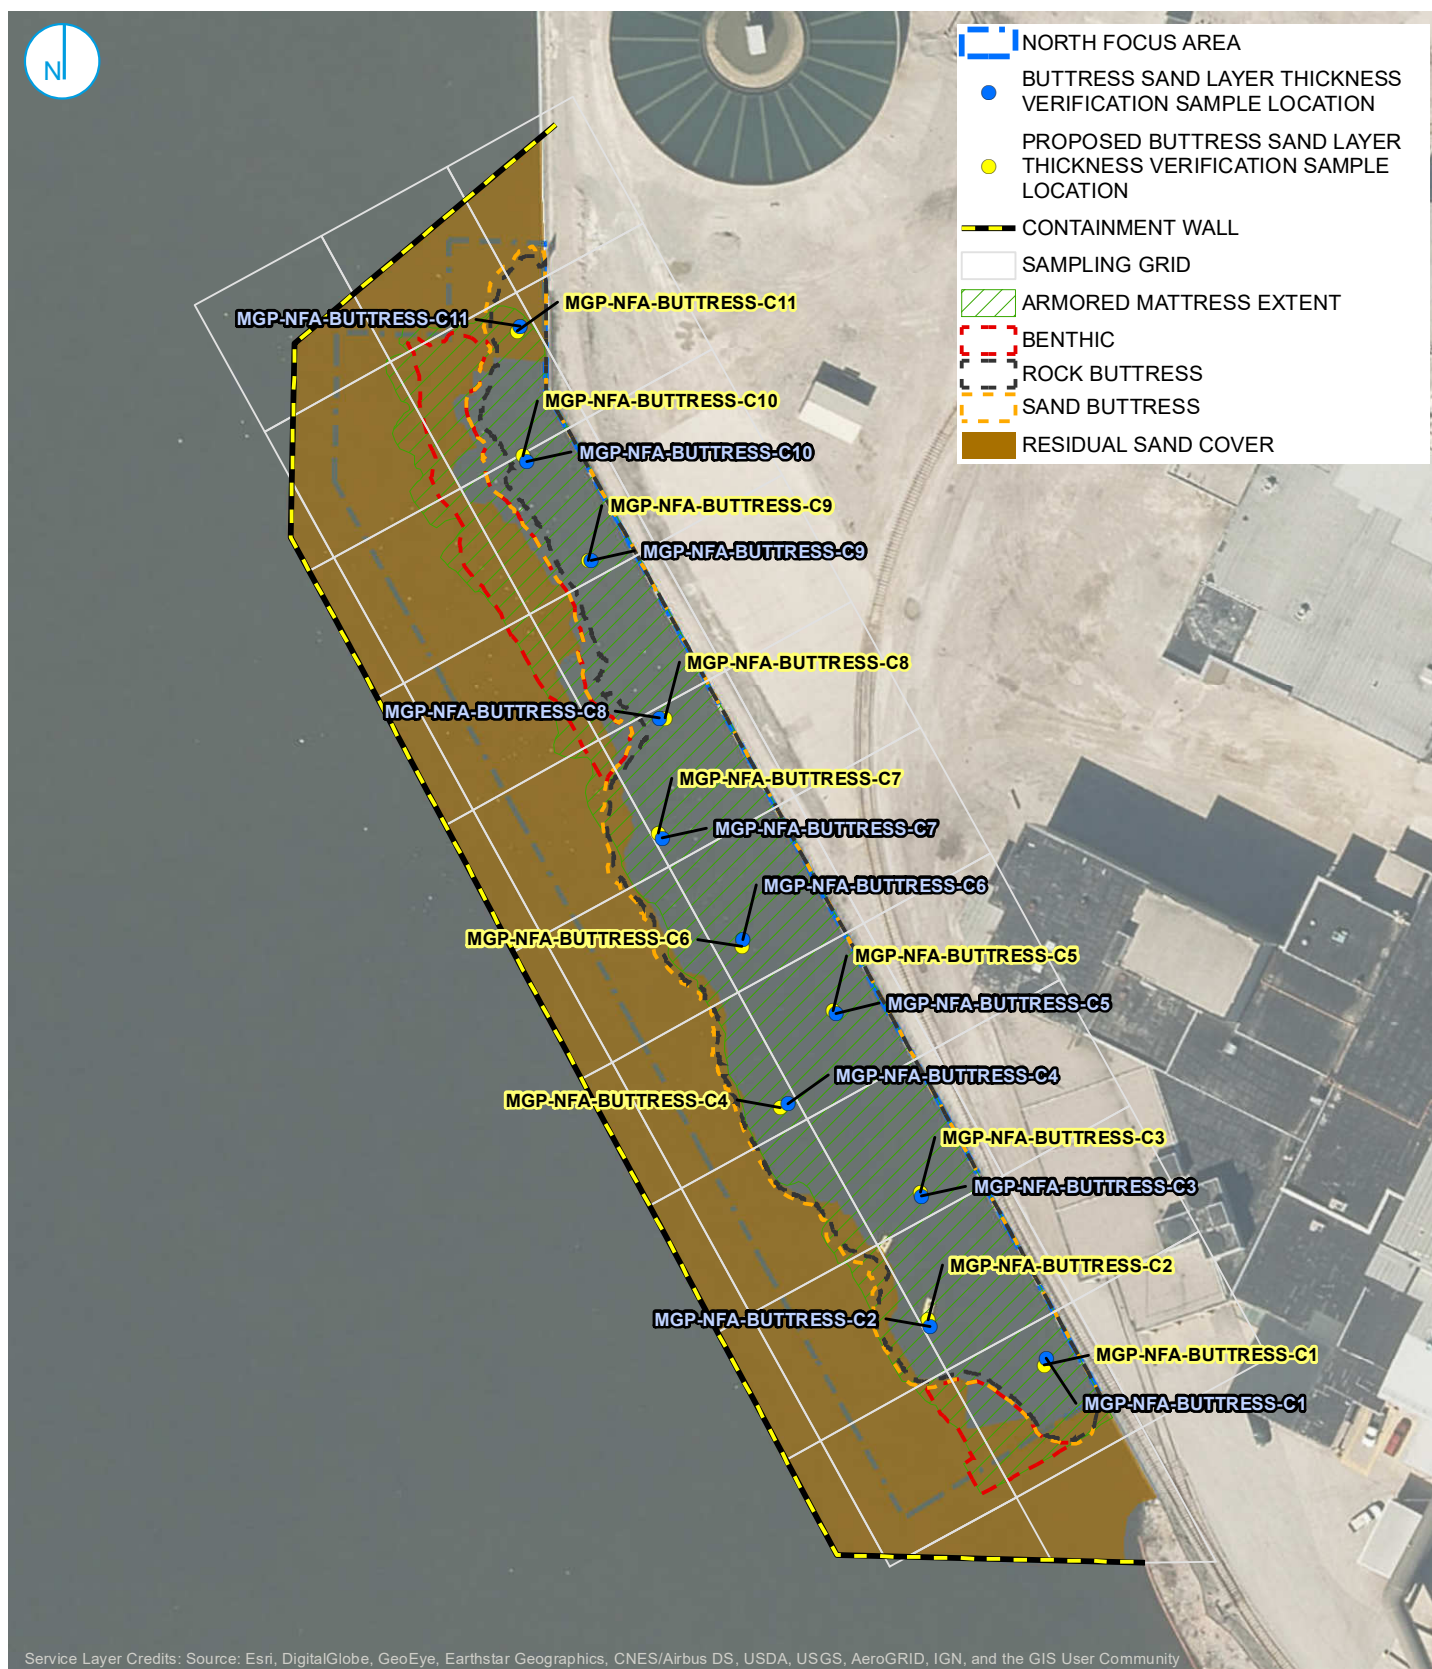
FIGURE 9

BUTTRESS SAND THICKNESS VERIFICATION CORING LOCATIONS

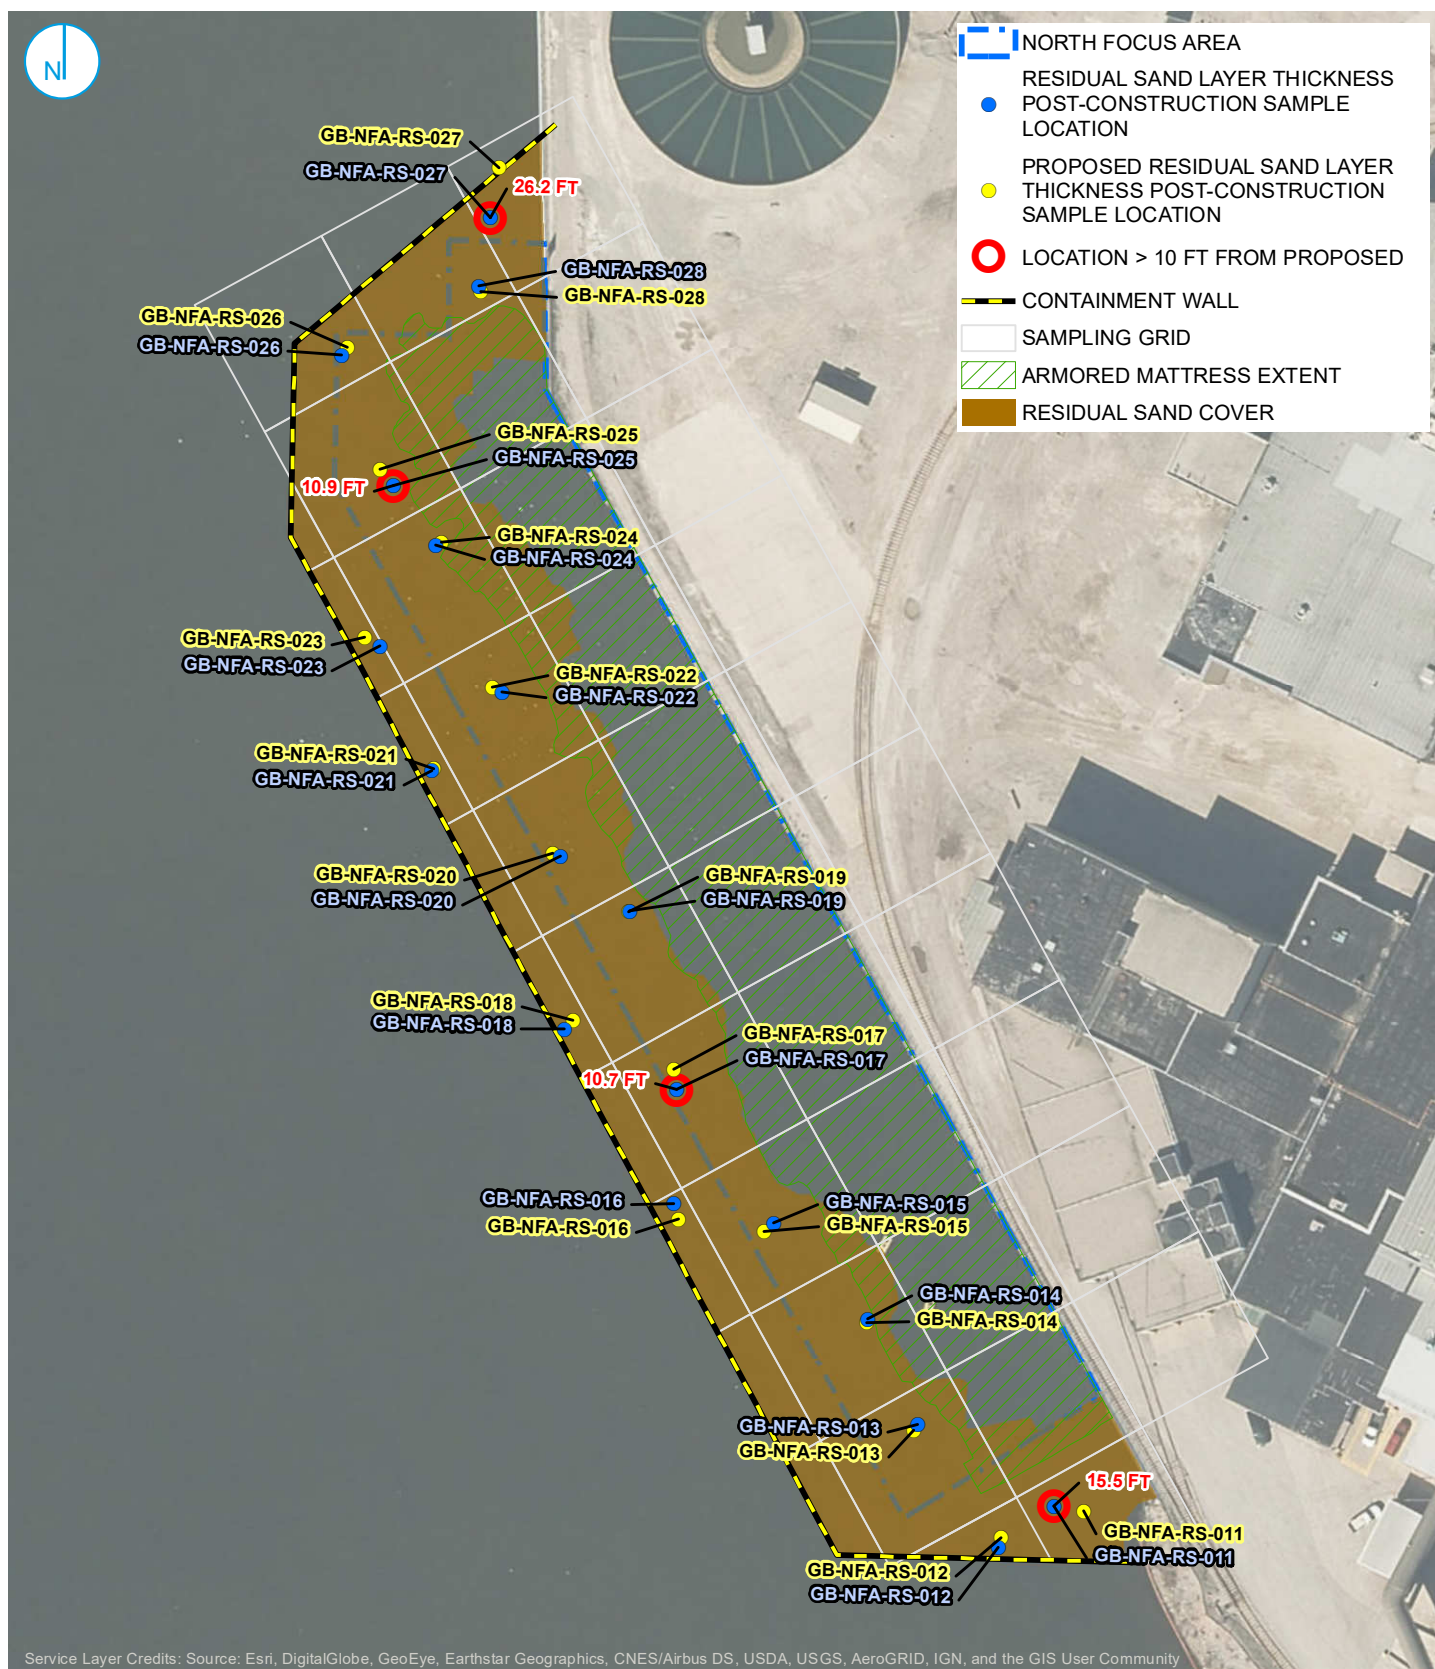
FIGURE 10

RESIDUAL SAND LAYER POST-CONSTRUCTION THICKNESS VERIFICATION LOCATIONS
