Memorandum

Foth Infrastructure & Environment, LLC

May 9, 2018

RE: Lower Fox River OU4 *COMMP* Cap Integrity Assessment - Year 2

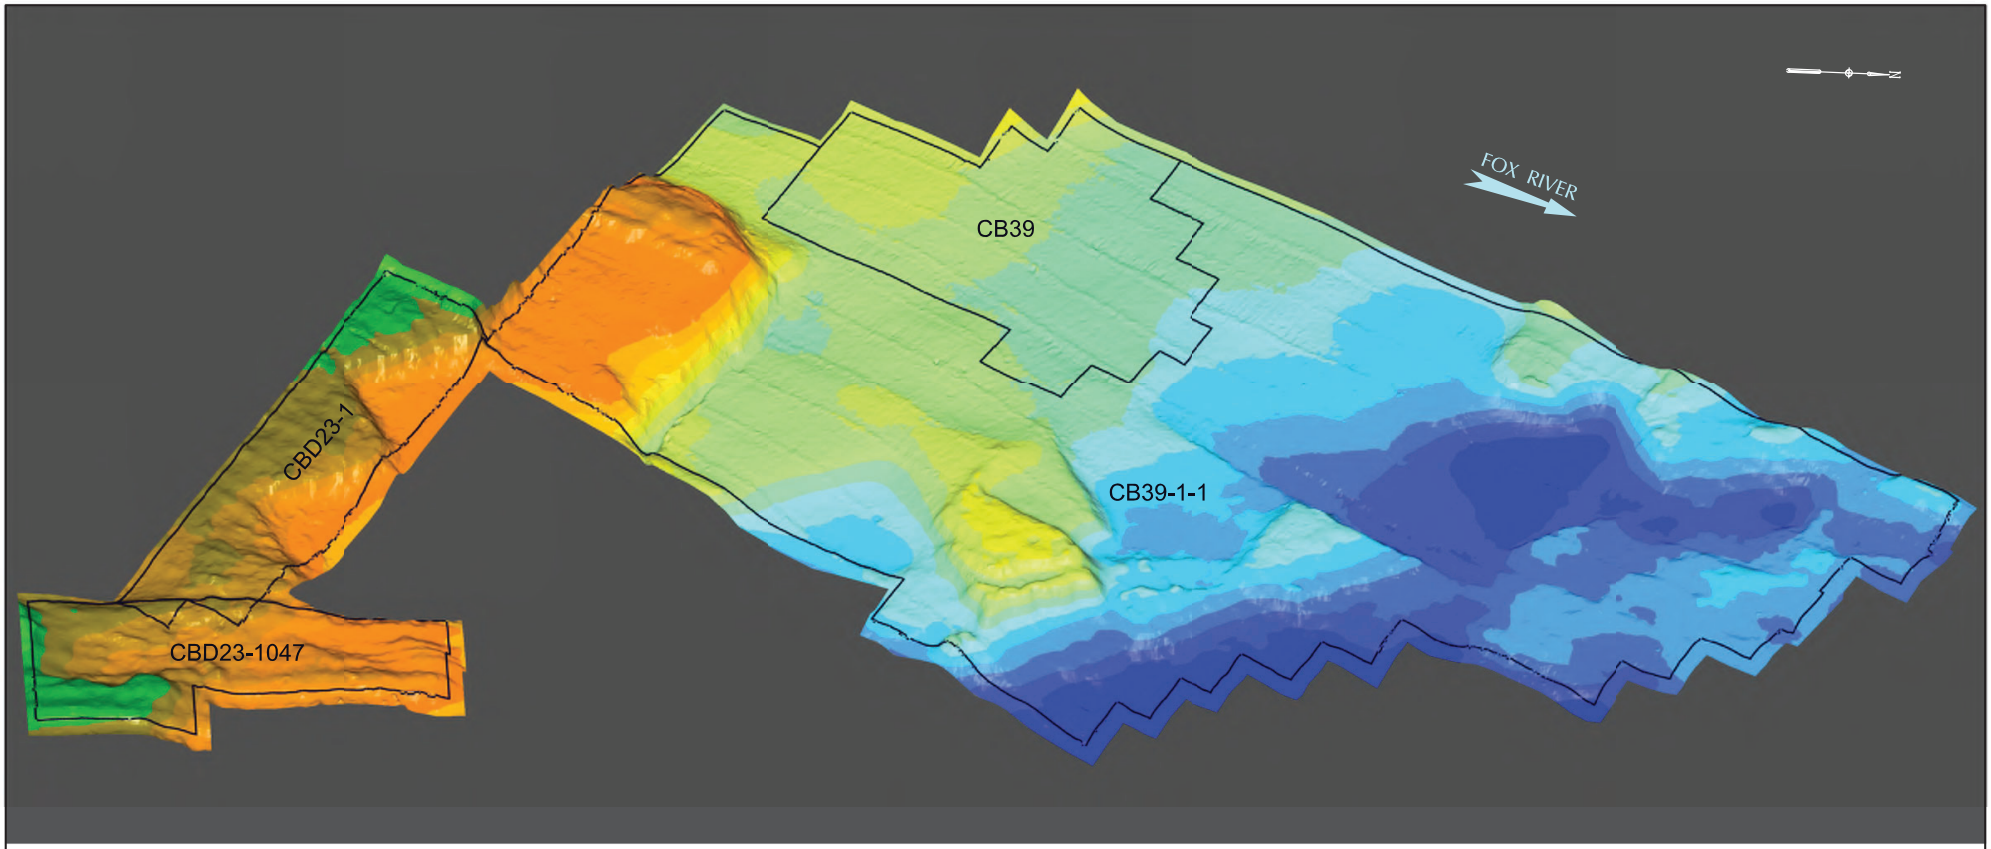
c:\pw_workdir\pw_ie\jrb2\d0153573\Fig-2B Cap Iso View.dgn
1/31/2018 1:40:56 PM JRB2

- Two triangular-shaped depression areas are visible in the mudline elevations in CBD23-1 (Figure 2B). No abrupt change in elevation is found, however, when comparing to the isopach difference figure (Figure 2C). Therefore, the depressed areas on Figure 2B are likely a reflection of the river bottom topography. In addition, the poling/probing evaluation confirms the existence of armor stone in these areas.

- A depression area is visible in the mudline elevations along the northern edge of CB6-1-1 (Figure 3B). No abrupt change in elevation is found, however, with this area when viewing the same areas in the isopach difference figure (Figure 3C). Therefore, the depressed area on Figure 3B is likely a reflection of the river bottom topography. To further confirm the integrity of the cap in this area, a cross-section was cut through the depressed area (Figure 3D). The 2014 and 2016 surveys follow a similar contour confirming that the depressed area on Figure 3B

- The 2016 top of cap elevations in D24-RDMU1 (Figure 3B) appear highly irregular. No abrupt change in elevation is found, however, when comparing to the isopach difference figure (Figure 3C). To further confirm the integrity of the cap, a cross-section was cut through the area (Figure 3D). The 2014 and 2016 surveys follow a similar contour confirming that the irregularity seen on Figure 3B is a reflection of the river bottom topography. In addition, the poling/probing evaluation confirms the existence of armor stone in these areas.

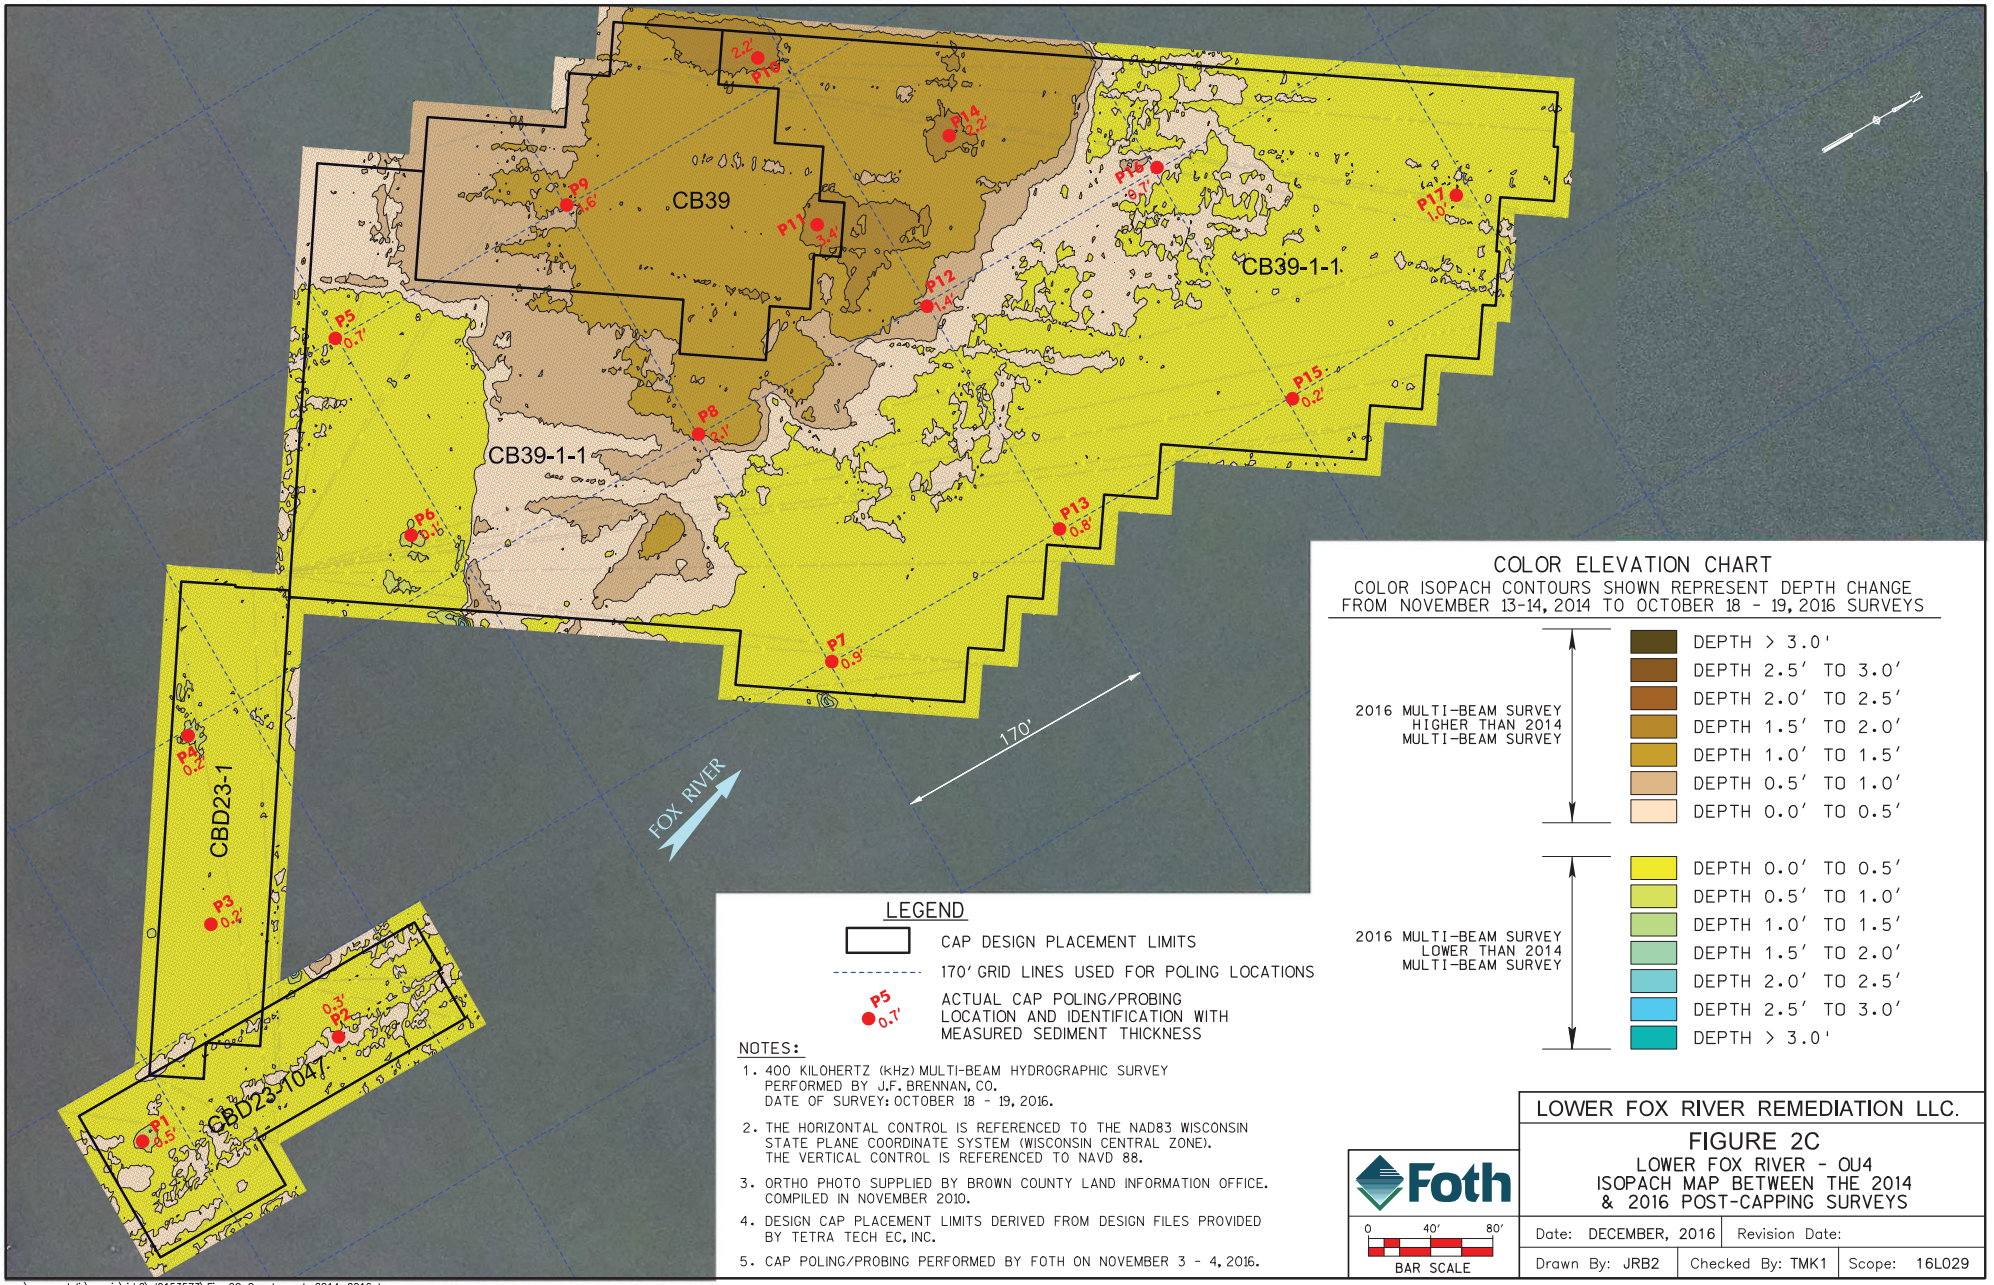
c:\pw_workdir\pw_ie\jrb2\d0153573\Fig-2C Cap Isopach 2014-2016.dgn
1/31/2018 3:47:58 PM JRB2

Year 2 (2016)	The isopach difference (Figure 2C) indicates that the 2016 survey is higher than the 2014 survey by 1.0-2.0' in a large portion of CB39 and the surrounding areas in CB39-1-1. Poling/probing measurements confirm that deposition of sediment has occurred in these areas of a similar magnitude as that indicated in the survey, as shown on Figure 2C. The poling/probing evaluation determined soft sediment exists over the cap armor stone.	Cap maintenance not required.	N/A
D24-RDMU1	2.06	2013	Year 0 (2014)	No irregularities noted.	Cap maintenance not required.	N/A
			Year 2 (2016)	The 2016 top of cap elevations in D24-RDMU1 (Figure 3B) appear highly irregular. No abrupt change in elevation is found, however, when comparing to the isopach difference figure (Figure 3C). To further confirm the integrity of the cap, a cross-section was cut through the area (Figure 3D). The 2014 and 2016 surveys follow a similar contour confirming that the irregularity seen on Figure 3B is a reflection of the river bottom topography. In addition, the poling/probing evaluation confirms the existence of armor stone in these areas.	Cap maintenance not required.	N/A

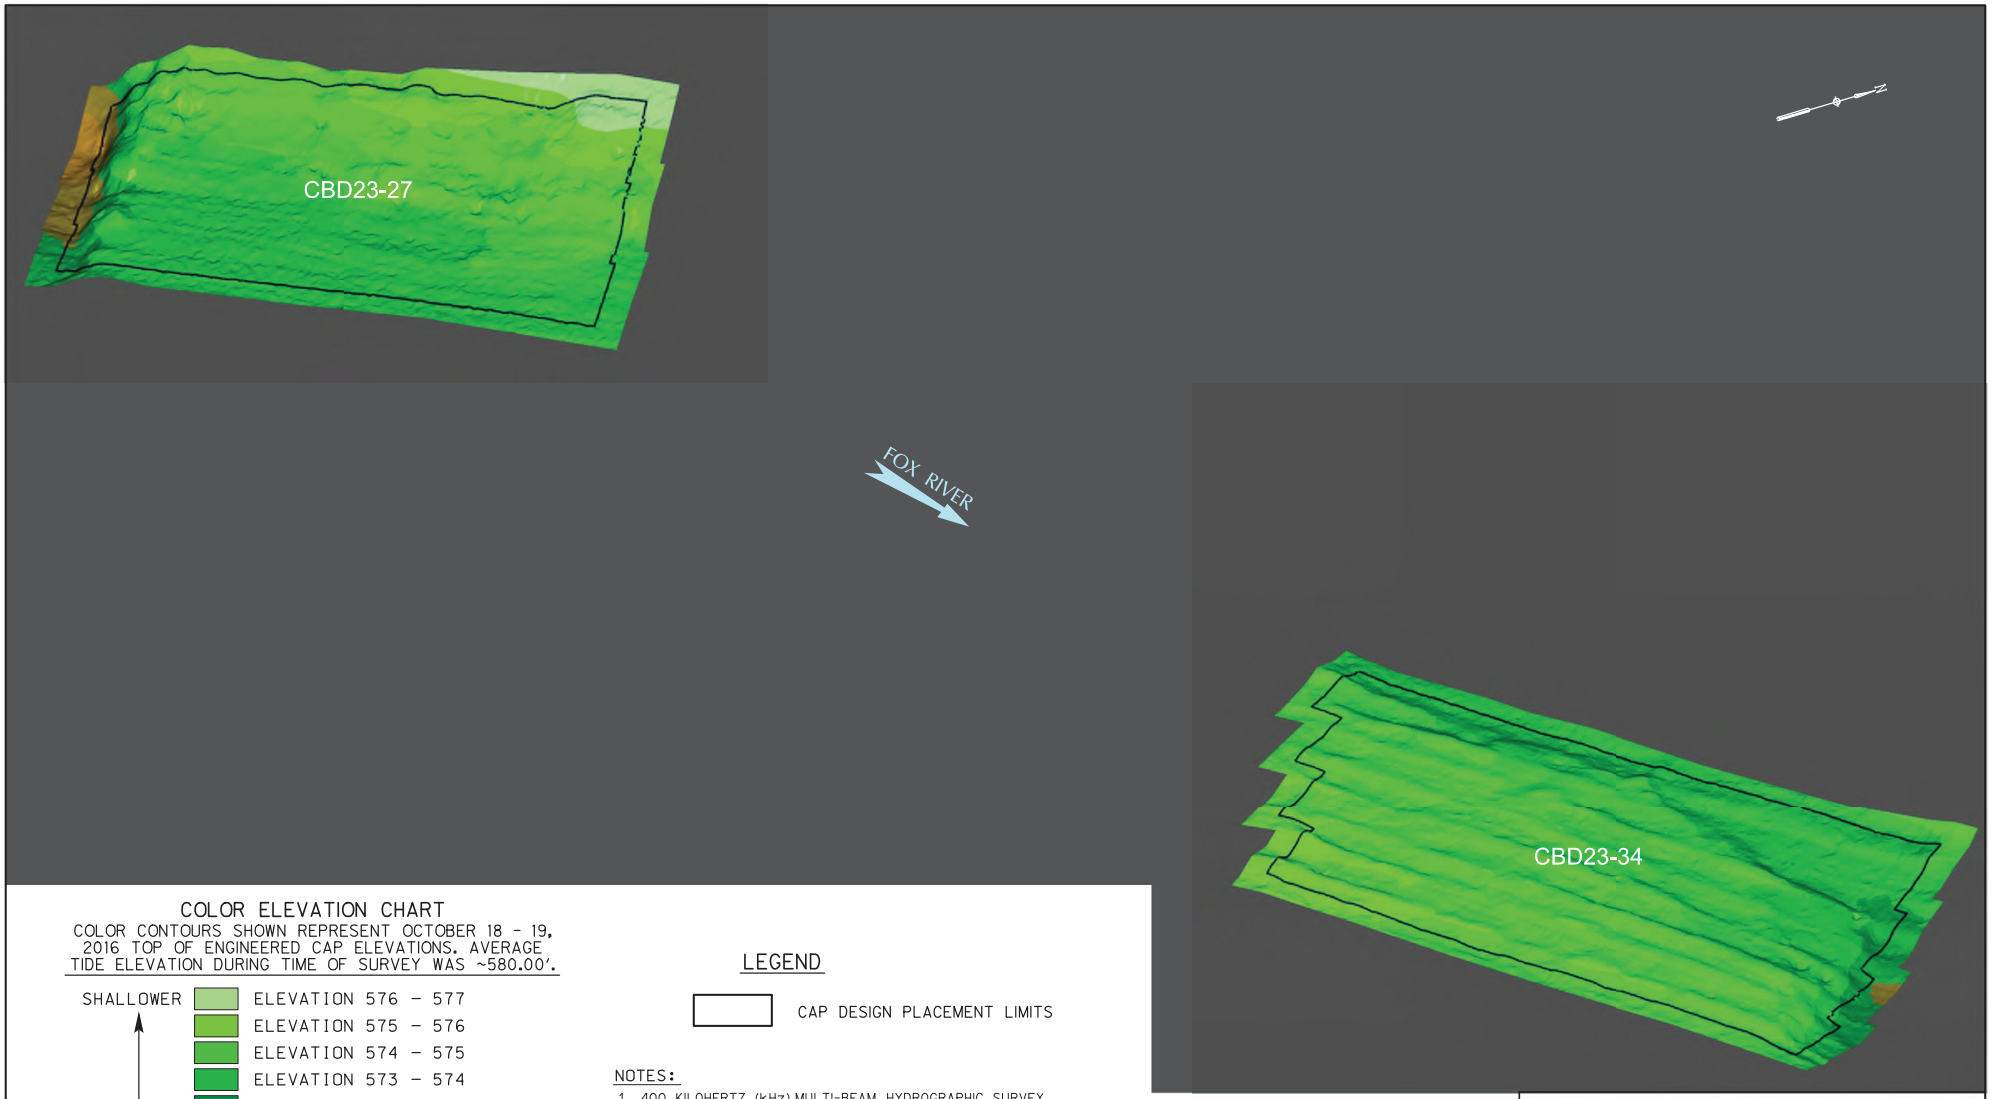
FIGURE 4B

CBD23-27	0.46	2014	Year 0 (2014)	No irregularities noted.	Cap maintenance not required.	N/A
			Year 2 (2016)	The top of cap elevations along the southern edge of CBD23-27 (Figure 4B) dips toward the south; however, the isopach difference (Figure 4C) indicates that the 2016 elevations are higher than the 2014 elevations by 0.5-1.5'. Therefore, this area reflects a depositional location. The poling/probing evaluation determined soft sediment exists over the cap armor stone.	Cap maintenance not required.	N/A

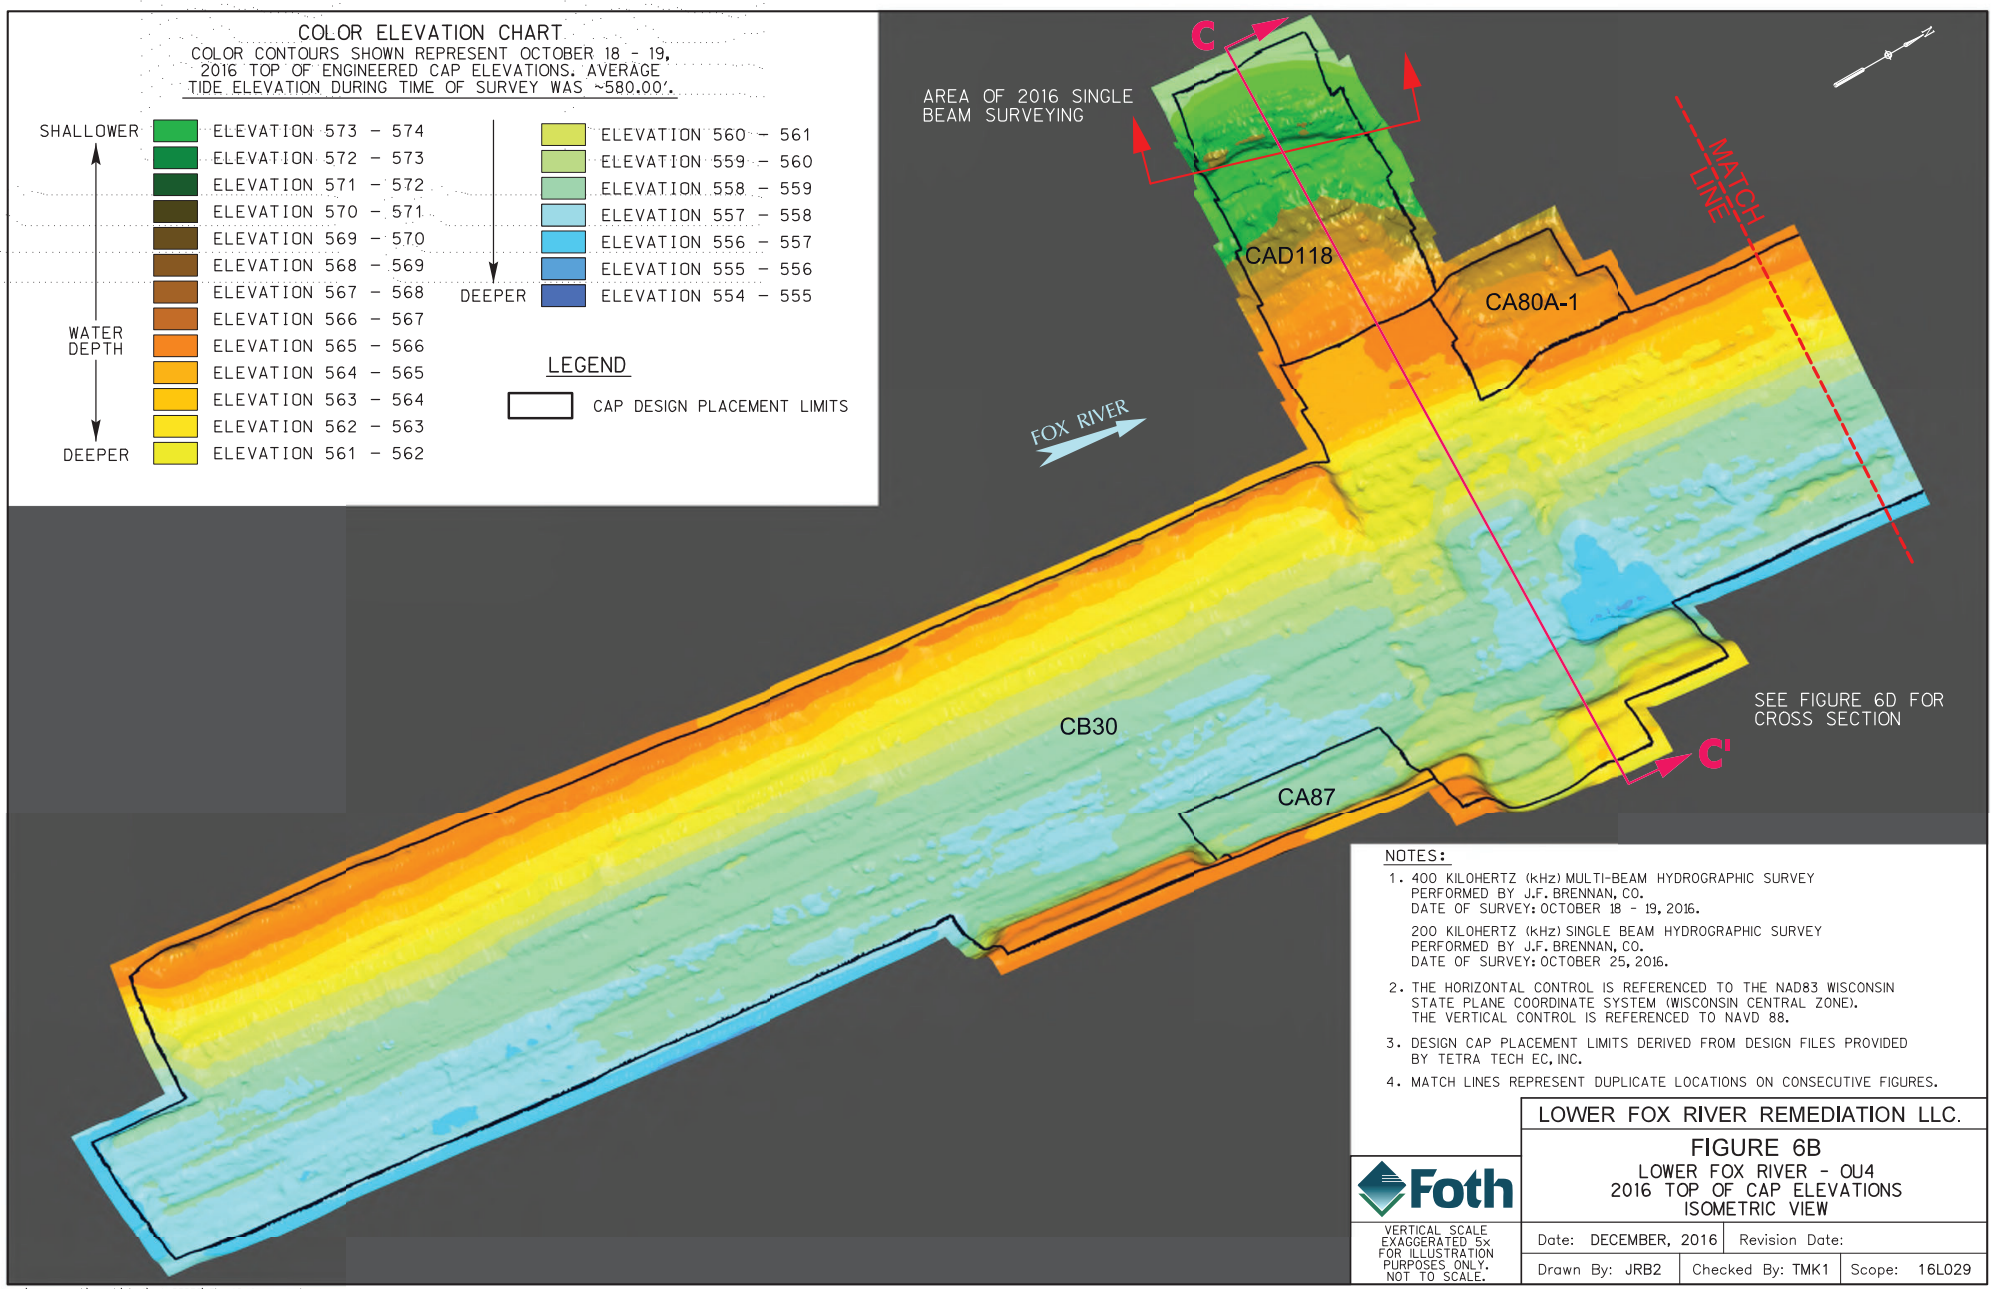
c:\pw_workdir\pw_ie\jrb2\d0153573\Fig-6C Cap Isopach 2014-2016.dgn
2/1/2018 10:36:02 AM JRB2

CB30	5.88	2014	Year 0 (2014)	No irregularities noted.	Cap maintenance not required.	N/A
			Year 2 (2016)	The isometric view for the top of cap elevations for CAD118 and the portion of CB30 east of CAD118 (Figure 6B) appeared irregular; therefore, a cross-section was cut through these areas (Figure 6D) to confirm cap integrity. The isopach difference (Figure 6C) did not show similar irregularities and the 2014 and 2016 surveys follow similar and parallel contours indicating that the irregularity is likely a reflection of the river bottom topography and consolidation of the underlying soft sediment. In addition, the poling/probing evaluation confirms the existence of armor stone in these areas.	Cap maintenance not required.	N/A
CA87	0.23	2014	Year 0 (2014)	No irregularities noted.	Cap maintenance not required.	N/A
			Year 2 (2016)	No irregularities noted.	Cap maintenance not required.	N/A
CAD118	0.41	2014	Year 0 (2014)	No irregularities noted.	Cap maintenance not required.	N/A

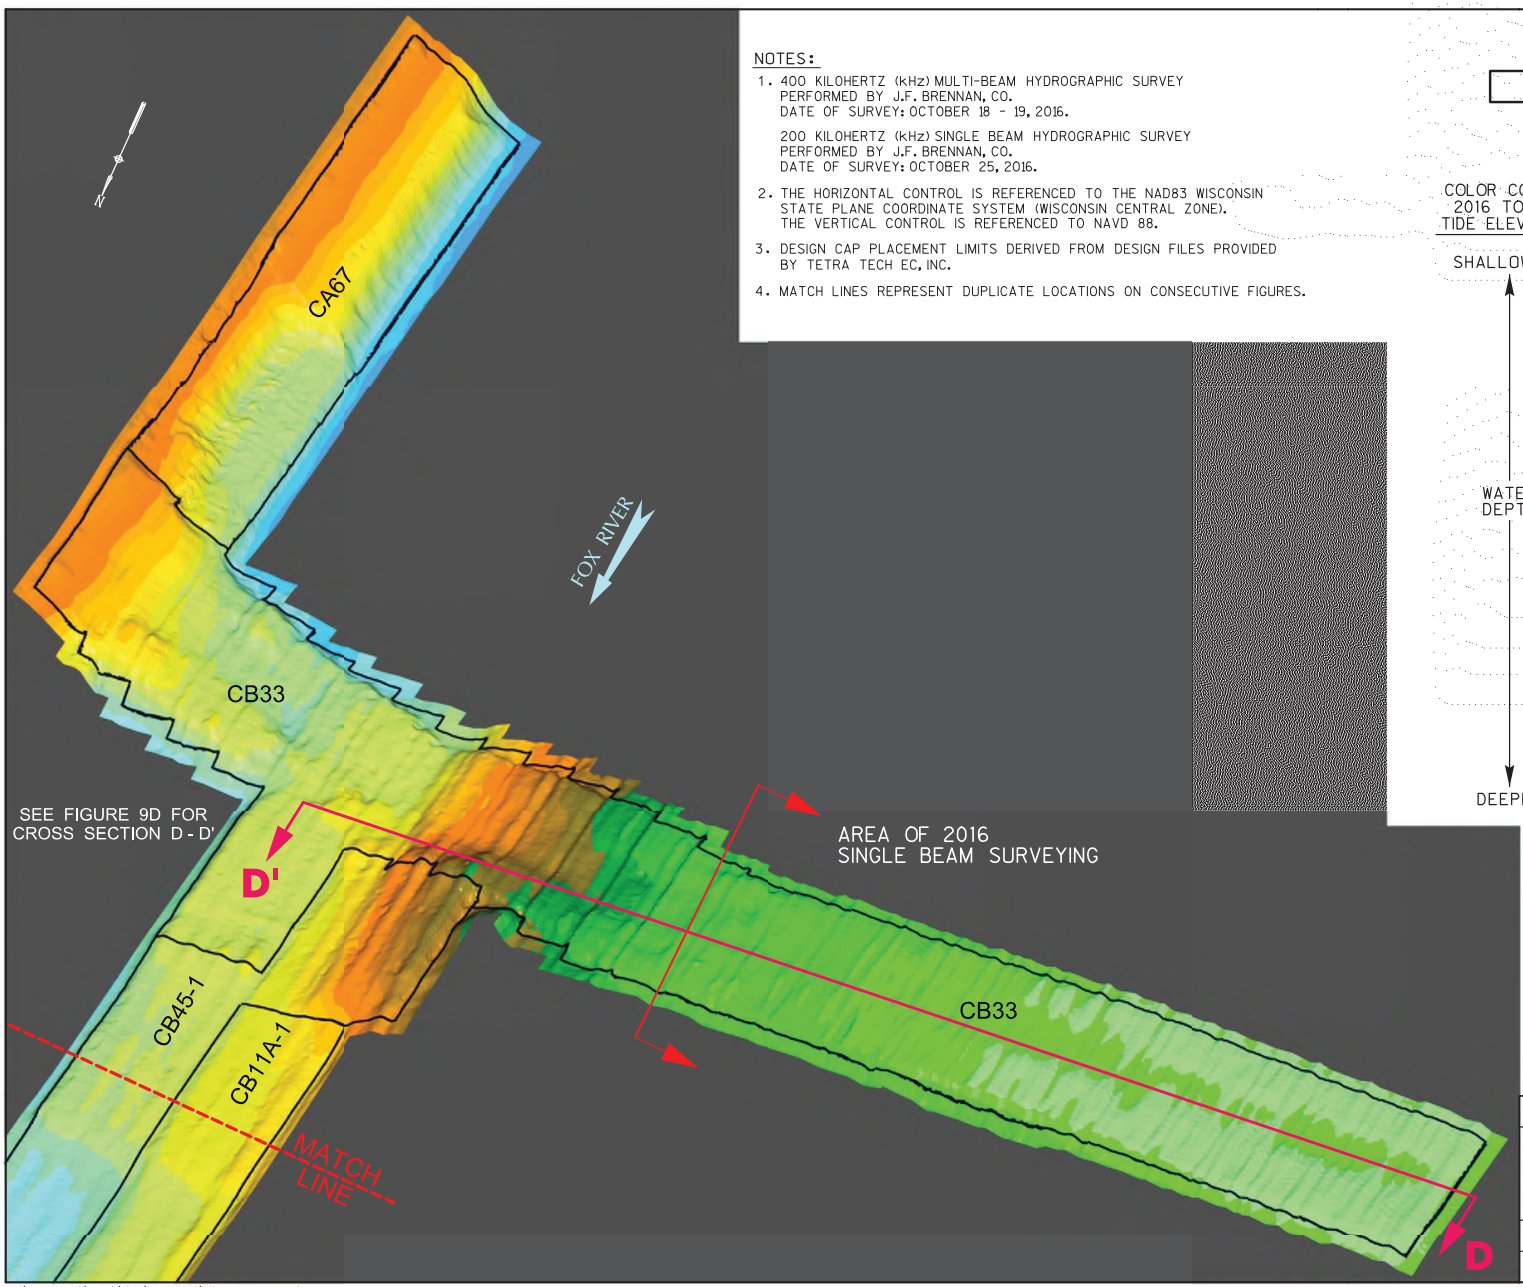
FIGURE 9B

- The isometric view for the top of cap elevations for CB33 (Figure 9B) appeared irregular and several depressed areas 0.5-1.5' were apparent in the isopach difference (Figure 9C); therefore, a cross-section was cut through the area (Figure 9D) to confirm cap integrity. The 2014 and 2016 surveys follow similar and parallel contours indicating that the irregularity is likely a reflection of the

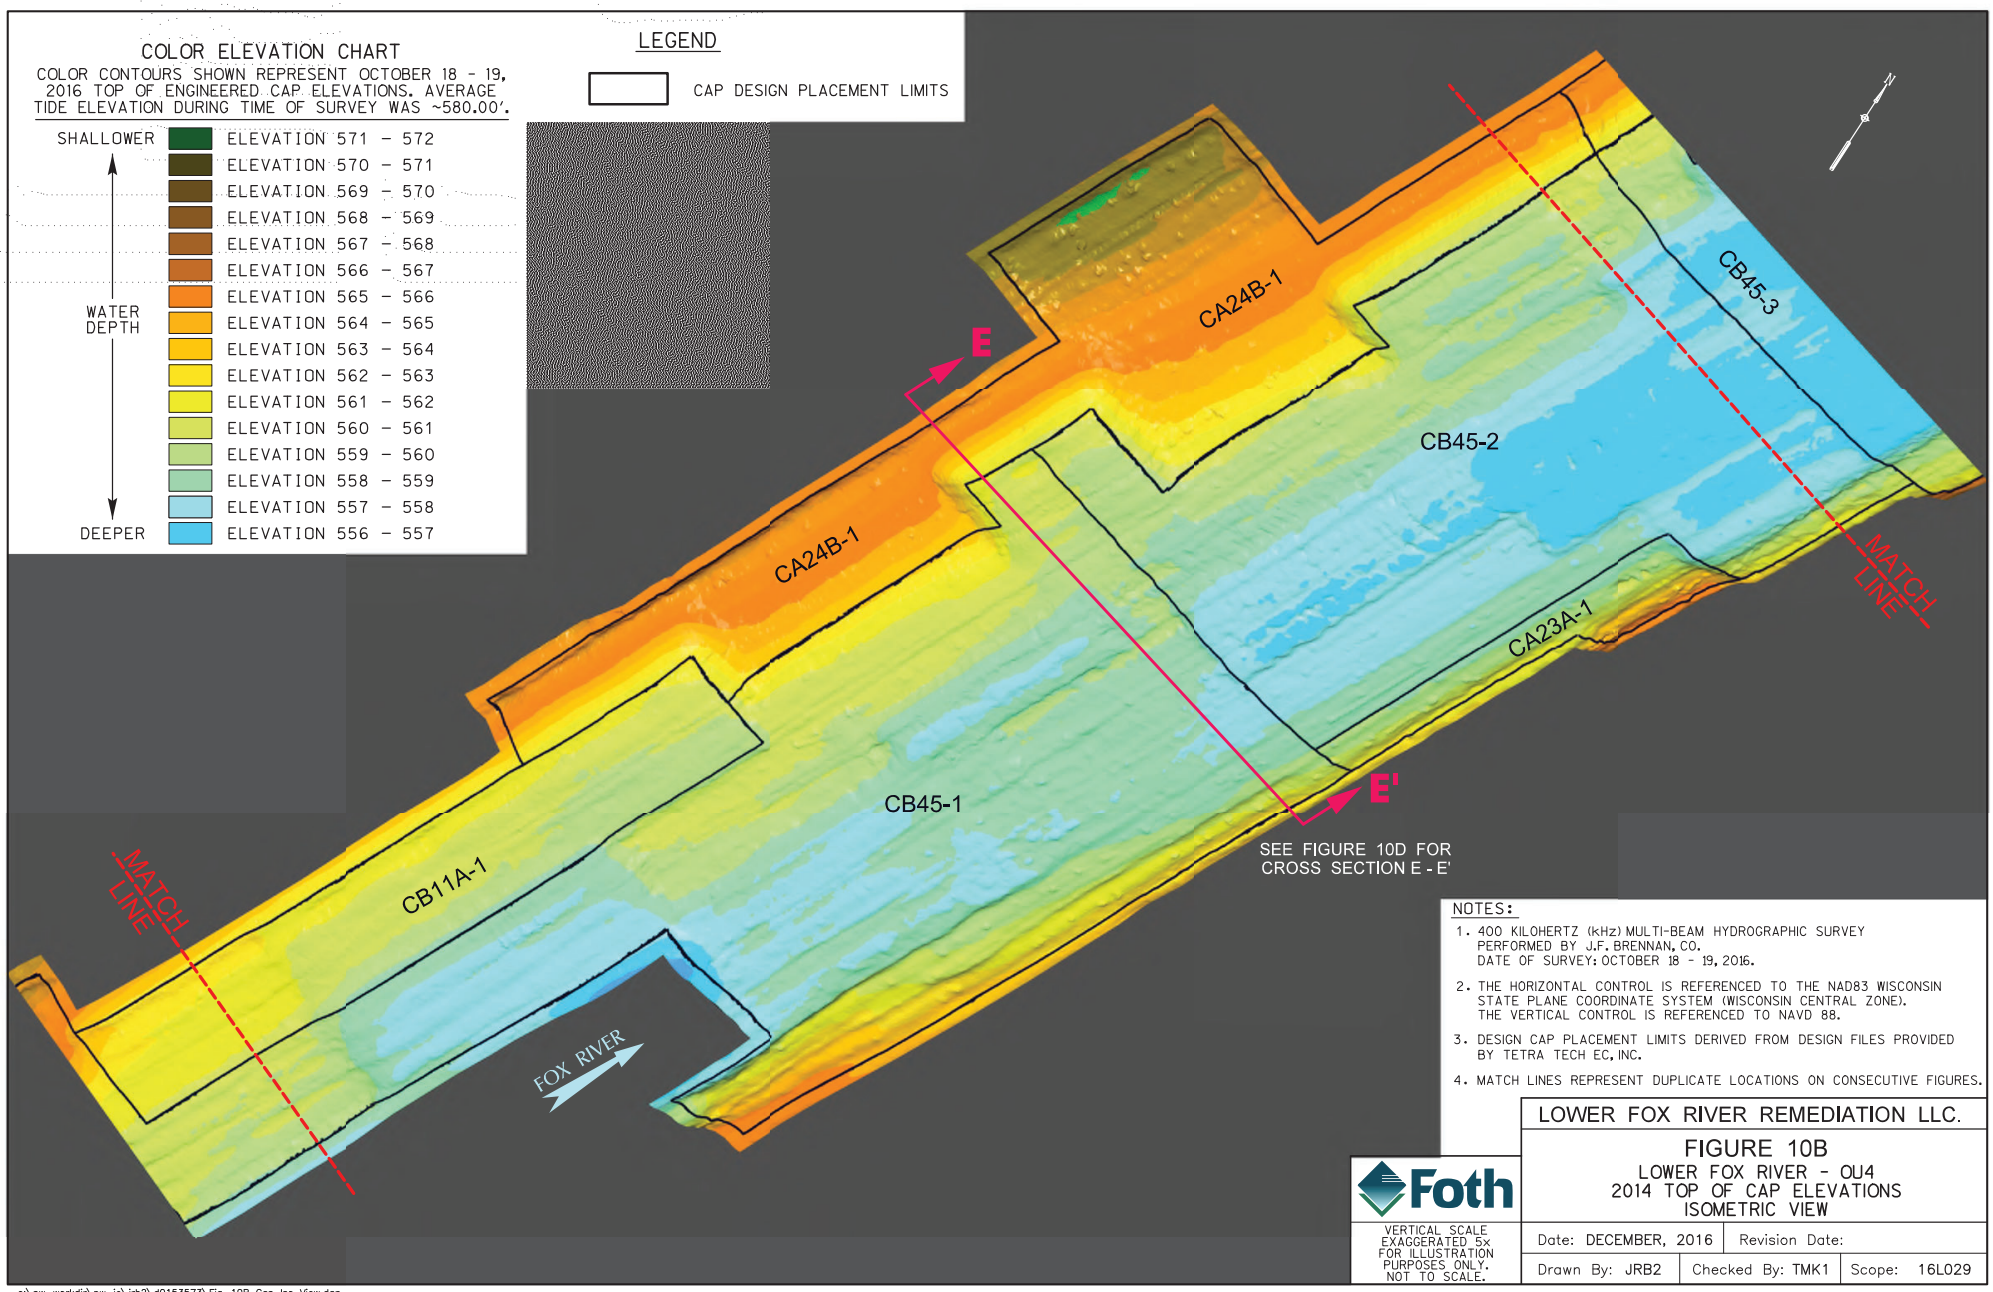
CB11A-1	0.76	2014	Year 0 (2014)	No irregularities noted.	Cap maintenance not required.	N/A
			Year 2 (2016)	No irregularities noted.	Cap maintenance not required.	N/A
CB45-1	3.47	2014	Year 0 (2014)	No irregularities noted.	Cap maintenance not required.	N/A
			Year 2 (2016)	Similar to CC9, contiguous cap areas CB45-1, CB45-2, and CA23A-1 (Figure 10C), as well as CB45-3 and the eastern portion of CA24B-2 (Figure 11C), contained relatively large areas in which the 2016 survey was lower than the 2014 survey by 0.5-1.0'. To confirm cap integrity, a cross-section was cut through CB45-1 as a representative section for these areas (Figure 10D). The 2014 and 2016 surveys follow a similar contour, though the 2016 survey is lower throughout CB45-1, indicating that the depressed areas are likely due to consolidation of underlying soft sediment. In addition, the poling/probing evaluation confirms the presence of the armor stone in these areas.	Cap maintenance not required.	N/A

CA23A-1	0.30	2014	Year 0 (2014)	No irregularities noted.	Cap maintenance not required.	N/A
			Year 2 (2016)	Similar to CC9, contiguous cap areas CB45-1, CB45-2, and CA23A-1 (Figure 10C), as well as CB45-3 and the eastern portion of CA24B-2 (Figure 11C), contained relatively large areas in which the 2016 survey was lower than the 2014 survey by 0.5-1.0'. To confirm cap integrity, a cross-section was cut through CB45-1 as a representative section for these areas (Figure 10D). The 2014 and 2016 surveys follow a similar contour, though the 2016 survey is lower throughout CB45-1, indicating that the depressed areas are likely due to consolidation of underlying soft sediment. In addition, the poling/probing evaluation confirms the presence of the armor stone in these areas.	Cap maintenance not required.	N/A
CA24B-1	1.37	2014	Year 0 (2014)	No irregularities noted.	Cap maintenance not required.	N/A

Location	Area (Acres)	Year Cap Completed	Routine Monitoring Event	Evaluation	Recommendation	Follow-up Action
CB45-2	2.39	2014	Year 0 (2014)	No irregularities noted.	Cap maintenance not required.	N/A
			Year 2 (2016)	Similar to CC9, contiguous cap areas CB45-1, CB45-2, and CA23A-1 (Figure 10C), as well as CB45-3 and the eastern portion of CA24B-2 (Figure 11C), contained relatively large areas in which the 2016 survey was lower than the 2014 survey by 0.5-1.0'. To confirm cap integrity, a cross-section was cut through CB45-1 as a representative section for these areas (Figure 10D). The 2014 and 2016 surveys follow a similar contour, though the 2016 survey is lower throughout CB45-1, indicating that the depressed areas are likely due to consolidation of underlying soft sediment. In addition, the poling/probing evaluation confirms the presence of the armor stone in these areas.	Cap maintenance not required.	N/A

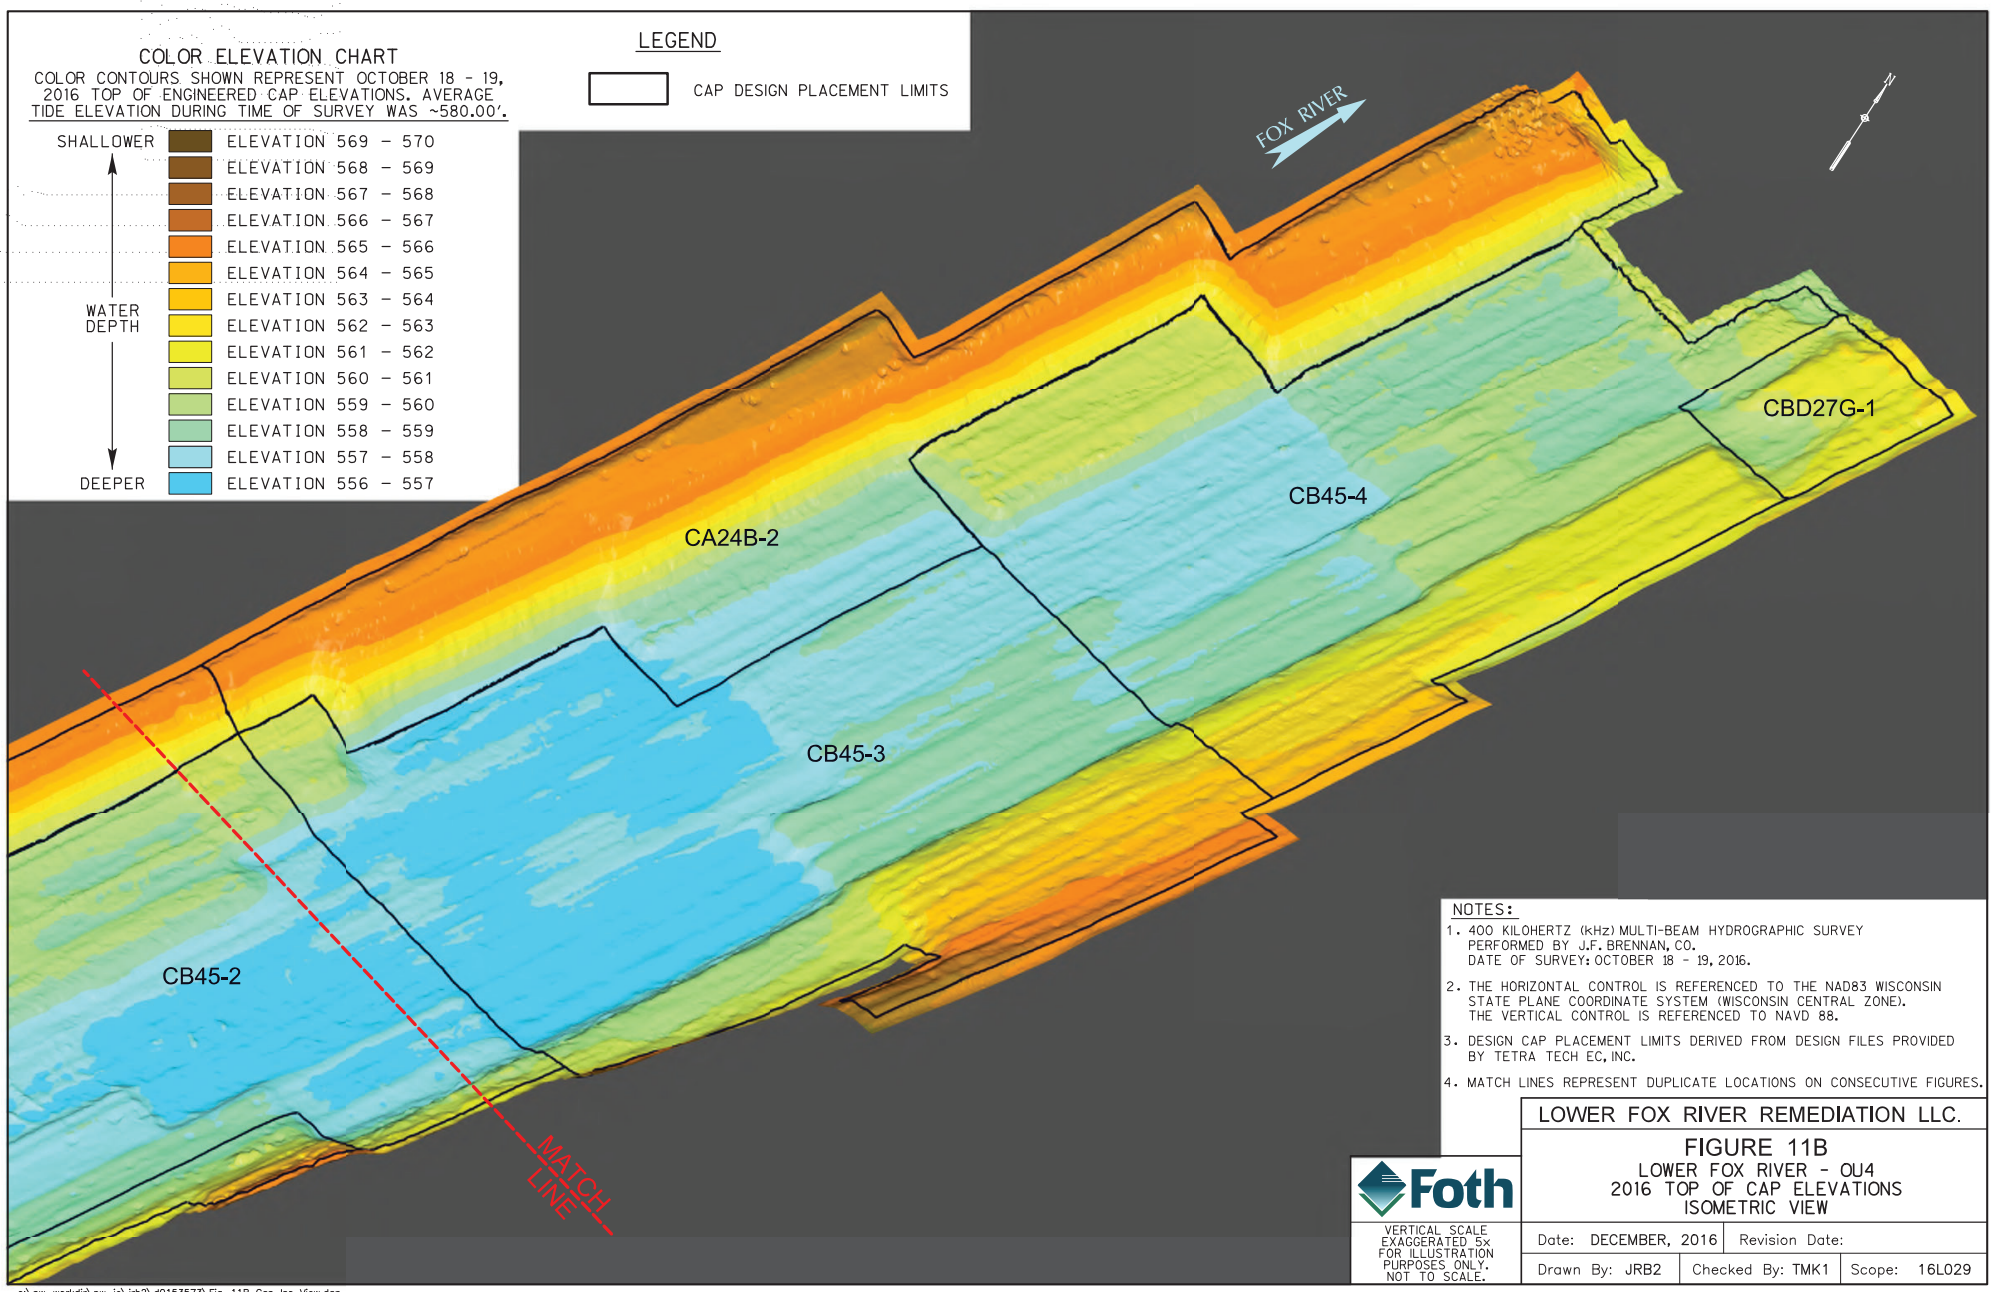
FIGURE 11C

Year 2 (2016)	No irregularities noted.	Cap maintenance not required.	N/A
CA24B-2	1.59	2014	Year 0 (2014)	No irregularities noted.	Cap maintenance not required.	N/A
			Year 2 (2016)	Similar to CC9, contiguous cap areas CB45-1, CB45-2, and CA23A-1 (Figure 10C), as well as CB45-3 and the eastern portion of CA24B-2 (Figure 11C), contained relatively large areas in which the 2016 survey was lower than the 2014 survey by 0.5-1.0'. To confirm cap integrity, a cross-section was cut through CB45-1 as a representative section for these areas (Figure 10D). The 2014 and 2016 surveys follow a similar contour, though the 2016 survey is lower throughout CB45-1, indicating that the depressed areas are likely due to consolidation of underlying soft sediment. In addition, the poling/probing evaluation confirms the presence of the armor stone in these areas.	Cap maintenance not required.	N/A

CB45-3	3.23	2014	Year 0 (2014)	No irregularities noted.	Cap maintenance not required.	N/A
			Year 2 (2016)	Similar to CC9, contiguous cap areas CB45-1, CB45-2, and CA23A-1 (Figure 10C), as well as CB45-3 and the eastern portion of CA24B-2 (Figure 11C), contained relatively large areas in which the 2016 survey was lower than the 2014 survey by 0.5-1.0'. To confirm cap integrity, a cross-section was cut through CB45-1 as a representative section for these areas (Figure 10D). The 2014 and 2016 surveys follow a similar contour, though the 2016 survey is lower throughout CB45-1, indicating that the depressed areas are likely due to consolidation of underlying soft sediment. In addition, the poling/probing evaluation confirms the presence of the armor stone in these areas.	Cap maintenance not required.	N/A
CB45-4	2.70	2014	Year 0 (2014)	No irregularities noted.	Cap maintenance not required.	N/A
			Year 2 (2016)	No irregularities noted.	Cap maintenance not required.	N/A

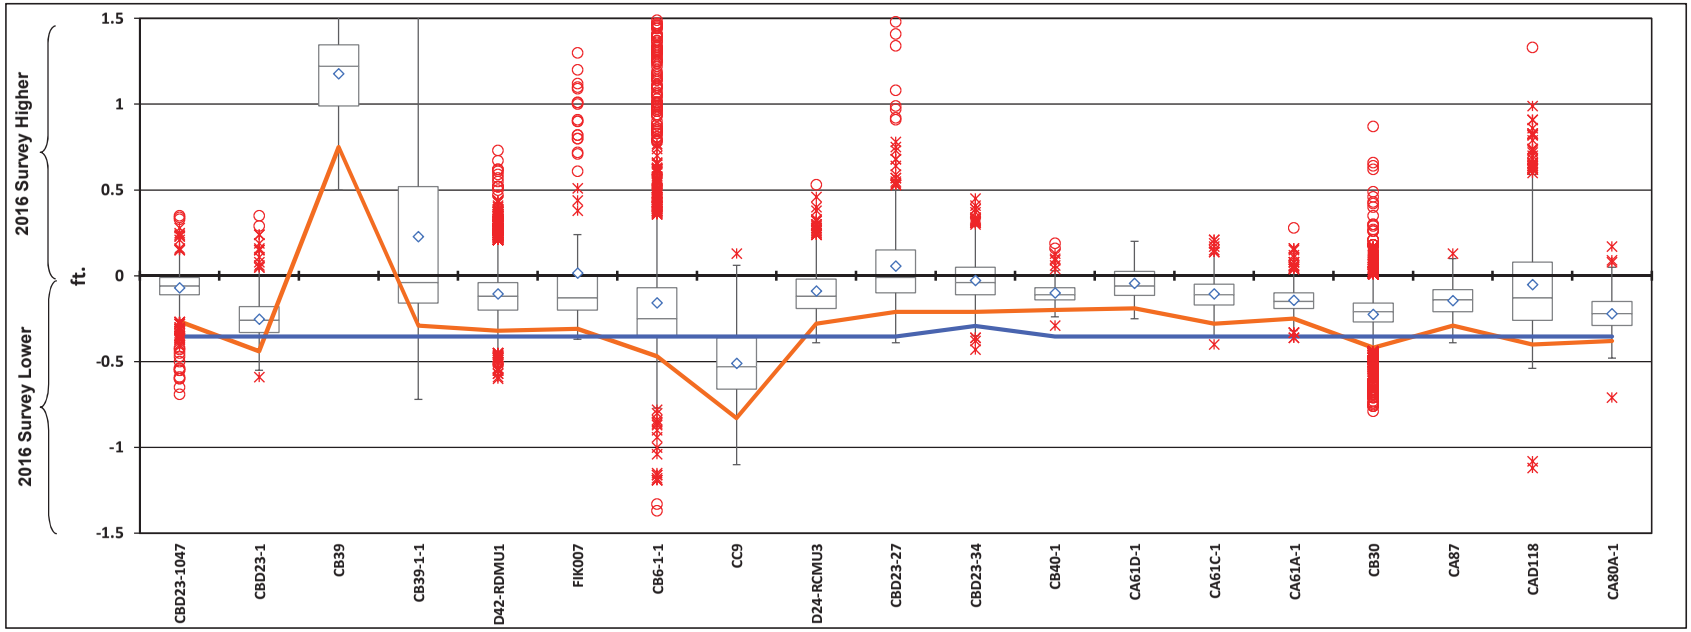
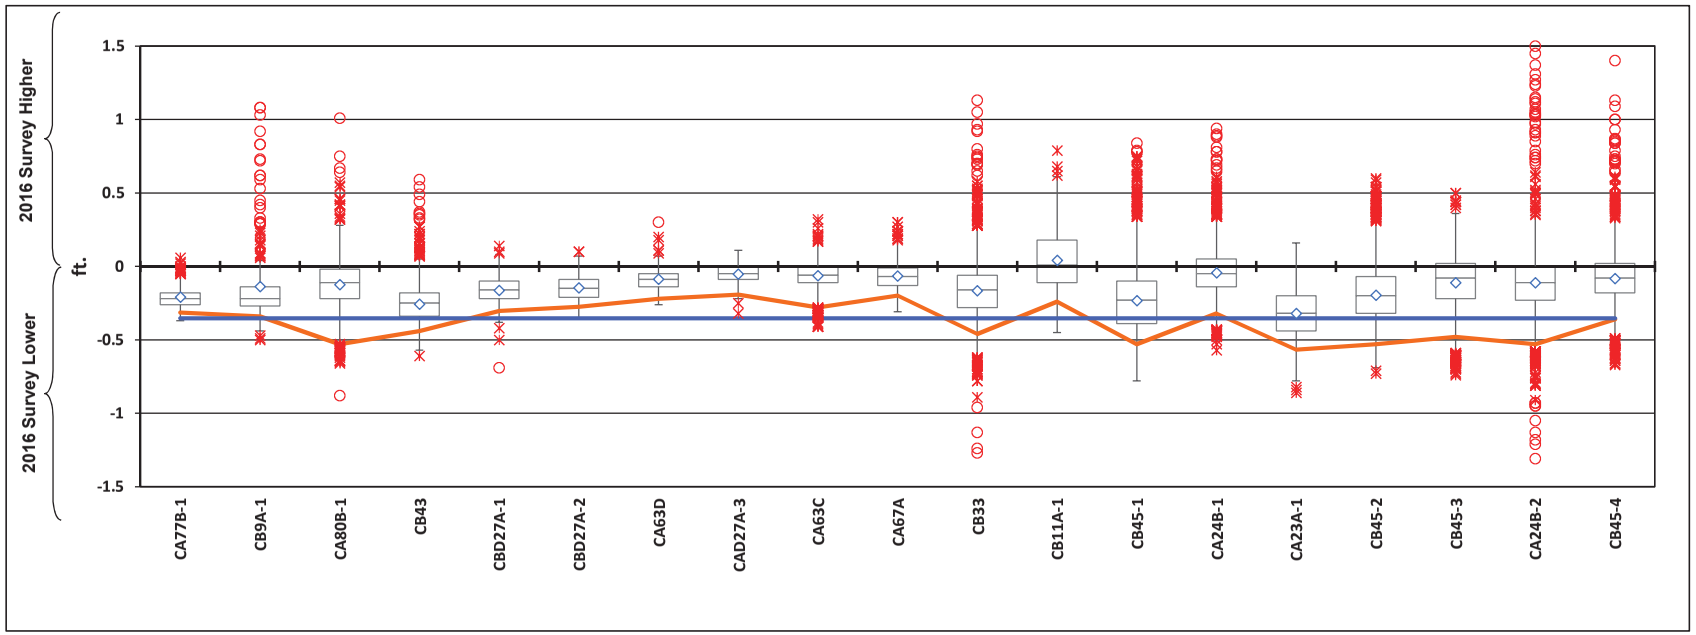
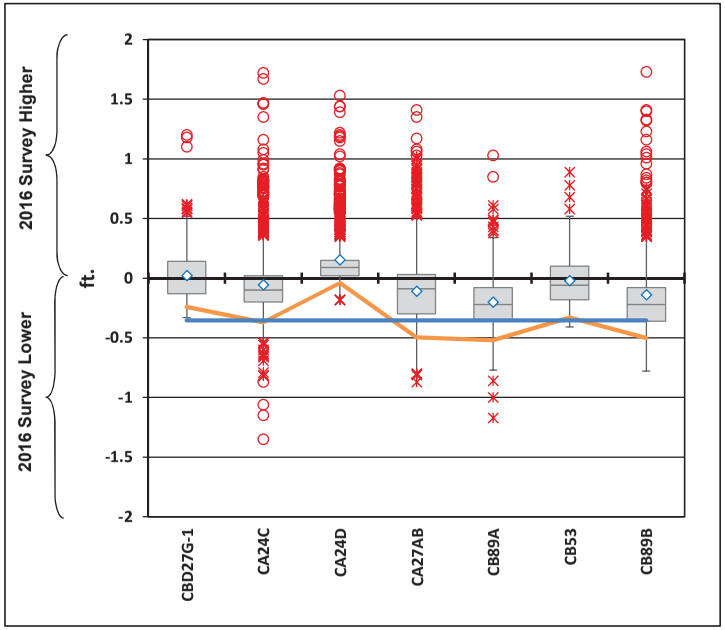
Boxplot Distributions of Survey Differences for 2016 Minus 2014 (400 kHz Multi-Beam[(1)])

The majority of CCUs are seen on Figures 15A through 15C to have survey differences which are lower on average by 0 to 0.5 feet in 2016 than in 2014. This matches the general observations made above for the cap integrity assessment. The only area which has an average decrease of over 0.5 feet is for CC9 (Cap Type C with quarry spall) with an average decrease in cap elevation of 0.51 feet, likely due to the increased weight of the capping materials).

The 5th percentile of the data (Figures 15A through 15C gold line) extends past the combined vertical survey accuracy (blue line) for CBD23-1, CB6-1-1, CC9, CB30, CAD118, CA80A-1, CA80B-1, CB43, CB33, CB45-1, CA23A-1, CB45-2, CB45-3, CA24B-2, CA24C, CA27AB, CB89A and CA89B. Therefore, potentially more than 5% of the area for these CCUs has experienced an elevation decrease from 2014 to 2016 which exceeds the combined survey vertical accuracy. As noted above, however, physical poling/probing confirmed in 2016 that armor stone remains intact at all locations visited, and therefore, it is assumed that the underlying soft sediment has consolidated resulting in settlement of the surface of the cap rather than the cap having been eroded.

As a note, several areas depicted increases in average elevation from 2014 to 2016. These are CB39, CB39-1-1, CBD23-27, CB11A-1 and CA24D. Of these, the largest elevation increase clearly occurred in CB39 and the surrounding area in CB39-1-1, with a median increase of 1.22 feet in CB39. The poling/probing survey confirmed that the increase in elevation in CB39 and CB39-1-1 is due to sediment deposition. As stated above, deposition in this area is expected due to the decrease in river flow caused by widening of the river channel downstream of the De Pere Dam. The average elevation increase for CBD23-27, CB11A-1 and CA24D was much less (0.15 feet or less) with the existence of sediment not confirmed with the discrete poling/probing locations.
