Memorandum

Foth Infrastructure & Environment, LLC

April 1, 2015

RE: Lower Fox River OU3 *COMMP* Cap Integrity Assessment - Year 3

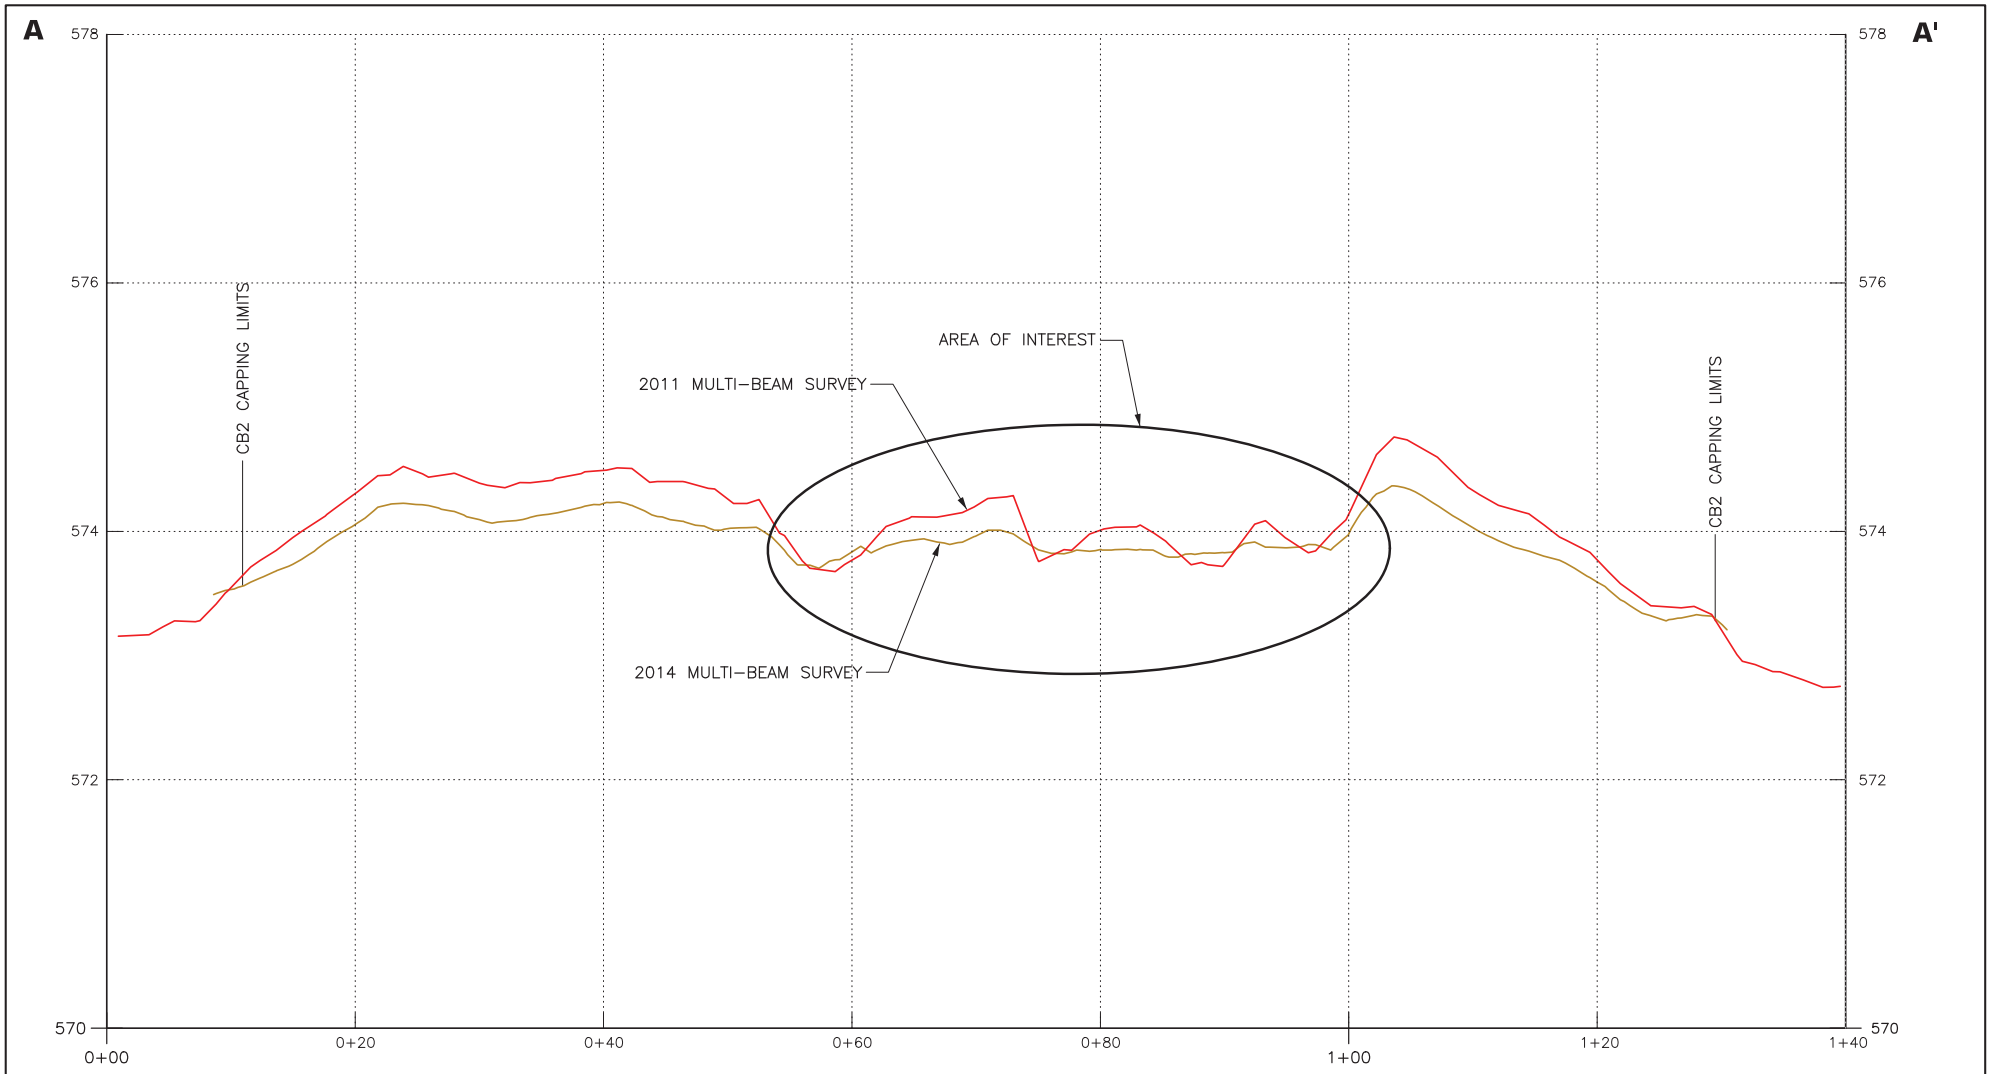
- General elevation decreases less than 0.6 feet between the 2011 and 2014 surveys (typically 0.2-0.4 feet) are noted throughout the OU3 cap areas, particularly in areas CB2, CA6, CA9B, CB5, CA13A, CB3A, CA13B, CA16A, CA13E, and CA15. This indicates consolidation of the soft sediment beneath the cap continues to occur, which is expected given the relatively short duration since completion of capping activities. In addition, poling in these CCUs confirmed that the armor stone was still in place.

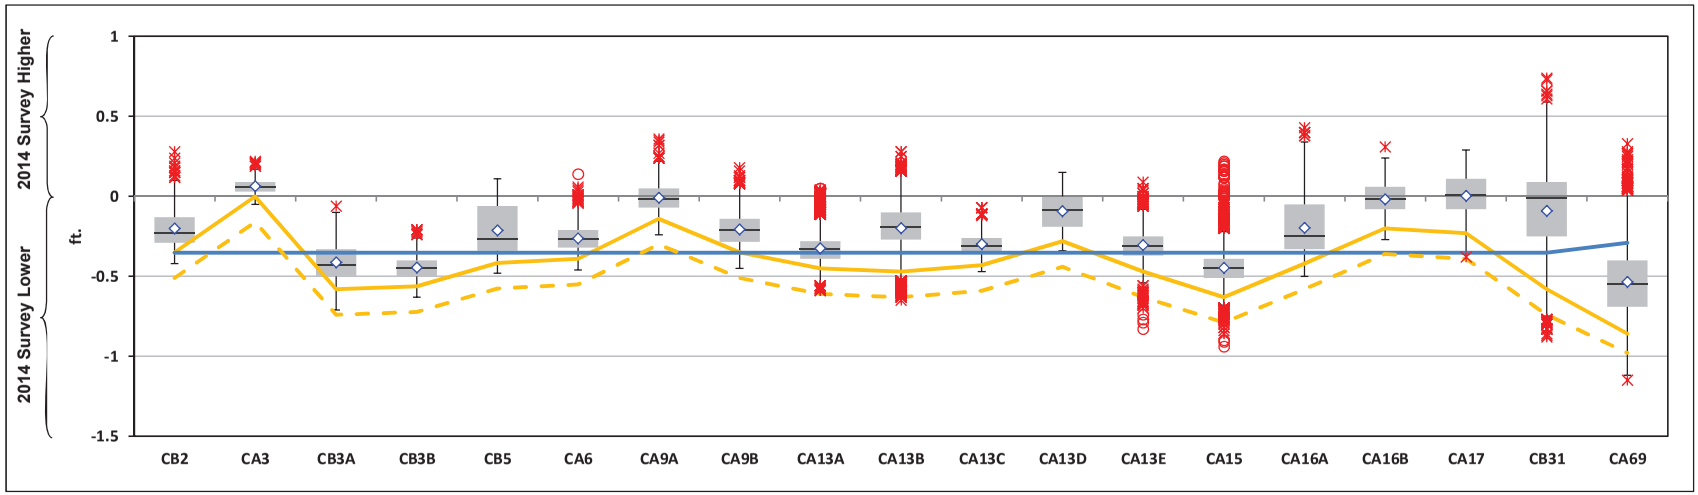
Boxplot Distributions of Survey Differences for 2014 (400 kHz Multi-beam) Minus 2011 (200 kHz Multi-Beam[1])

The 5th percentile of the data (Figure 16 gold line) extends past the combined vertical survey accuracy (Figure 16 blue line) for CB3A, CB3B, CB5, CA6, CA13A, CA13B, CA13C, CA13E, CA15, CA16A, CB31 and CA69. Therefore, potentially more than 5% of the area for these CCUs has experienced an elevation decrease from 2011 to 2014 which exceeds the combined survey vertical accuracy. As noted above, however, physical poling confirmed in 2014 that armor stone remains intact at all locations visited with no discernible sediment deposition, and therefore, it is assumed that the underlying soft sediment has consolidated resulting in settlement of the surface of the cap rather than the cap having been eroded.

2. A direct comparison of the 2011 and 2014 hydrographic surveys indicates there are several CCUs for which greater than 5% of the area has decreased in elevation, beyond the range of the combined survey vertical uncertainty level. This is the case for CB3A, CB3B, CB5, CA6, CA13A, CA13B, CA13C, CA13E, CA15, CA16A, CB31 and CA69. Of these CCUs, the largest average differences were observed for CB3A, CB3B, CA13A, CA13C, CA13E, CA15 and CA69.

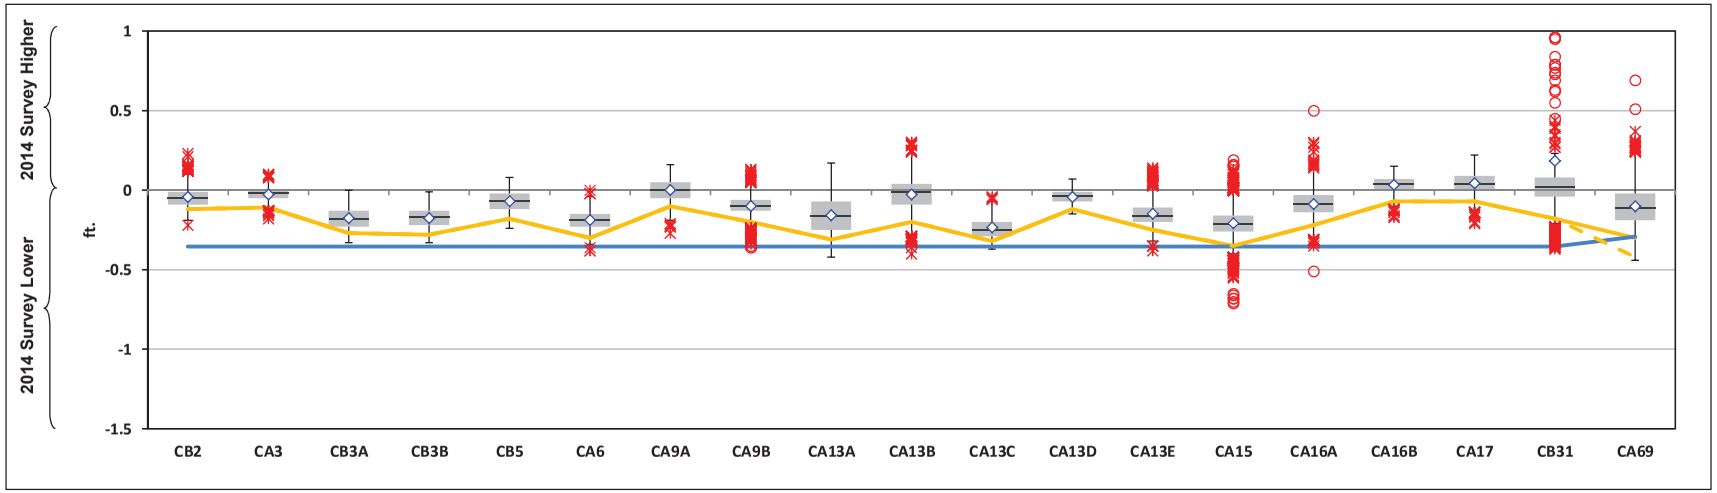
Boxplot Distributions of Survey Differences for 2014 (400 kHz Multi-beam) Minus 2012 (400 kHz Multi-Beam[1])

The results of the 2014 to 2012 comparison are presented on Figure 17. There is still, on average, a small decrease in elevation observed for certain CCUs, but to a much lesser degree than seen on Figure 16 with the 2014 to 2011 comparison. Most of the CCUs mentioned above having the largest degree of settling from 2011 to 2014 (i.e., CB3A, CB3B, CA13A, CA13C, CA13E and CA15) continue to show the largest differences between the 2012 and 2014 data. However, CA69, which had the largest drop in the 2011 to 2014 data, shows much less difference from 2012 to 2014.

4. The general settling for each CCU observed between 2012 and 2014 slowed considerably (consistent with the anticipated slowing rate of consolidation of the underlying soft sediments) from that observed between 2011 and 2012. After accounting for an estimated factor of bias between the 400 kHz survey (collected in 2014 and 2012) and the 200 kHz survey (collected in 2011 for all CCUs and in 2012 for CA69), the degree of settling between 2012 and 2014 was approximately 50% or less of the 2011 to 2012 values for all CCUs except CA6, CA13C and CA69.

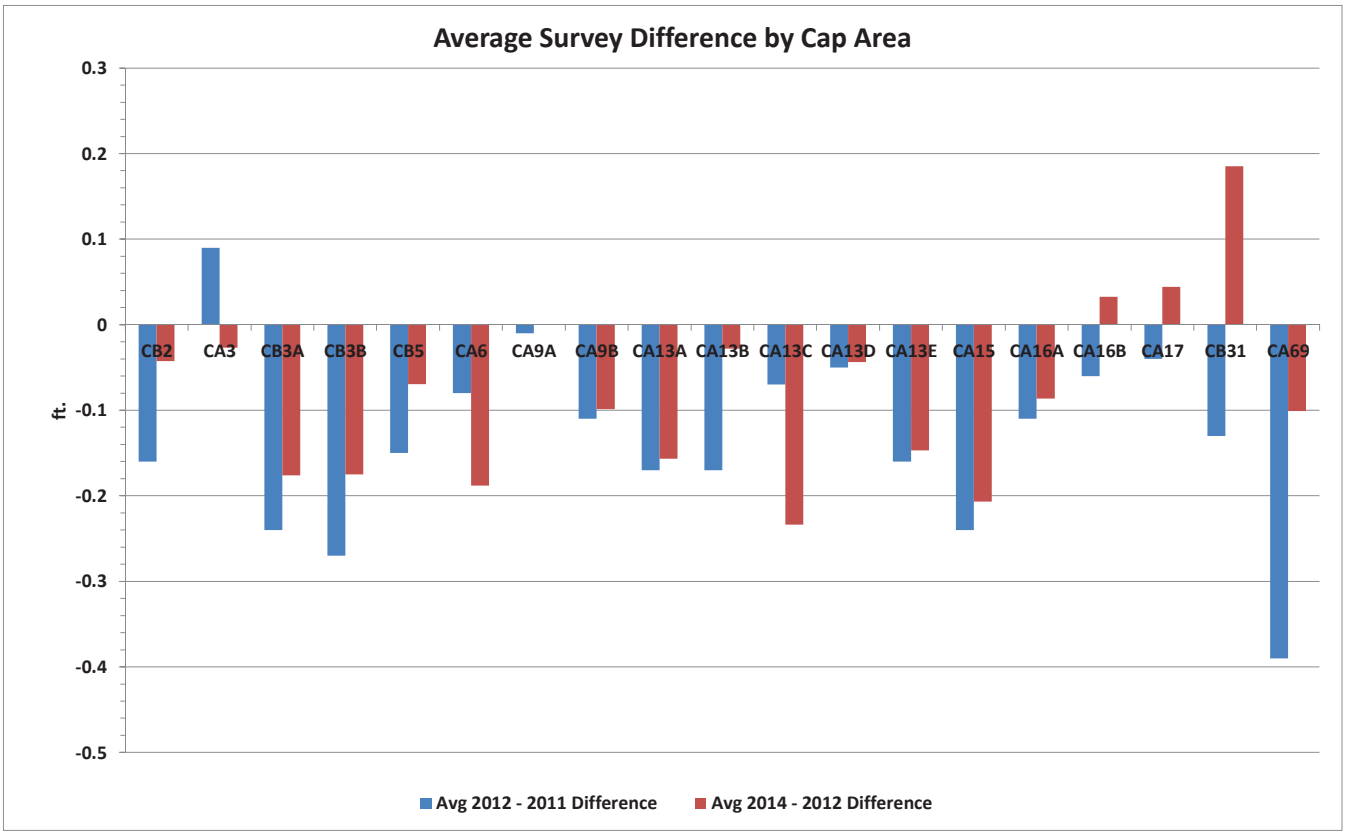
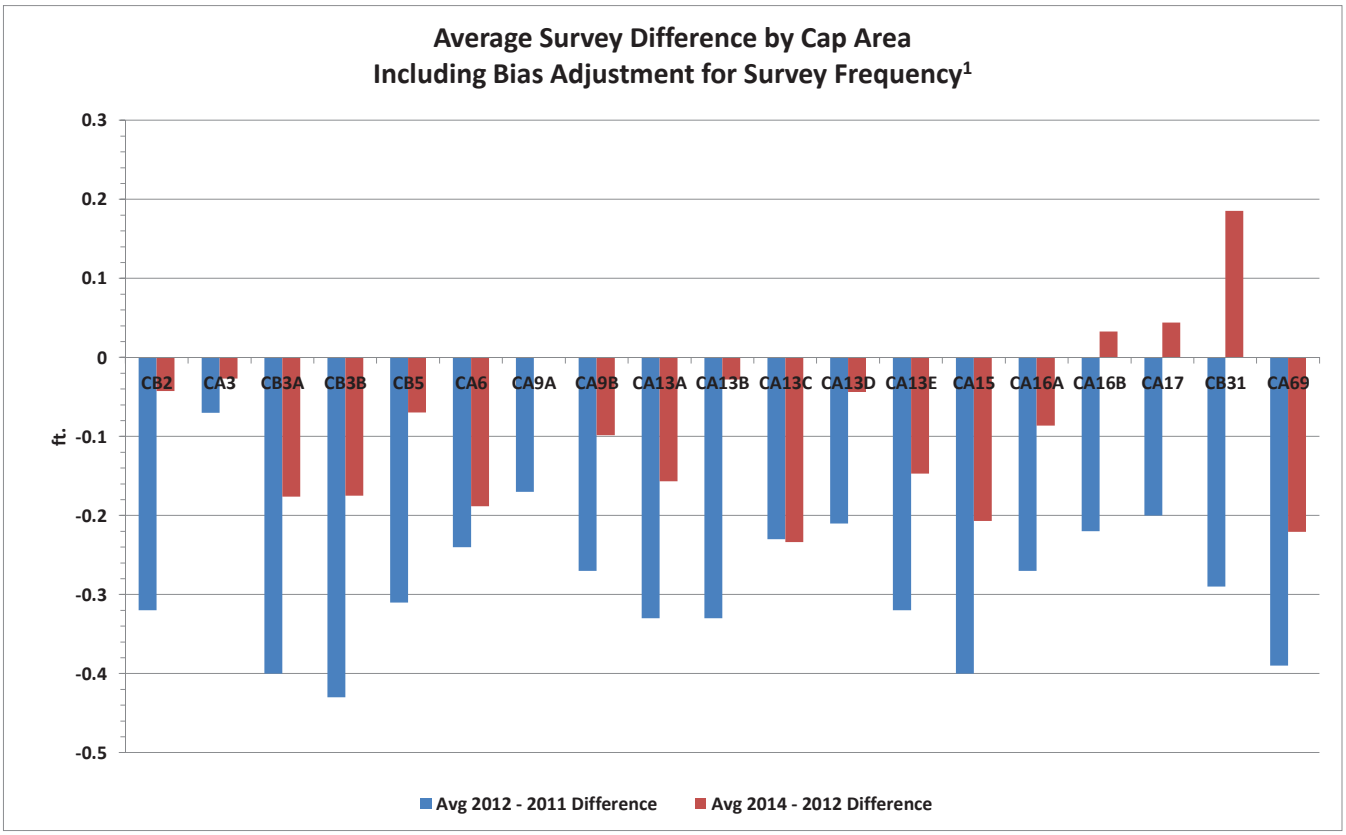
Finally, a comparison of the average difference observed for each CCU from 2011 to 2012, and from 2012 to 2014, is provided on Figure 18. The top graphic on Figure 18 illustrates the CCU average difference without considering the assumed bias factor between the 200 kHz and 400 kHz surveys, while the bottom graphic on Figure 18 presents the average differences when the bias factor is included. Particularly, when the bias factor is considered, a significant slowing of the settling is seen on average between the 2012 and 2014 data, as compared to the 2011 and 2012 data. The only CCU, which shows an equal amount of settling between 2012 and 2014 as to 2011 and 2012, is CA13C. For CA6, the 2012 to 2014 settling was approximately 20% less than that from 2011 to 2012; and for CA69, the 2012 to 2014 settling was approximately 45% less. For all other CCUs, the approximate degree of settling between 2012 and 2014 was at least 50% less than the 2011 to 2012 values. This evaluation supports the expected result in cap settlement, with rapid consolidation occurring in the first year, slowing thereafter, as well documented in Lower Fox River OU1 caps (Foth, 2013). The anomalous increase from 2012 to 2014 in CB31 was due to the eastern areas of this CCU and is discussed in the Cap Integrity Assessment by CCU section above.

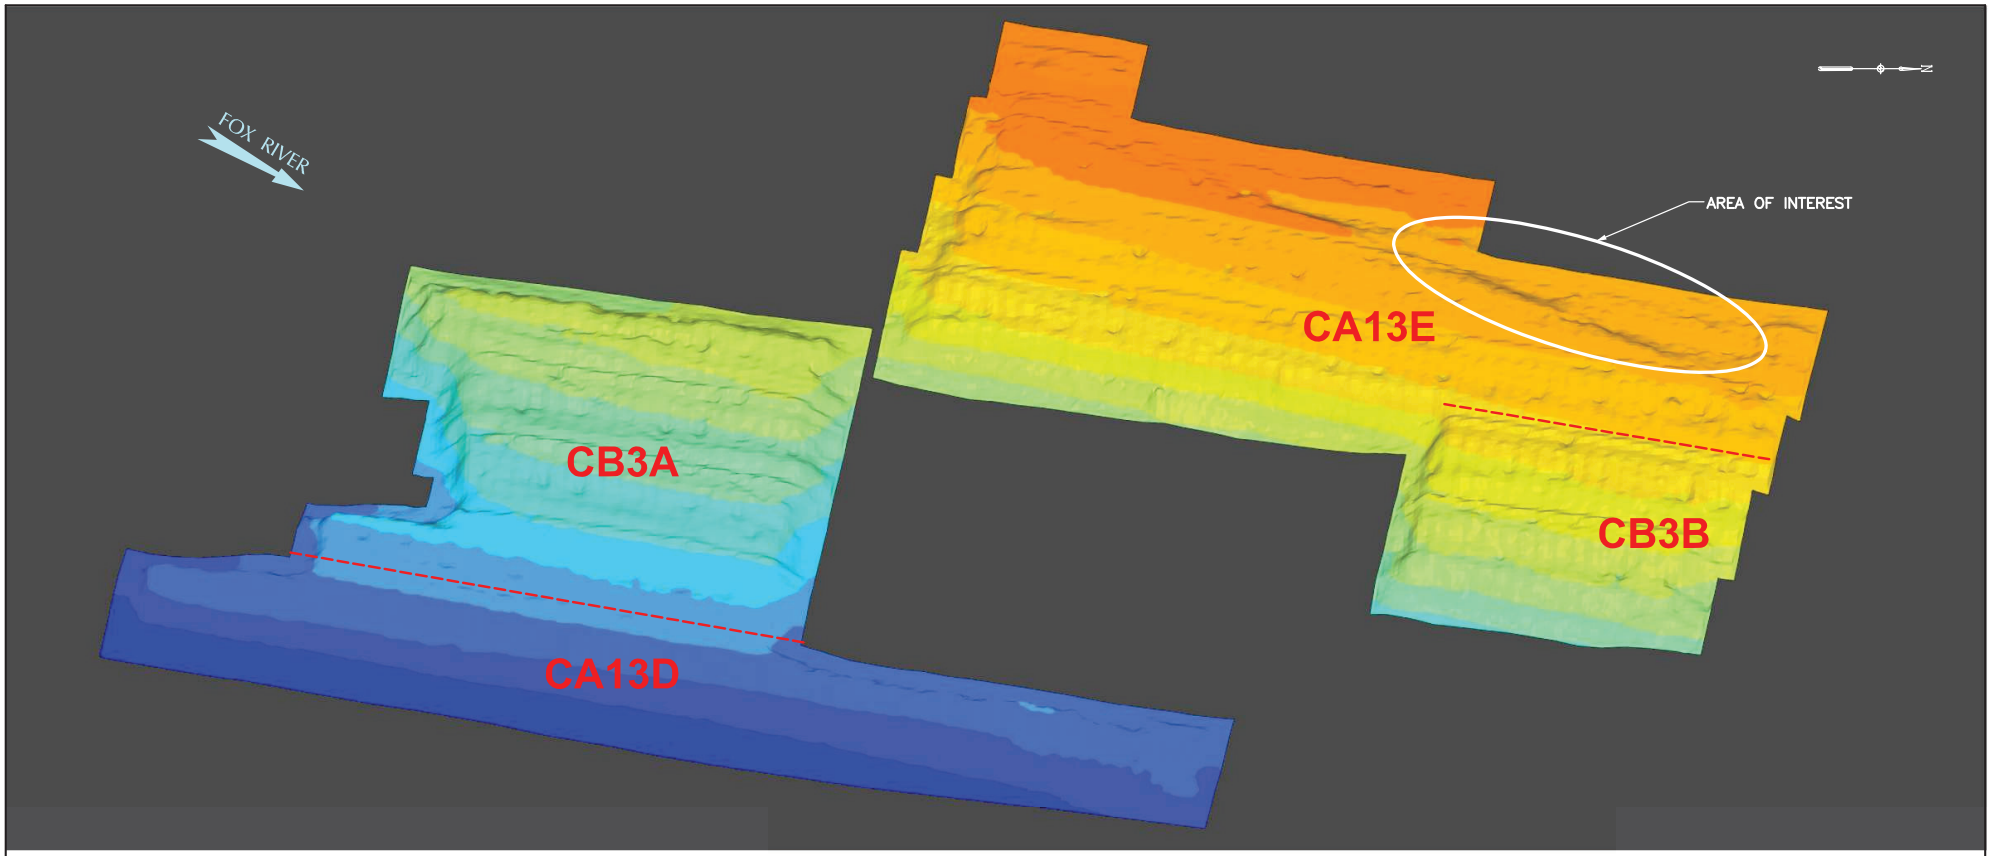
X:\GB\IE\2012\12A029\cad\COMMP\figures\Fig-10B Cap Elevations.dgn
12/14/2012 jow

- A small depressed area is visible in the west to northwest edge of CA13E (Figure 10B). Little correlation is found, however, with this area when comparing to the same area in the isopach difference (Figure 10C). Therefore, the depressed area in Figure 10B may be a reflection of the river bottom topography. Supporting this conclusion is the chemical isolation layer sample for CB2 which indicates no cap abnormality in this location.

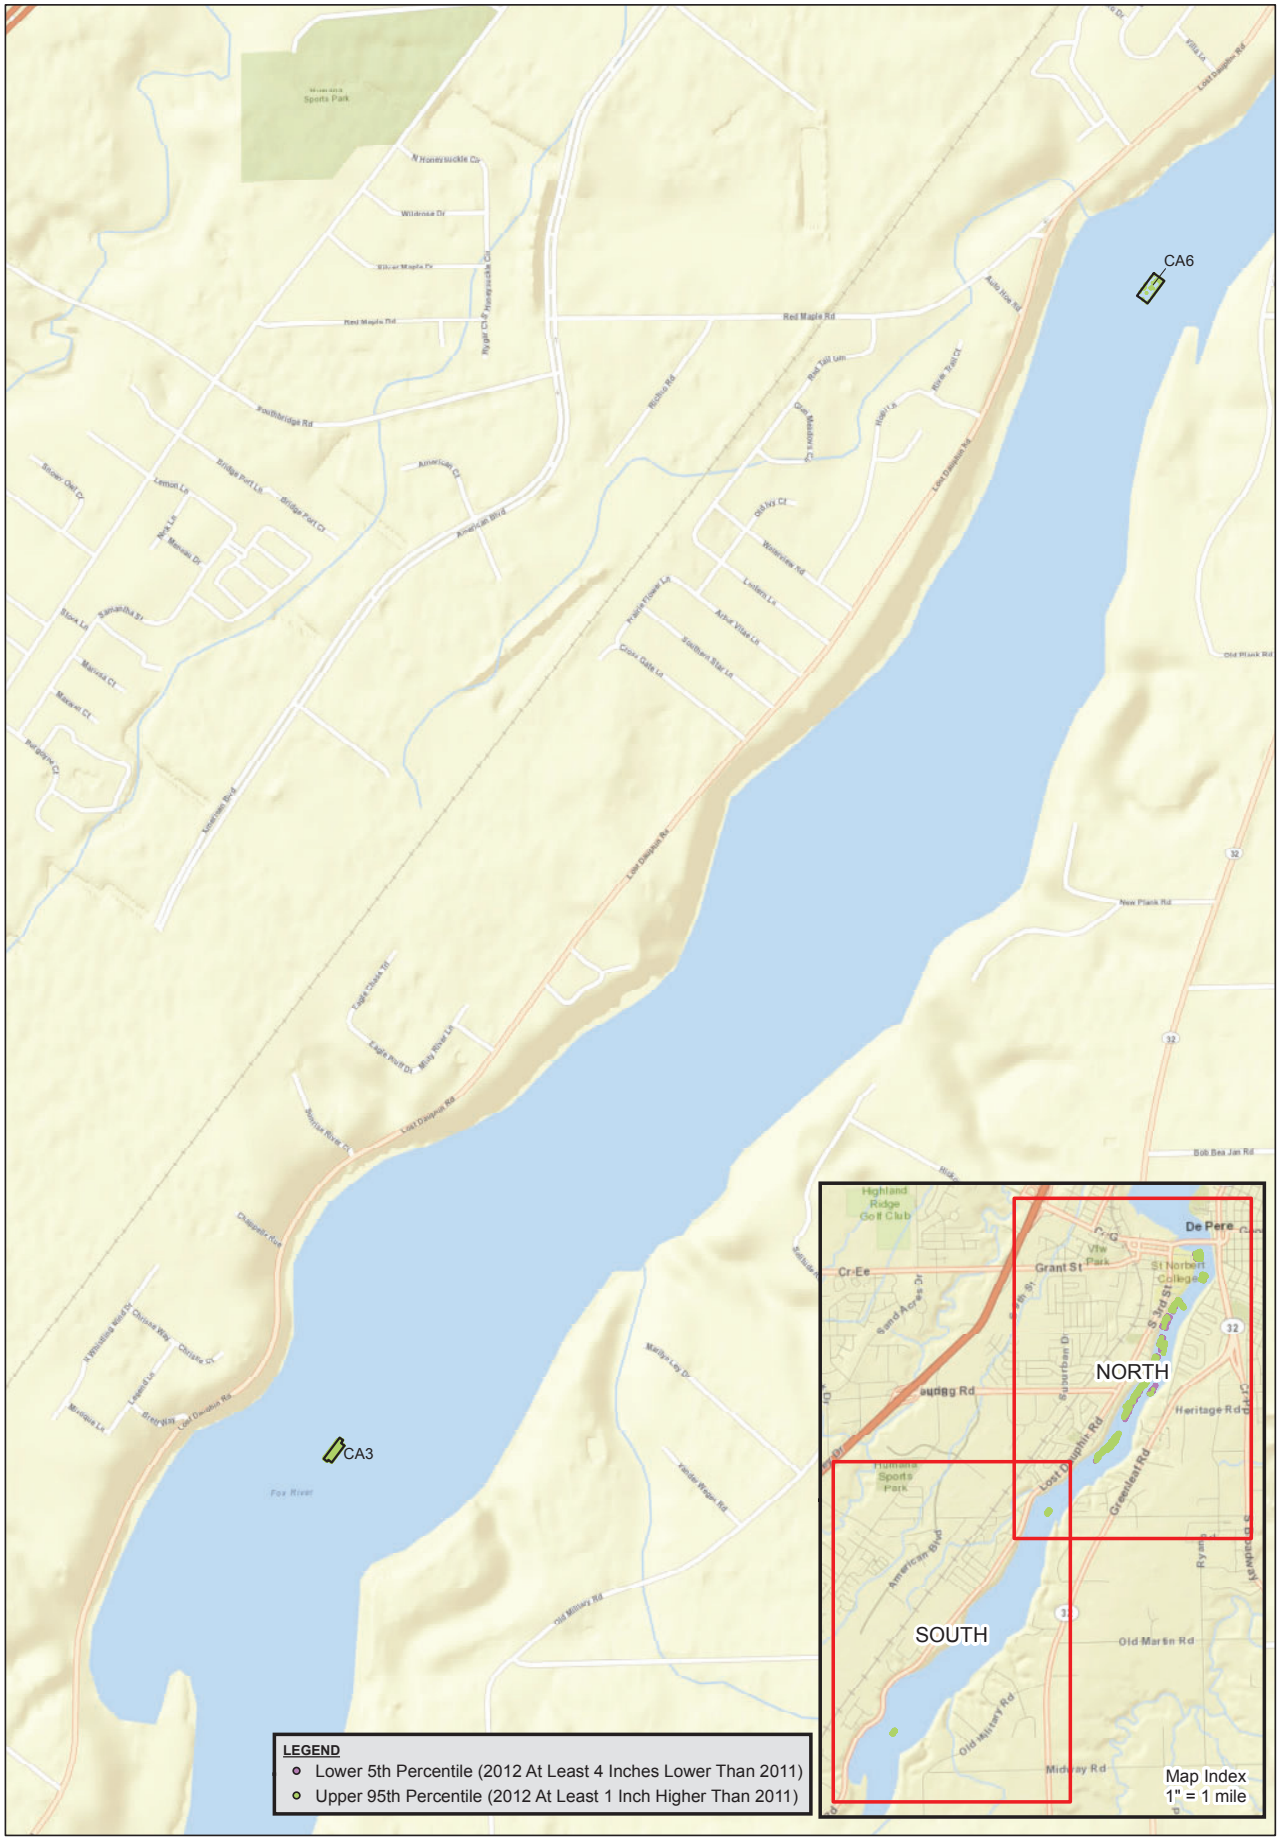
Notes:
1. Base Map downloaded from ESRI. Copyright:© 2009 ESRI, AND, TANA, ESRI Japan, UNEP-WCMC
2. Figure illustrates points where the differences between the 2011 and 2012 bathymetric surveys were on the lower or upper tails of the overall distribution. Locations where the 2012 survey indicates more than a 0.34 foot decrease from the 2011 survey are indicated and represent the lower 5th percentile of the entire distribution. Locations where the 2012 survey indicates more than a 0.08 foot increase from the 2011 survey are also indicated and represent the upper 95th percentile of the entire distribution.

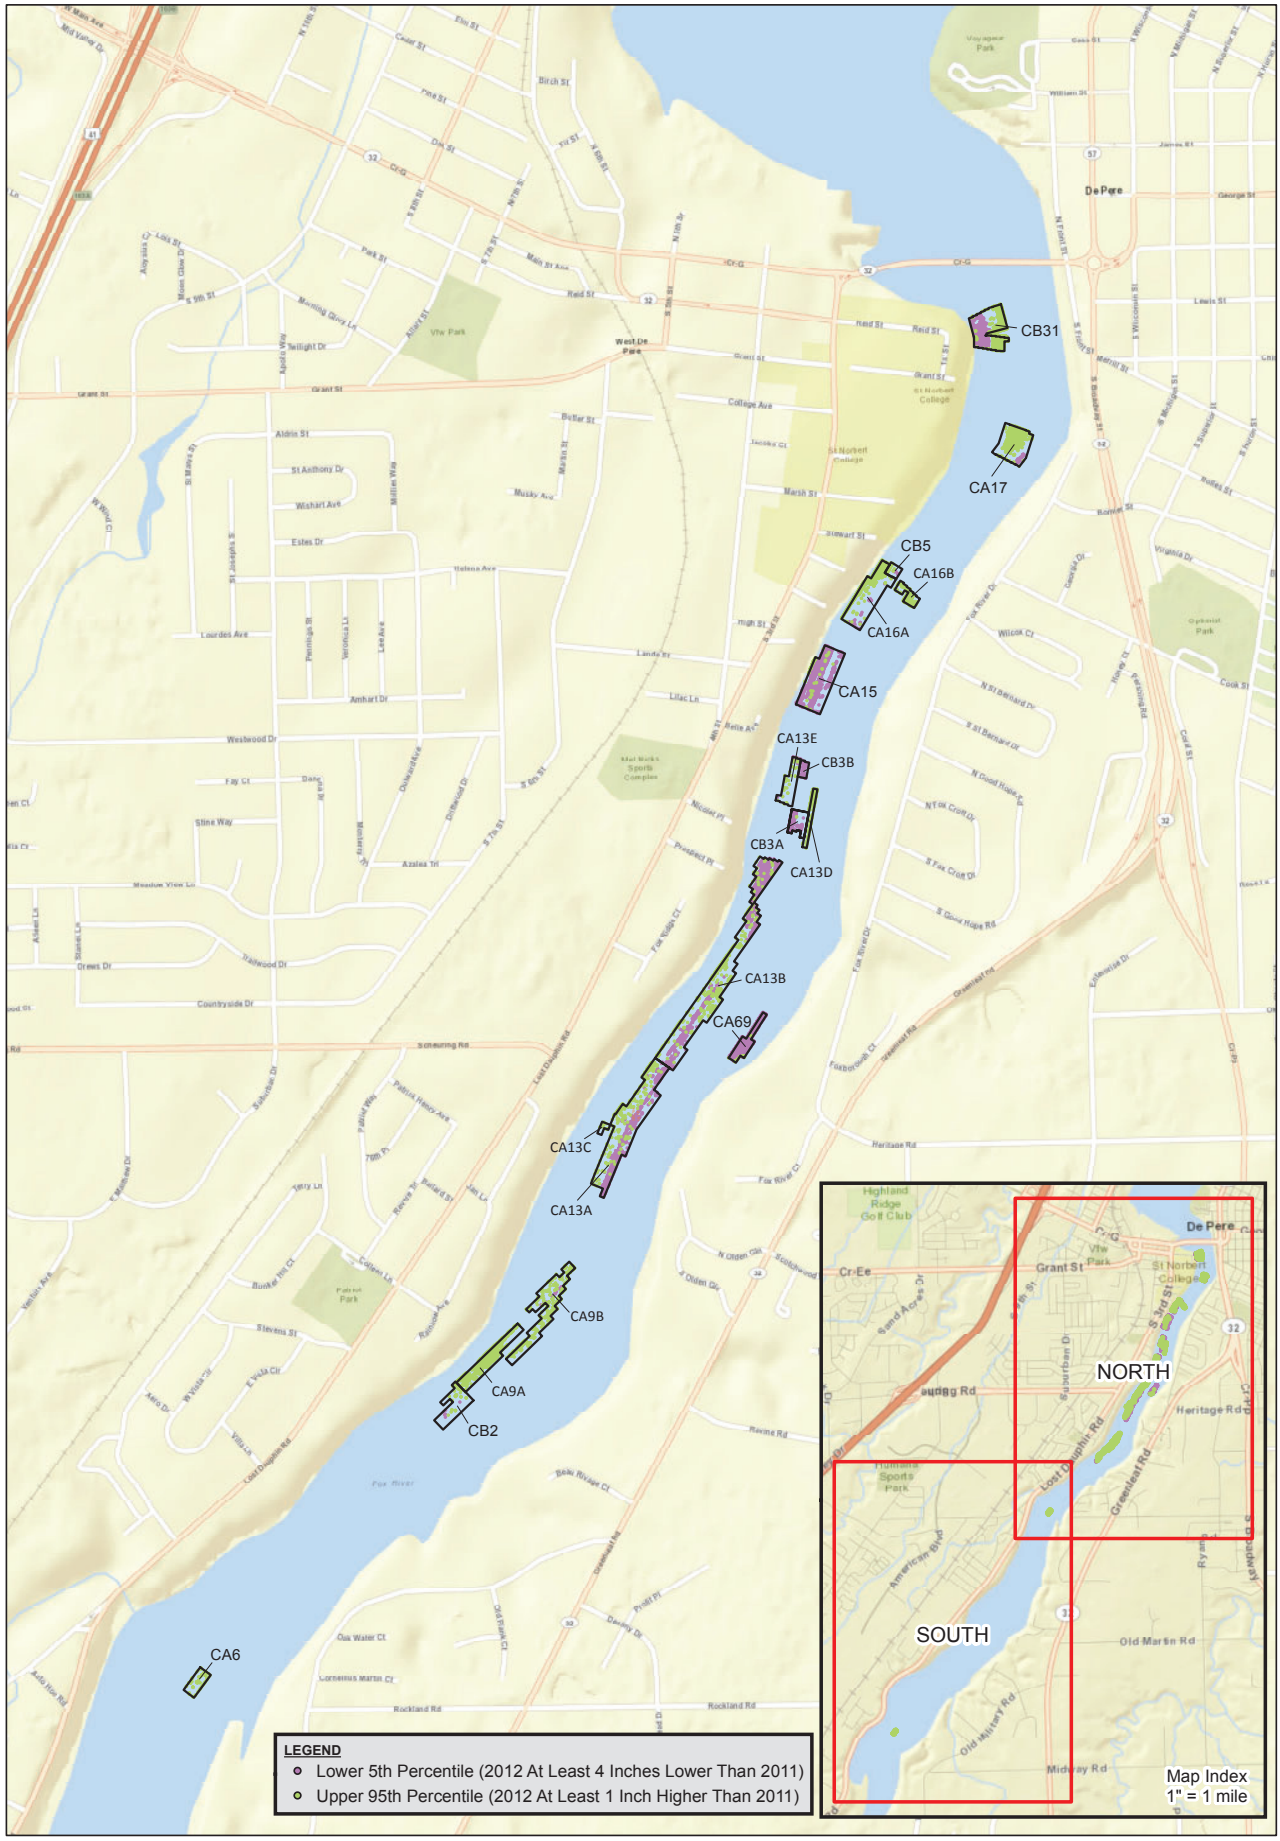
Notes:
1. Base Map downloaded from ESRI. Copyright:© 2009 ESRI, AND, TANA, ESRI Japan, UNEP-WCMC
2. Figure illustrates points where the differences between the 2011 and 2012 bathymetric surveys were on the lower or upper tails of the overall distribution. Locations where the 2012 survey indicates more than a 0.34 foot decrease from the 2011 survey are indicated and represent the lower 5th percentile of the entire distribution. Locations where the 2012 survey indicates more than a 0.08 foot increase from the 2011 survey are also indicated and represent the upper 95th percentile of the entire distribution.

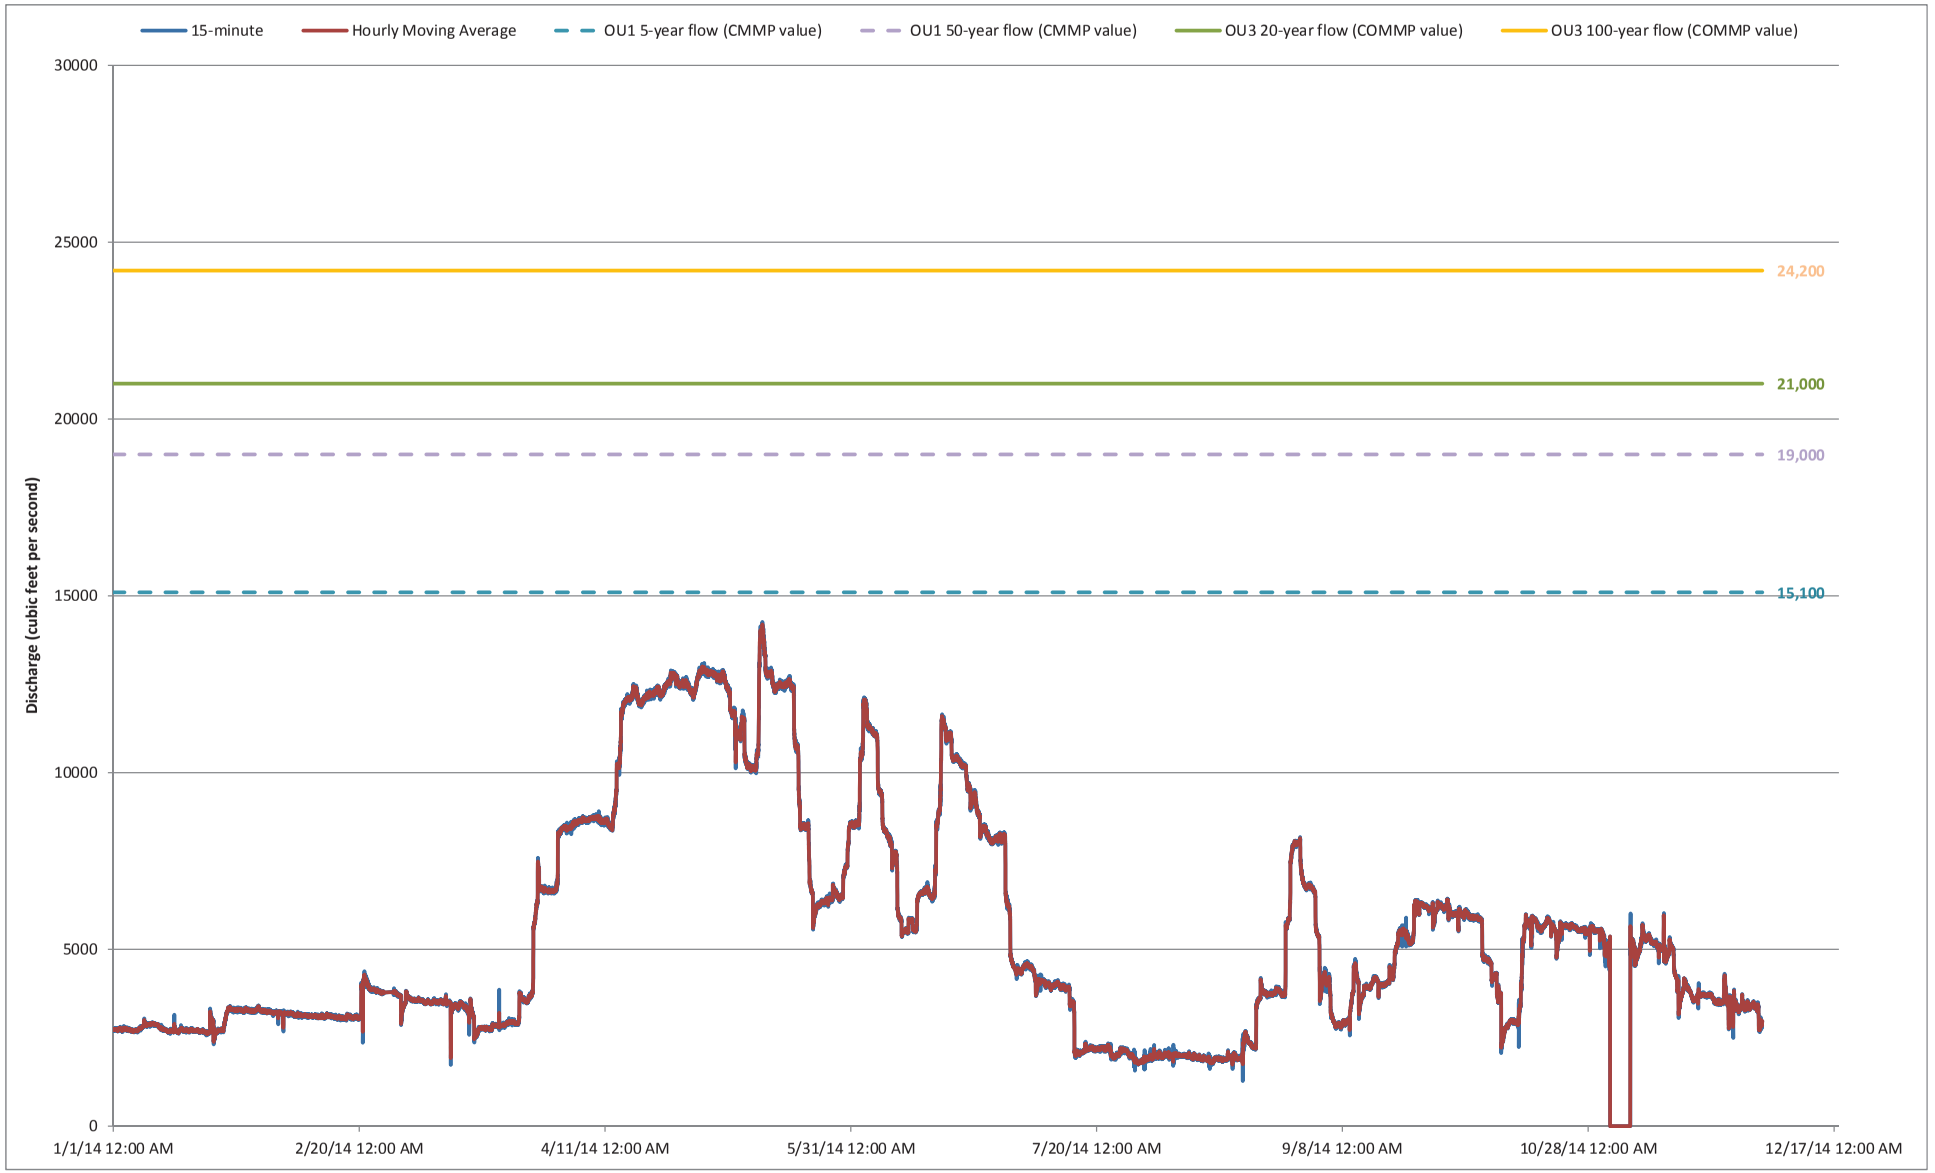
FIGURE 1
OU1 USGS 04084445 Fox River Appleton, WI

To further evaluate discharge values for the river, data were reviewed for OU4 at the U.S. Oil Tank Depot (USGS Station 040851385), and for OU1 at USGS Station 04084445 near Appleton, Wisconsin (http://waterdata.usgs.gov/nwis/). Flows at the Appleton gauging station are measured approximately every 15 minutes. Figure 1, in Attachment D, presents the 2014 discharge values compared to the OU1 5-year and 50-year recurrence intervals and the OU3 20-year and 100-year recurrence intervals. The OU3 20-year and 100-year recurrence intervals were not exceeded during the peak discharge event occurring in May 2014 for flow measured at the Appleton gauge; not even the OU1 5-year recurrence interval was exceeded.

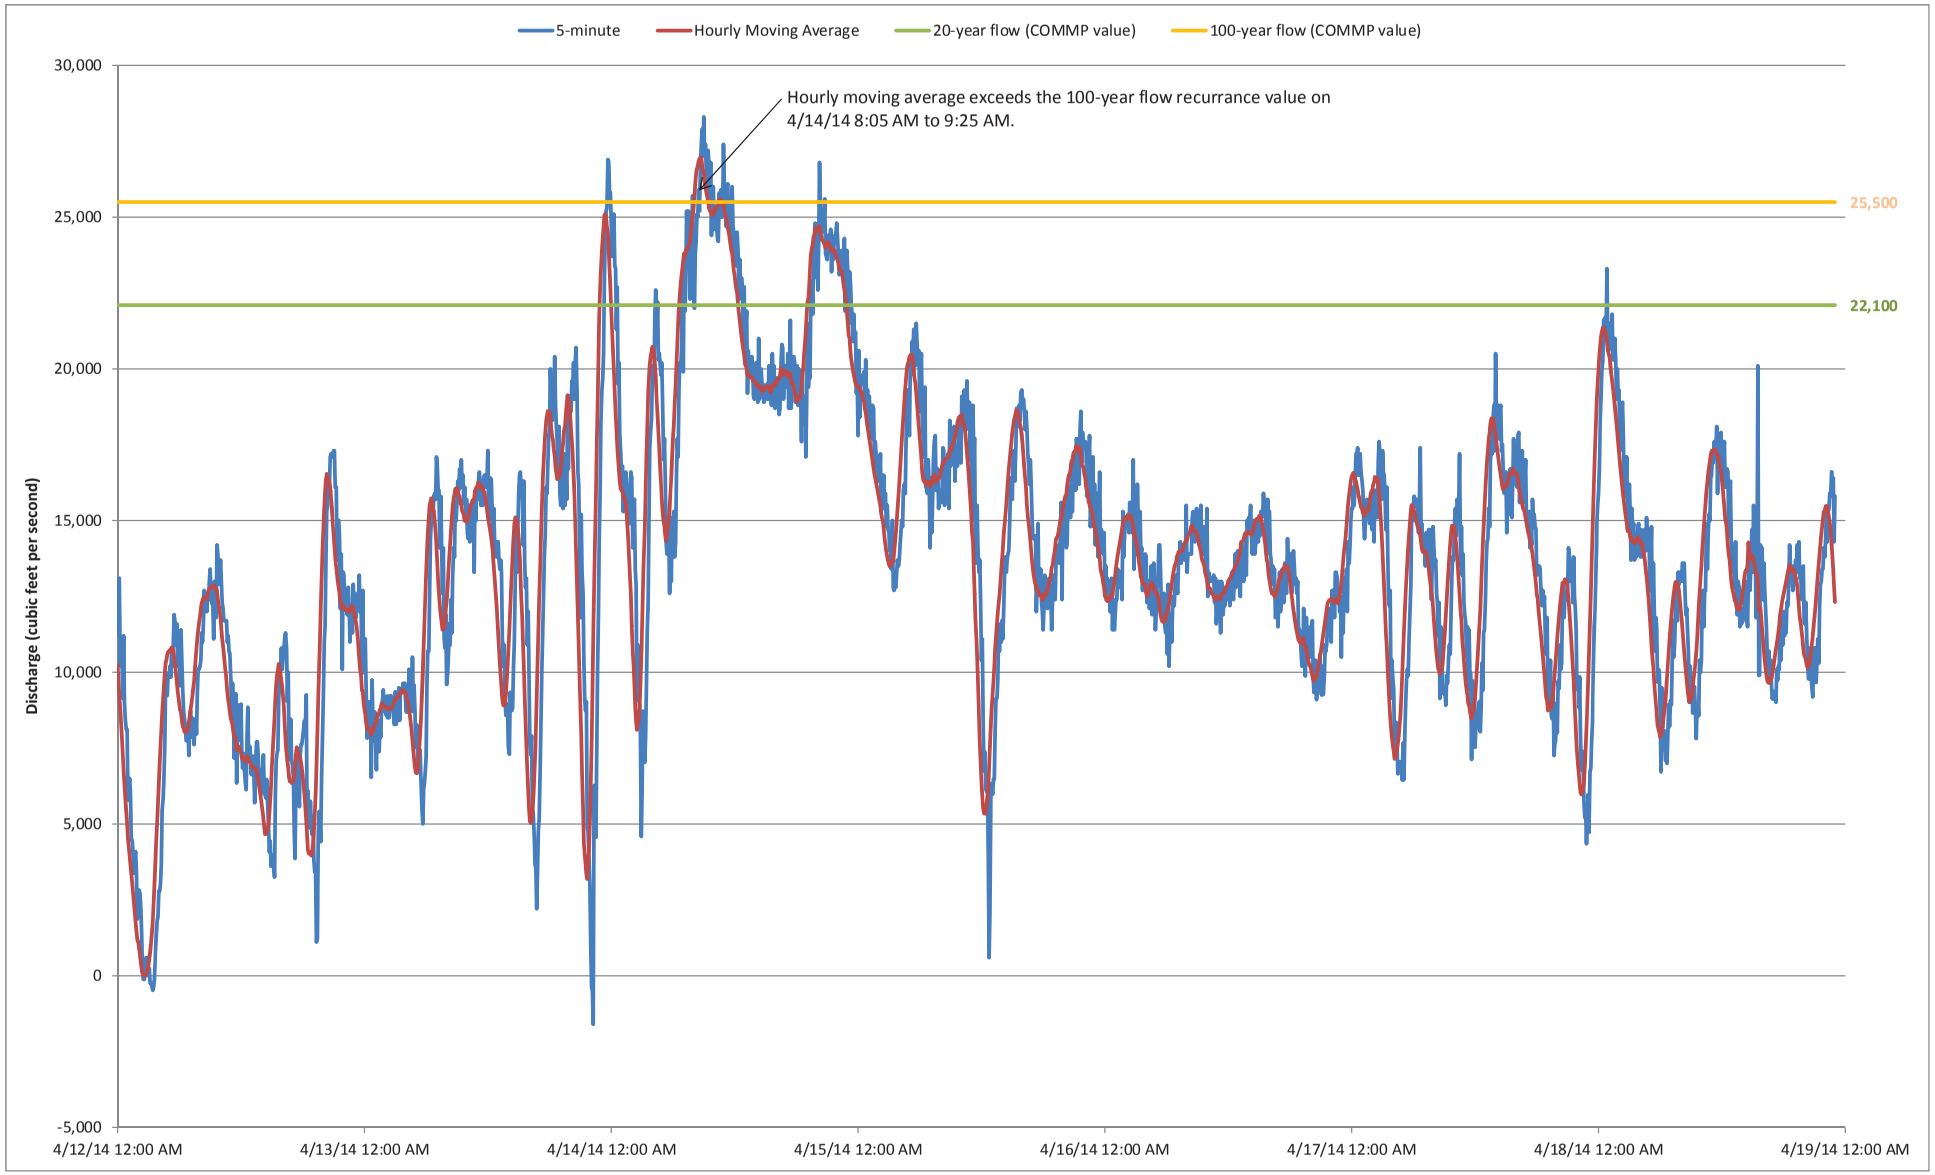
FIGURE 2
OU4 USGS 040851385 Fox River Oil Tank Depot at Green Bay, WI

By comparison, the 20-year and the 100-year recurrence intervals were exceeded for OU4 in April 2014. Flows near the mouth of the Fox River (including the combined effects of upstream floods and seiches) are measured approximately every 5 minutes at the Oil Tank Depot gaging station. Figure 2, in Attachment D, presents the mid-April 2014 discharge values, at which time a peak discharge event occurred for OU4, compared to the OU4 20-year and 100-year recurrence intervals.
