FIVE-YEAR REVIEW REPORT FOR FOX RIVER NRDA/PCB RELEASES SUPERFUND SITE

BROWN, DOOR, MARINETTE, OCONTO, OUTAGAMIE, KEWAUNEE, AND WINNEBAGO COUNTIES, WISCONSIN, AND DELTA AND MENOMINEE COUNTIES, MICHIGAN

U.S. Environmental Protection Agency
Region 5
Chicago, Illinois

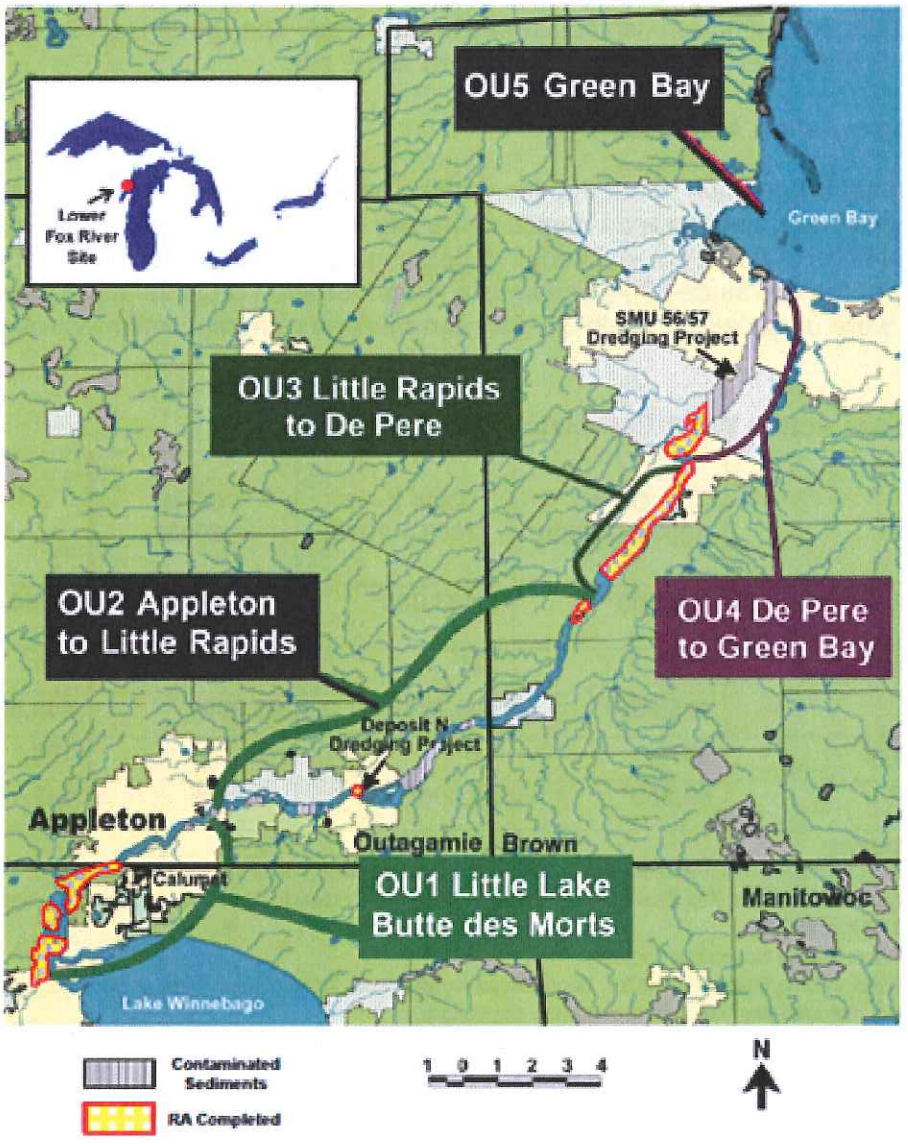
Figure 1. Work Completed and Planned at Fox River NRDA/PCB Releases Site

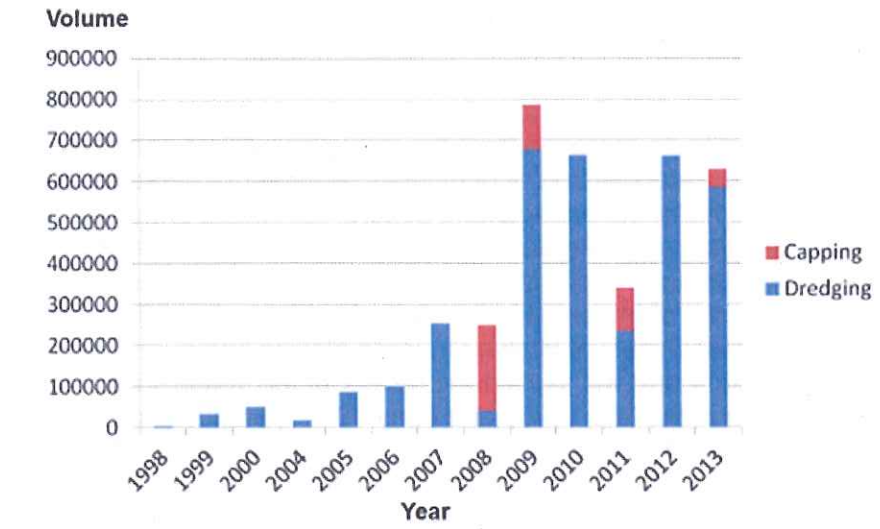
Figure 2. Dredging and Capping Work Completed Through 2013

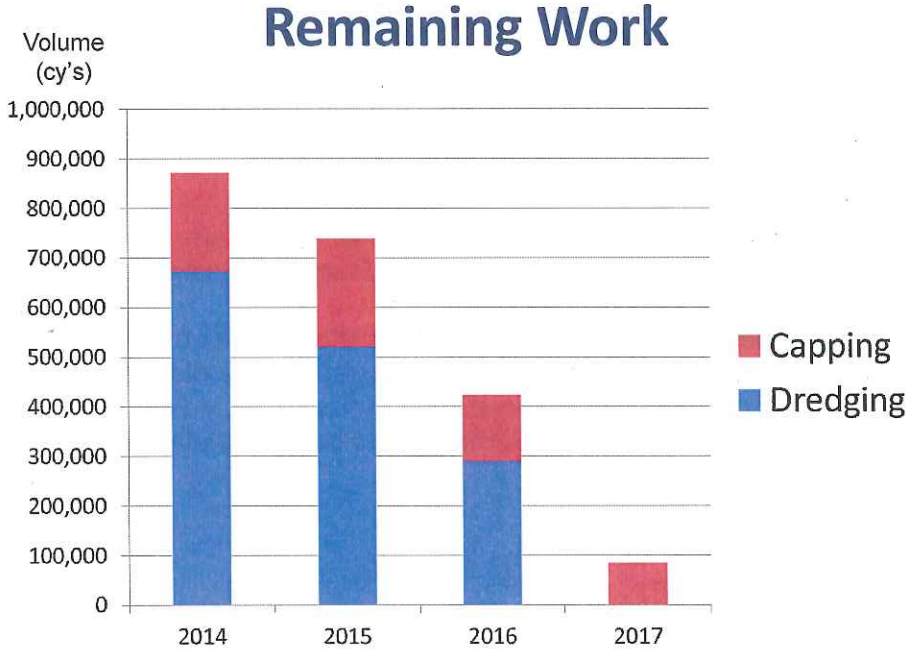
Figure 3. Dredging and Capping Work Remaining After 2013

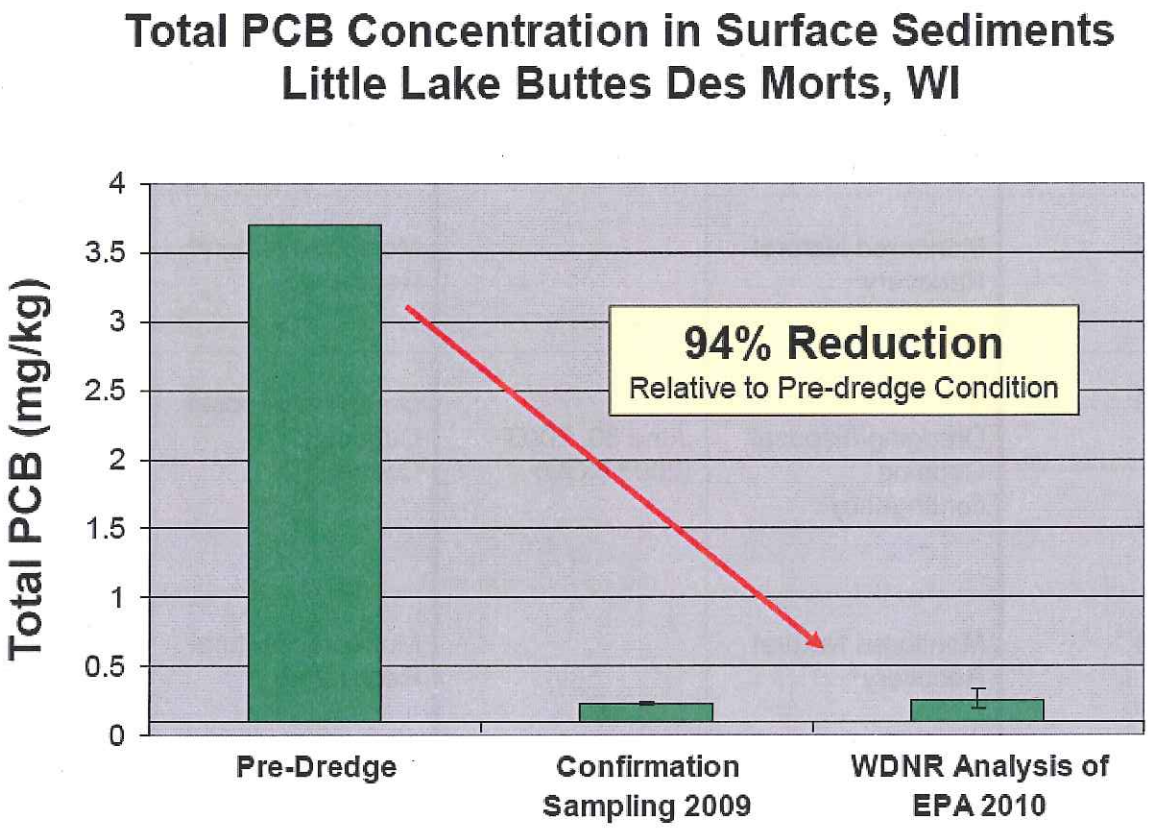
From 2004 to 2009, 371,600 cy of PCB-contaminated sediment in OU 1 were dredged, and 260 acres were capped with sand and armor stone or covered with sand. Dredged sediments were disposed offsite. Table 3 and Figures 2, 3, 4, and 5 summarize these actions. Final remedial action construction activities for OU 1 were completed on May 19, 2009. These actions provided a final PCB SWAC concentration of 0.22 ppm, less the 2008 ROD Amendment goal of 0.25 ppm.

Figure 2. Pre-remedial (i.e., pre-dredge) PCB surface sediment concentration, and surface sediment PCB concentration in 2010 after remediation (i.e., 2009 Confirmation Sampling and "WDNR Analysis of EPA Data, 2010") for Little Lake Butte des Mort (OU 1).

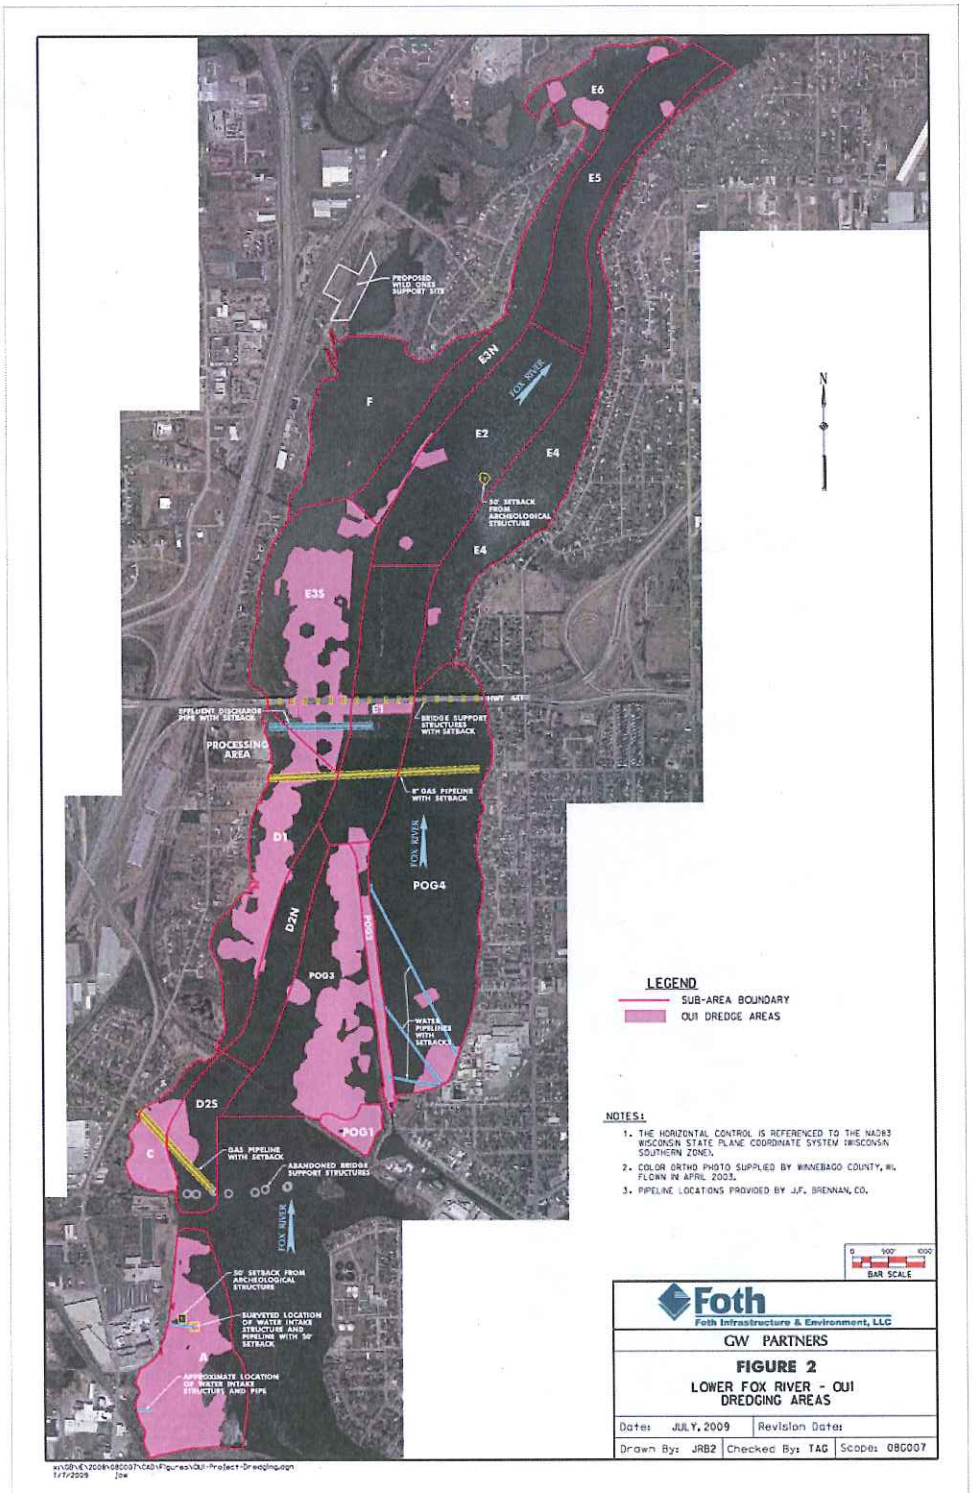
Figures 3, 4, and 5 below show areas where dredging, capping, and sand covering, respectfully, were completed in OU 1 through May 19, 2009.

Figure 3. OU 1 Dredged Areas

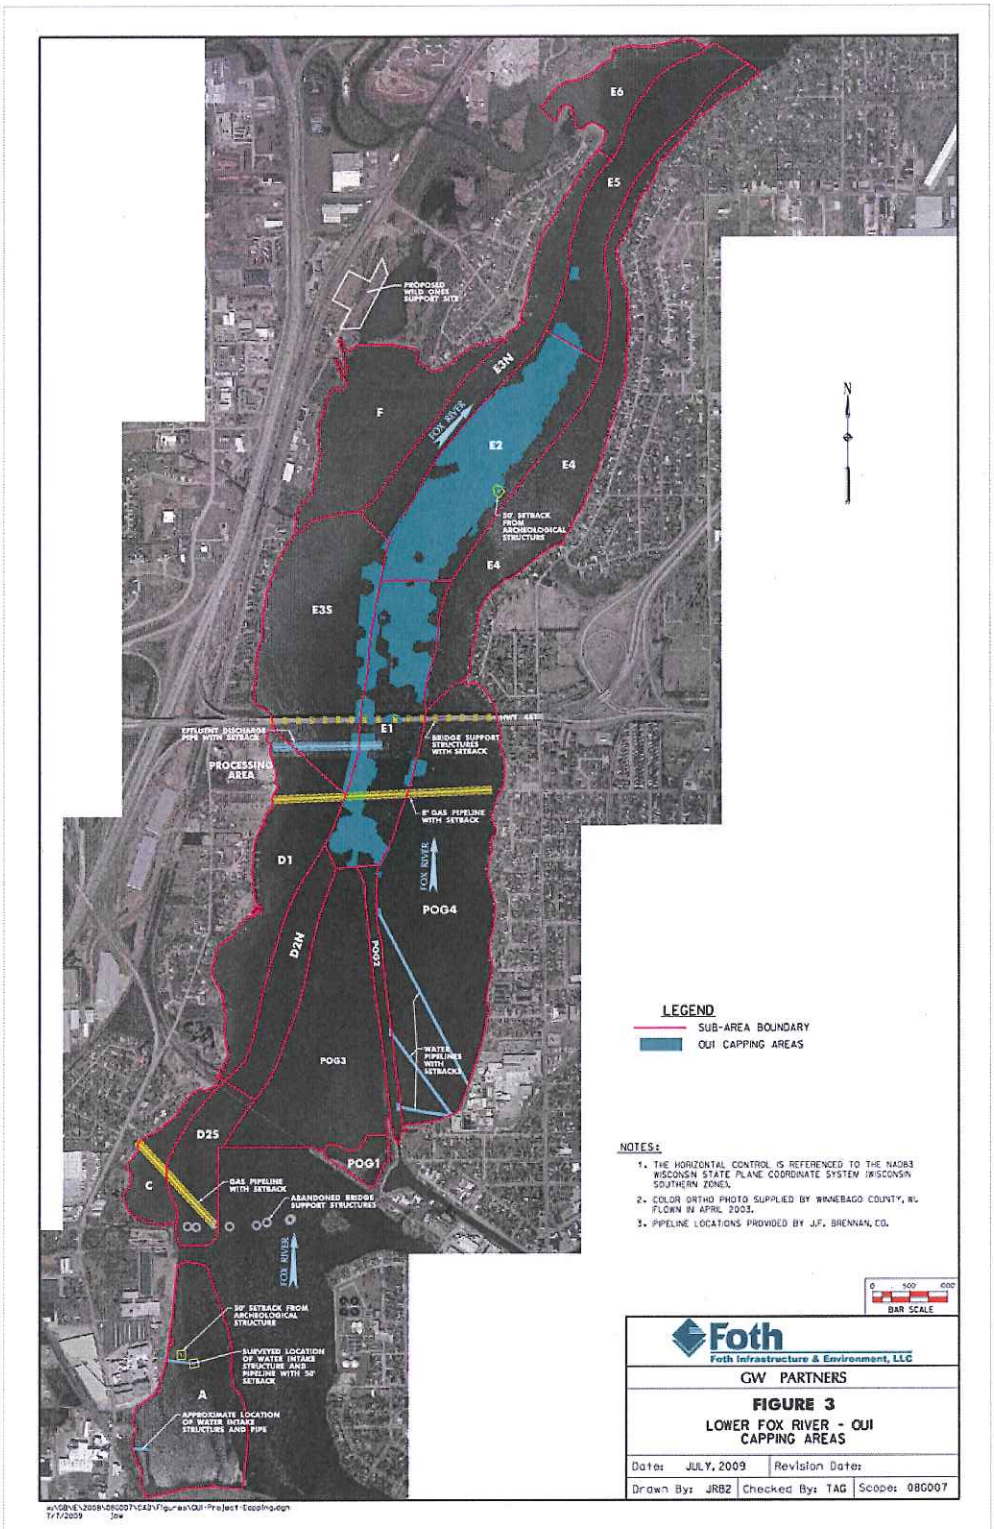
Figure 4. OU 1 Capped Areas

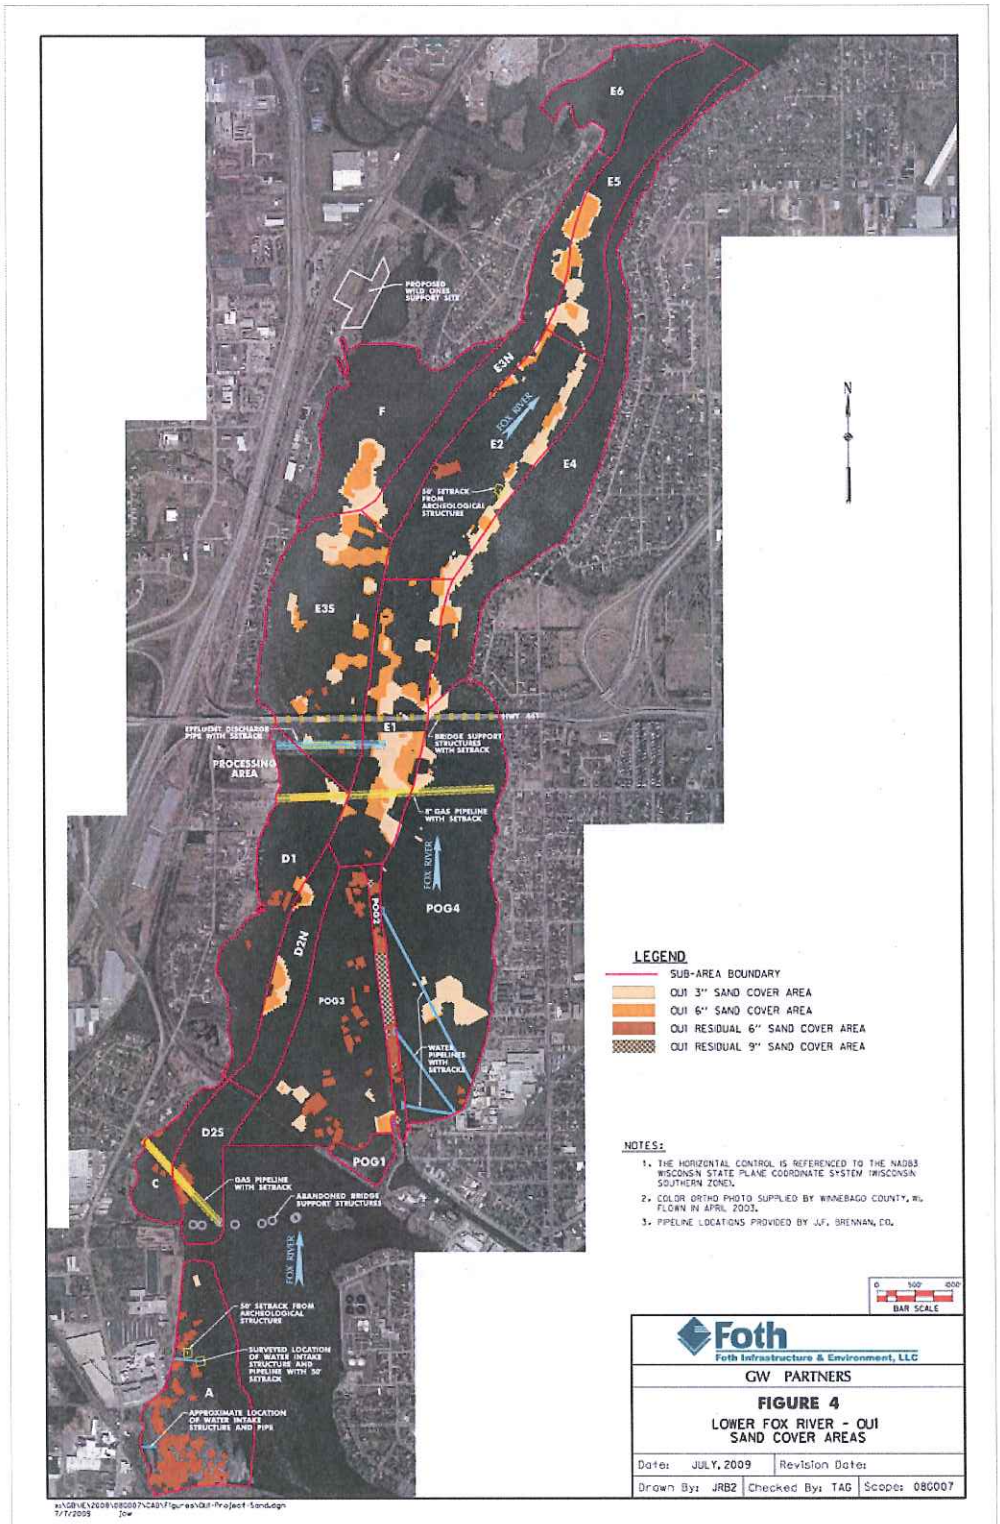
Figure 5. OU 1 Sand-Covered Areas

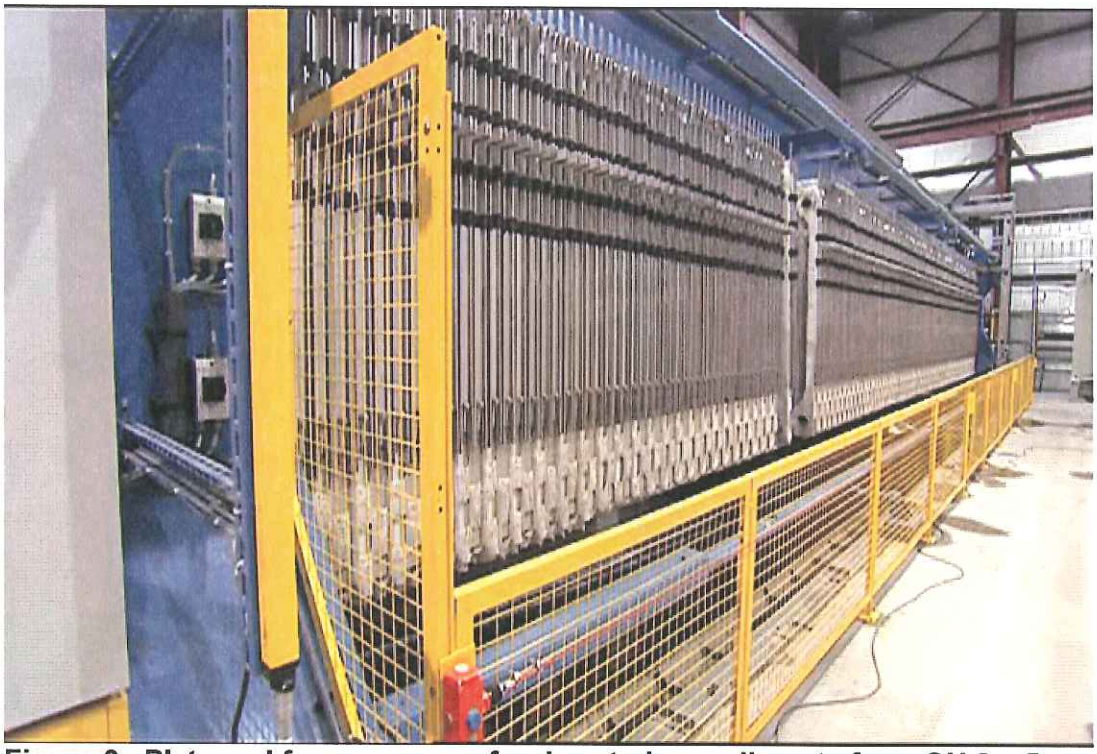
Figure 3. Plate and frame presses for dewatering sediments from OU 2 – 5.

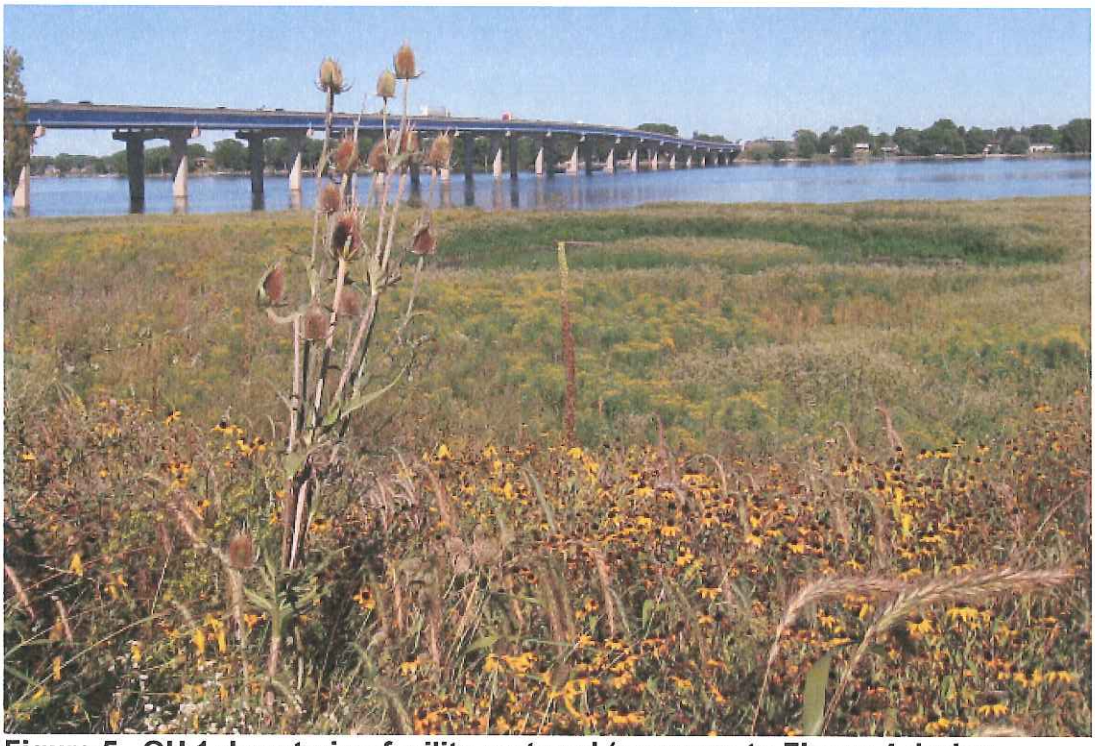
Figure 5. OU 1 dewatering facility restored (compare to Figure 4 during remediation).

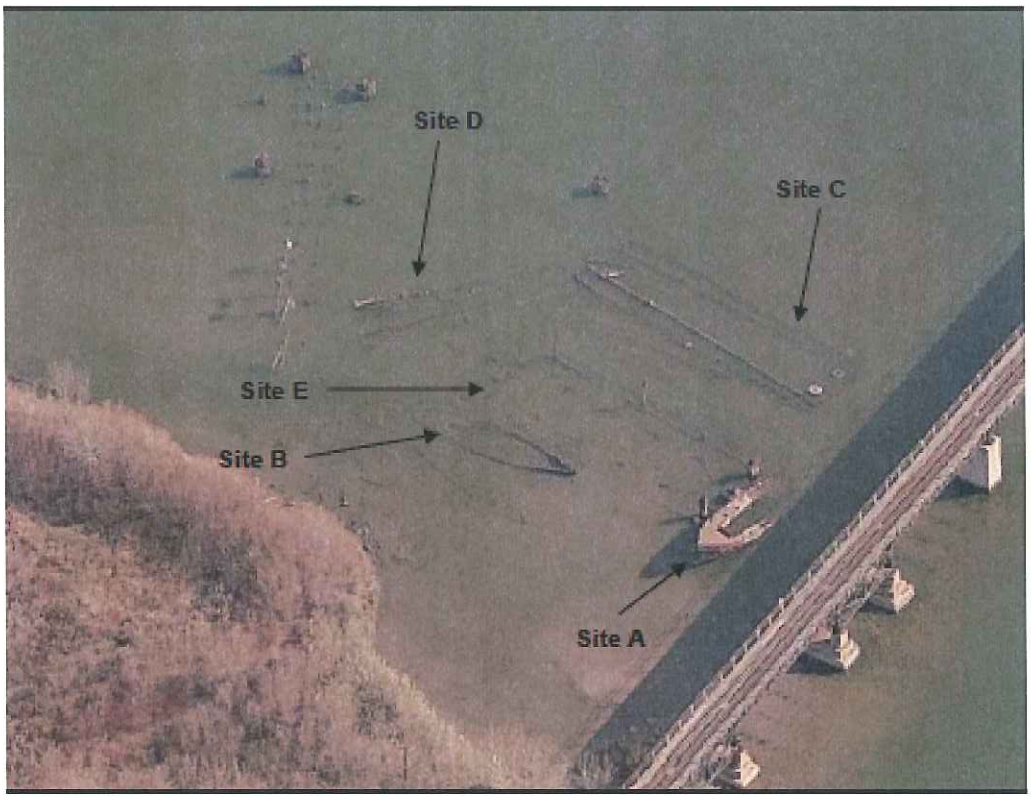
During the ongoing cleanup, it was determined that the partially submerged hulls of two steam-powered tugboats – the *Bob Teed* and *Satisfaction* – and debris from what is believed to be three old barges needed to be removed from the river within OU 4 and disposed offsite. The tugboats and barges were located within contaminated sediment targeted for remedial action. The vessels were declared historical artifacts and cultural resources under the National Historic Preservation Act. A Memorandum of Agreement among EPA, WDNR, the Wisconsin State Historical Preservation Office, the Neville Museum, and certain PRPs was finalized in September 2013, and removal of the shipwrecks started in November 2014. The MOA requires the creation of an interpretive display at Brown County's Neville Museum. The display will be completed by December 2014 and will explain the history of the vessels and other interesting facts about river commerce in the late 1800s and early 1900s. Shipwreck removal activities were completed on May 9, 2014. See Figures 7, 8, 9, and 10 in Appendix B.

Figure 7. Shipwrecks in OU4 prior to dredging of contaminated sediments. Site A is the Bob Teed and Site B is the Satisfaction, both meriting placement of the shipwreck disposal site on the Historical Site listing.

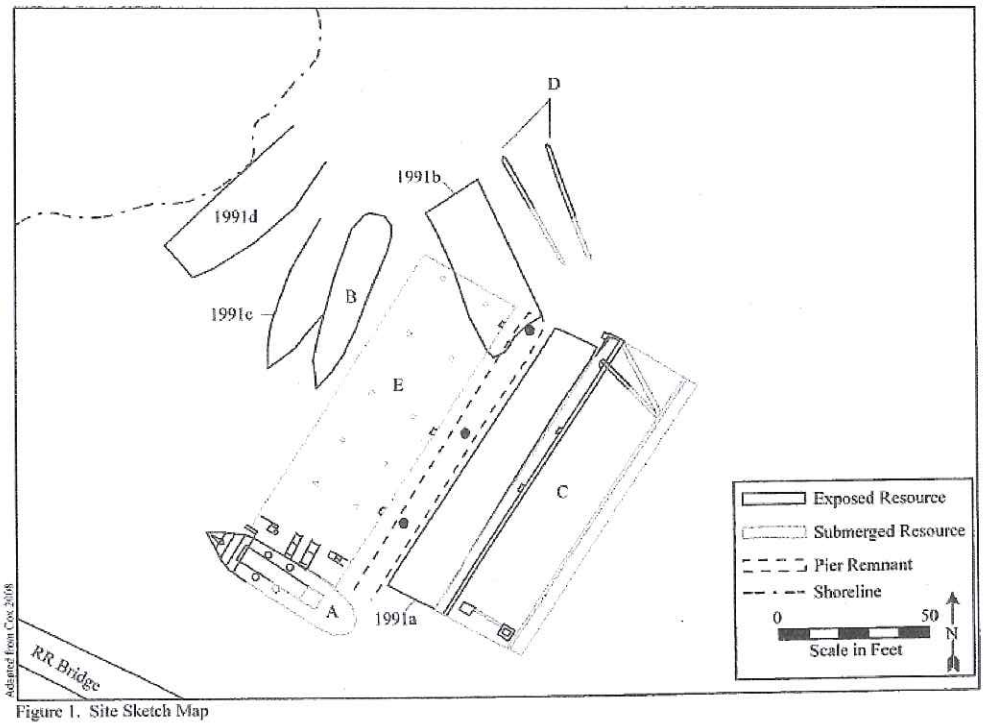
Figure 8. Line drawing of shipwrecks in OU 4. Site A is the Bob Teed, and Site B is the Satisfaction. Both of these ships were tugboats, operational from the late 1800s to the 1940s. Sites 1991a, 1991b, 1991c and 1991d were discovered during excavation activities in November 2013.
