Memorandum

March 4, 2019

RE: Lower Fox River OU4 *COMMP* Year 0 Cap Integrity Assessment – Caps Completed 2015-2017

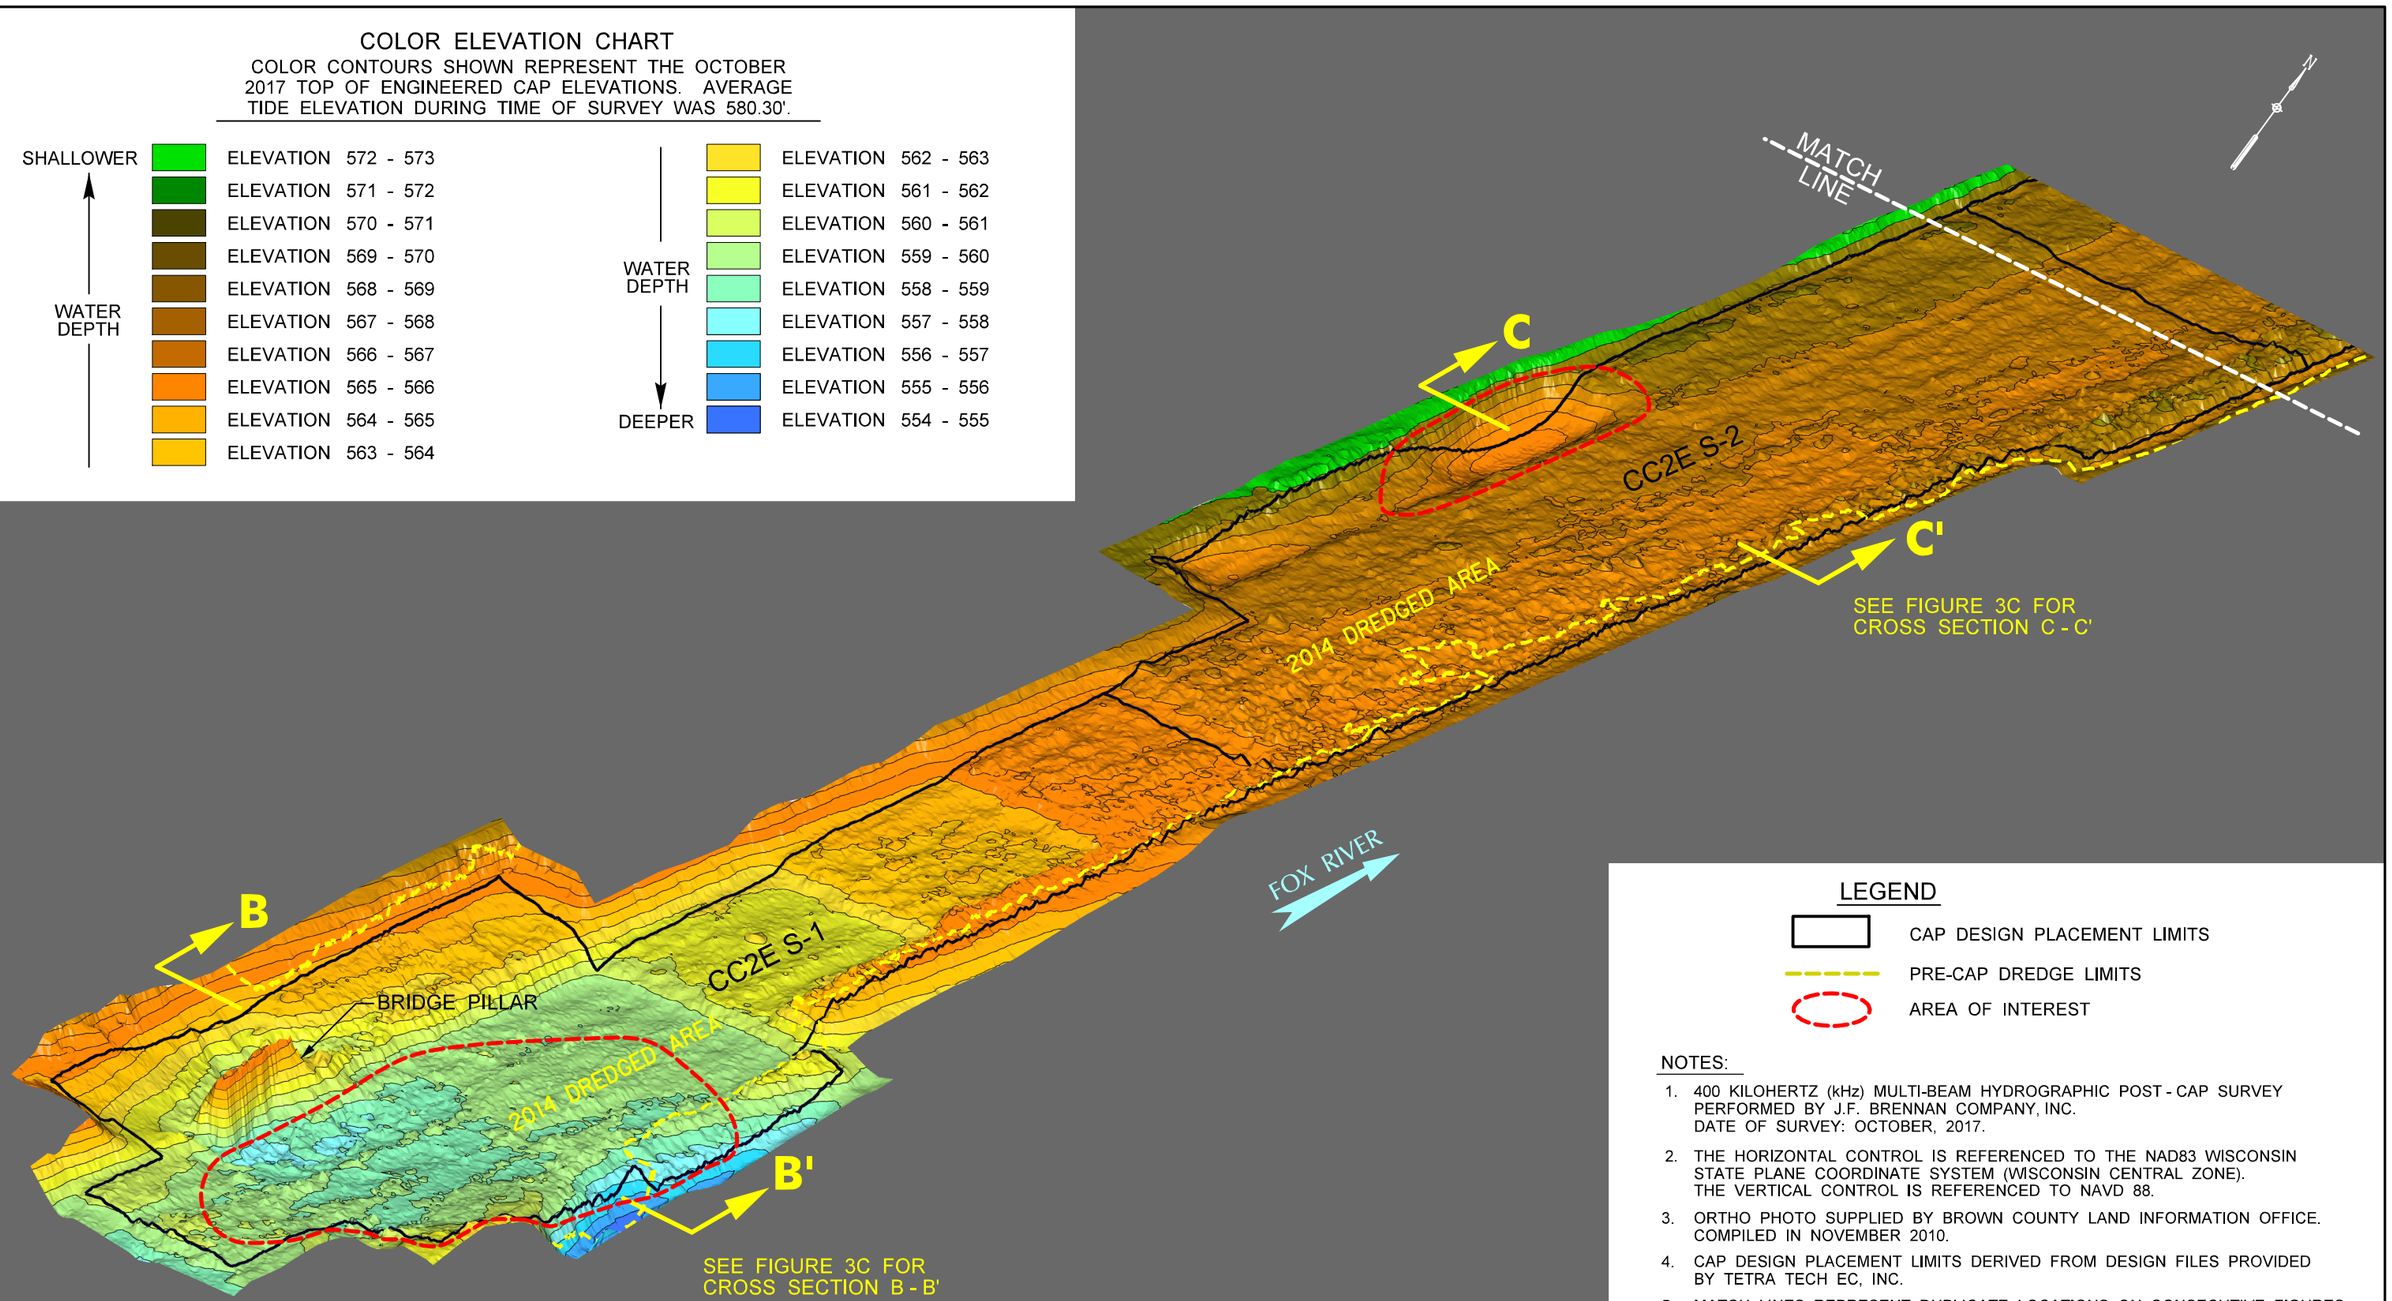
FIGURE 3B

CC2E South-2	3.23	2015	Year 0 (2017)	A large depression area is visible in the surface elevations along the west edge of CC2E South-2 (Figure 3B). To further evaluate this depression area, a cross-section (C-C') was cut through the area (Figure 3C), and the 2017 top of cap elevations were compared to the single-beam 2014 post-dredge bathymetry. The depression area in question aligns with areas of deeper dredge grades, and the two surveys follow a similar profile indicating that the depressed area is a reflection of the river bottom topography rather than the cap having been eroded or undergone significant differential settlement.	Cap maintenance not required.	N/A
				Because 2017 top of cap elevations on the eastern side of the cap area were lower than expected as compared to the single-beam 2014 post-dredge bathymetry, the 2017 top of cap elevations were compared to the single-beam 2016 post top of cap bathymetry (cross section C-C'). Some consolidation of the underlying sediment (approximately 3 inches) occurred on the eastern side of the cap area, as evident from the comparison of the 2016 and 2017 surveys.	Cap maintenance not required.	This area will be reviewed again in the Year 1 COMMP cap integrity assessment (fall 2018) for signs of erosion (cap presence/cap thinning).

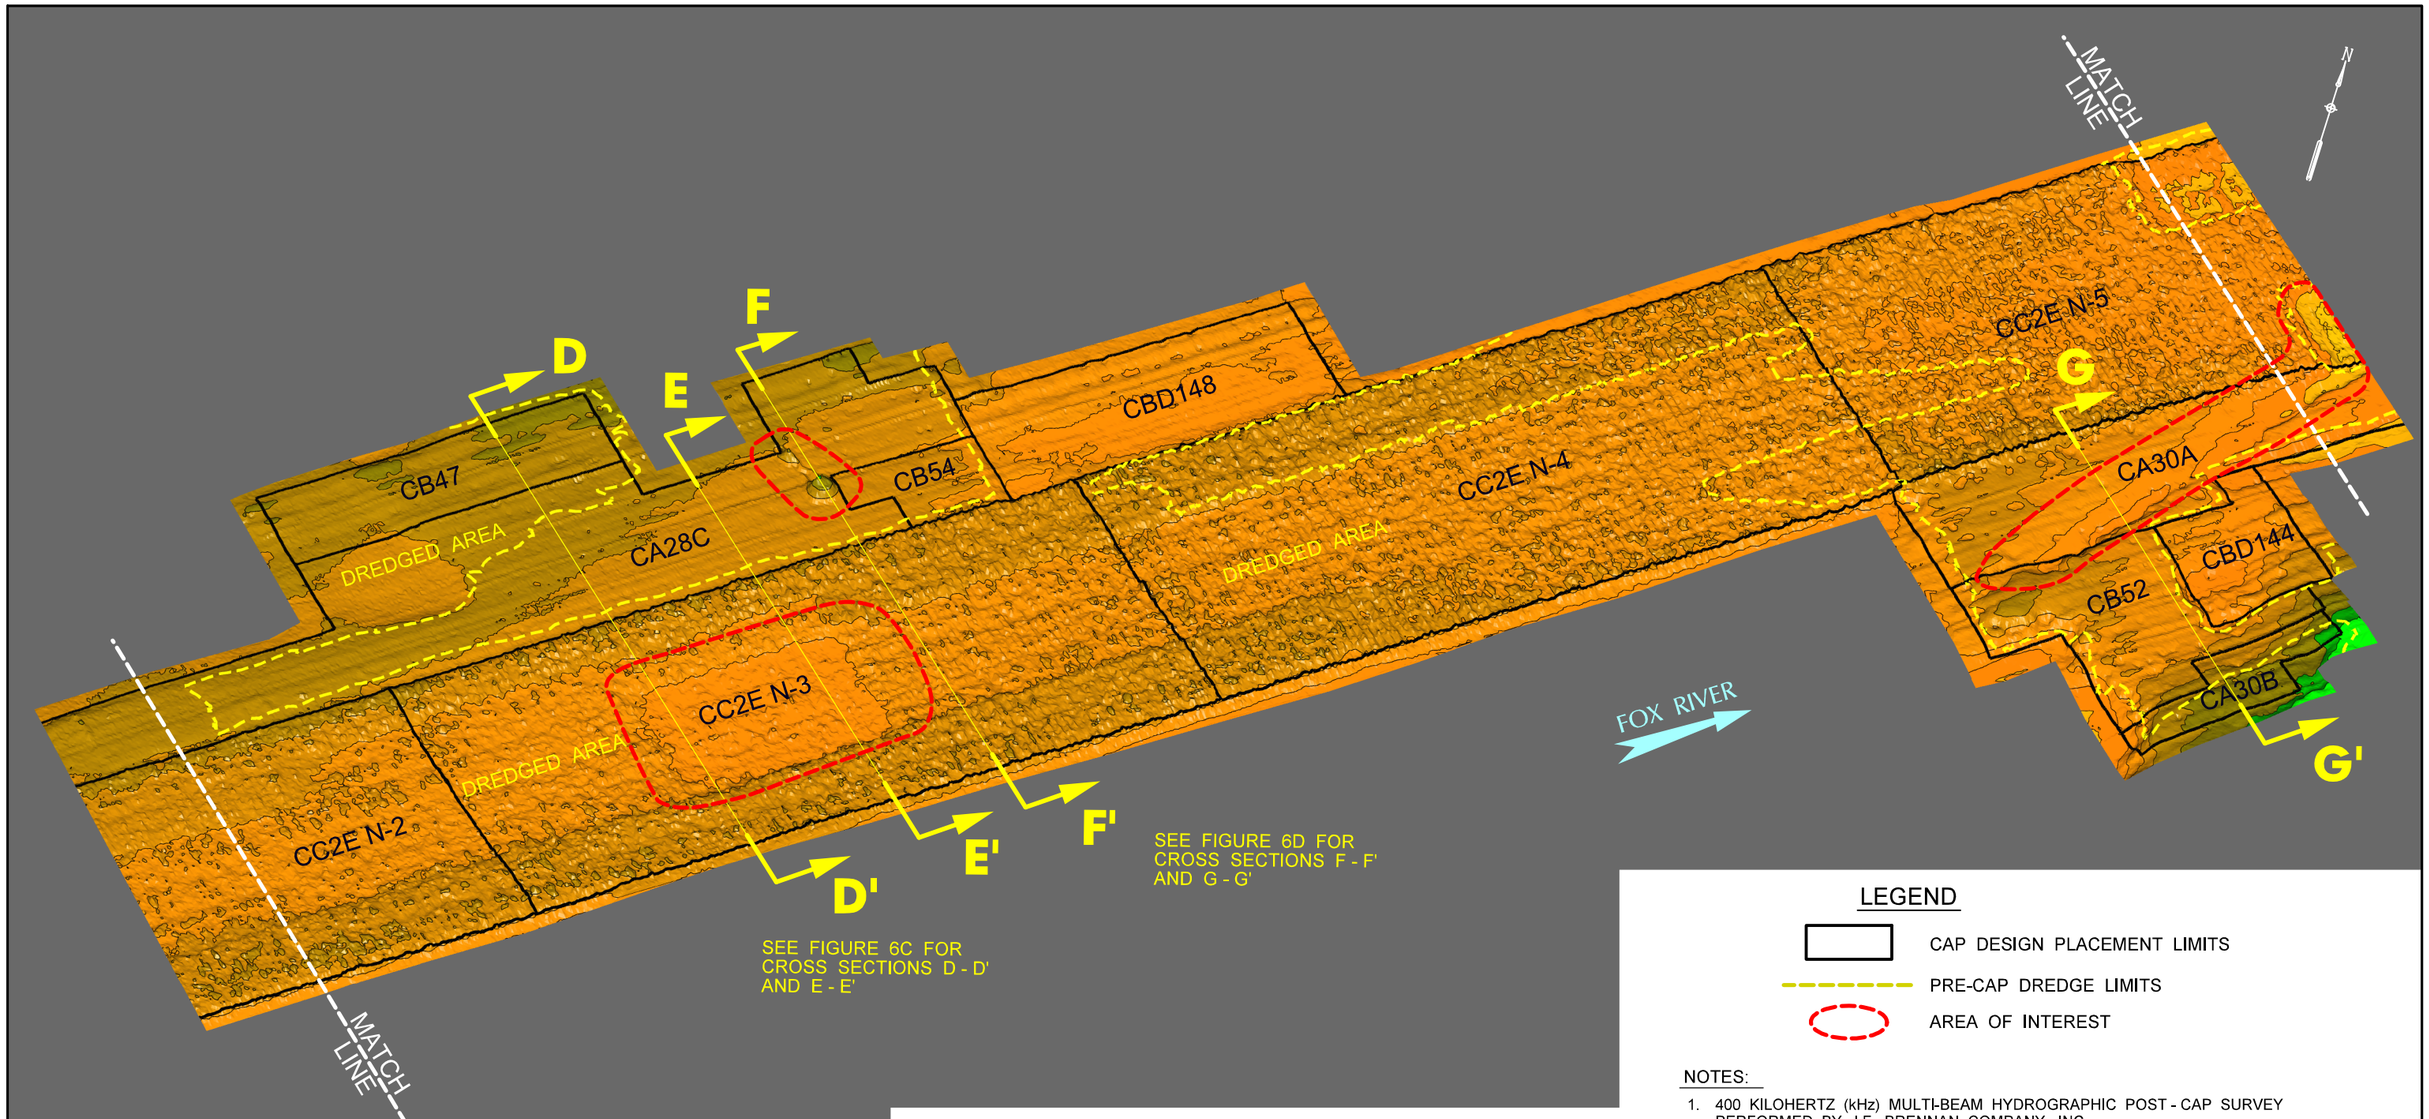
1. A small mound is visible in the surface elevations near the north side of CA28C, along the southern edge of CB54 (Figure 6B). To further evaluate this area, a cross-section (F-F') was cut through the area (Figure 6D), and the 2017 top of cap elevations were compared to the single-beam 2015 pre-cap placement bathymetry. The mound was not observed in the 2015 bathymetry indicating that it is a feature that developed/appeared between the two surveys. Because no other irregularities are seen in the top of cap elevations and in the cross-section, it is not expected to diminish cap integrity. The source of the mound may be additional capping material left behind during placement, as it is present in both the 2016 and 2017 post-top of cap surveys.

CA28C	2.08	2015	Year 0 (2017)	A small mound is visible in the surface elevations near the north side of CA28C, along the southern edge of CB54 (Figure 6B). To further evaluate this area, a cross-section (F-F') was cut through the area (Figure 6D), and the 2017 top of cap elevations were compared to the single-beam 2015 pre-cap placement bathymetry. The mound was not observed in the 2015 bathymetry indicating that it is a feature that developed/appeared between the two surveys. Because no other irregularities are seen in the top of cap elevations and in the cross-section, it is not expected to diminish cap integrity. The source of the mound may be additional capping material left behind during placement, as it is present in both the 2016 and 2017 post-top of cap surveys.	Cap maintenance not required.	N/A
				Because 2017 top of cap elevations across the central portion of the area were lower than expected as compared to the single-beam 2015 pre-cap placement bathymetry, the 2017 top of cap elevations were compared to the single-beam 2016 post top of cap bathymetry (cross sections D-D' and E-E' on Figure 6C). Some consolidation of the underlying sediment (at least an inch or more) occurred over much of the cap area, as evident from the comparison of the 2016 and 2017 surveys. The central portion of the CA28C cap area was not dredged prior to capping, and soft sediment thickness may be substantial, leading to more significant settlement of the cap due to consolidation of the underlying soft sediment. Such settlement would not be reflected in the 2015 survey. Future consolidation would be expected to be minimal based on consolidation evaluations performed in other Lower Fox River locations (i.e. OU1) (Foth, 2010). The cross-sections and isometric view do not indicate scouring.	Cap maintenance not required.	This area will be reviewed again in the Year 1 COMMP cap integrity assessment (fall 2018) for signs of erosion (cap presence/cap thinning).

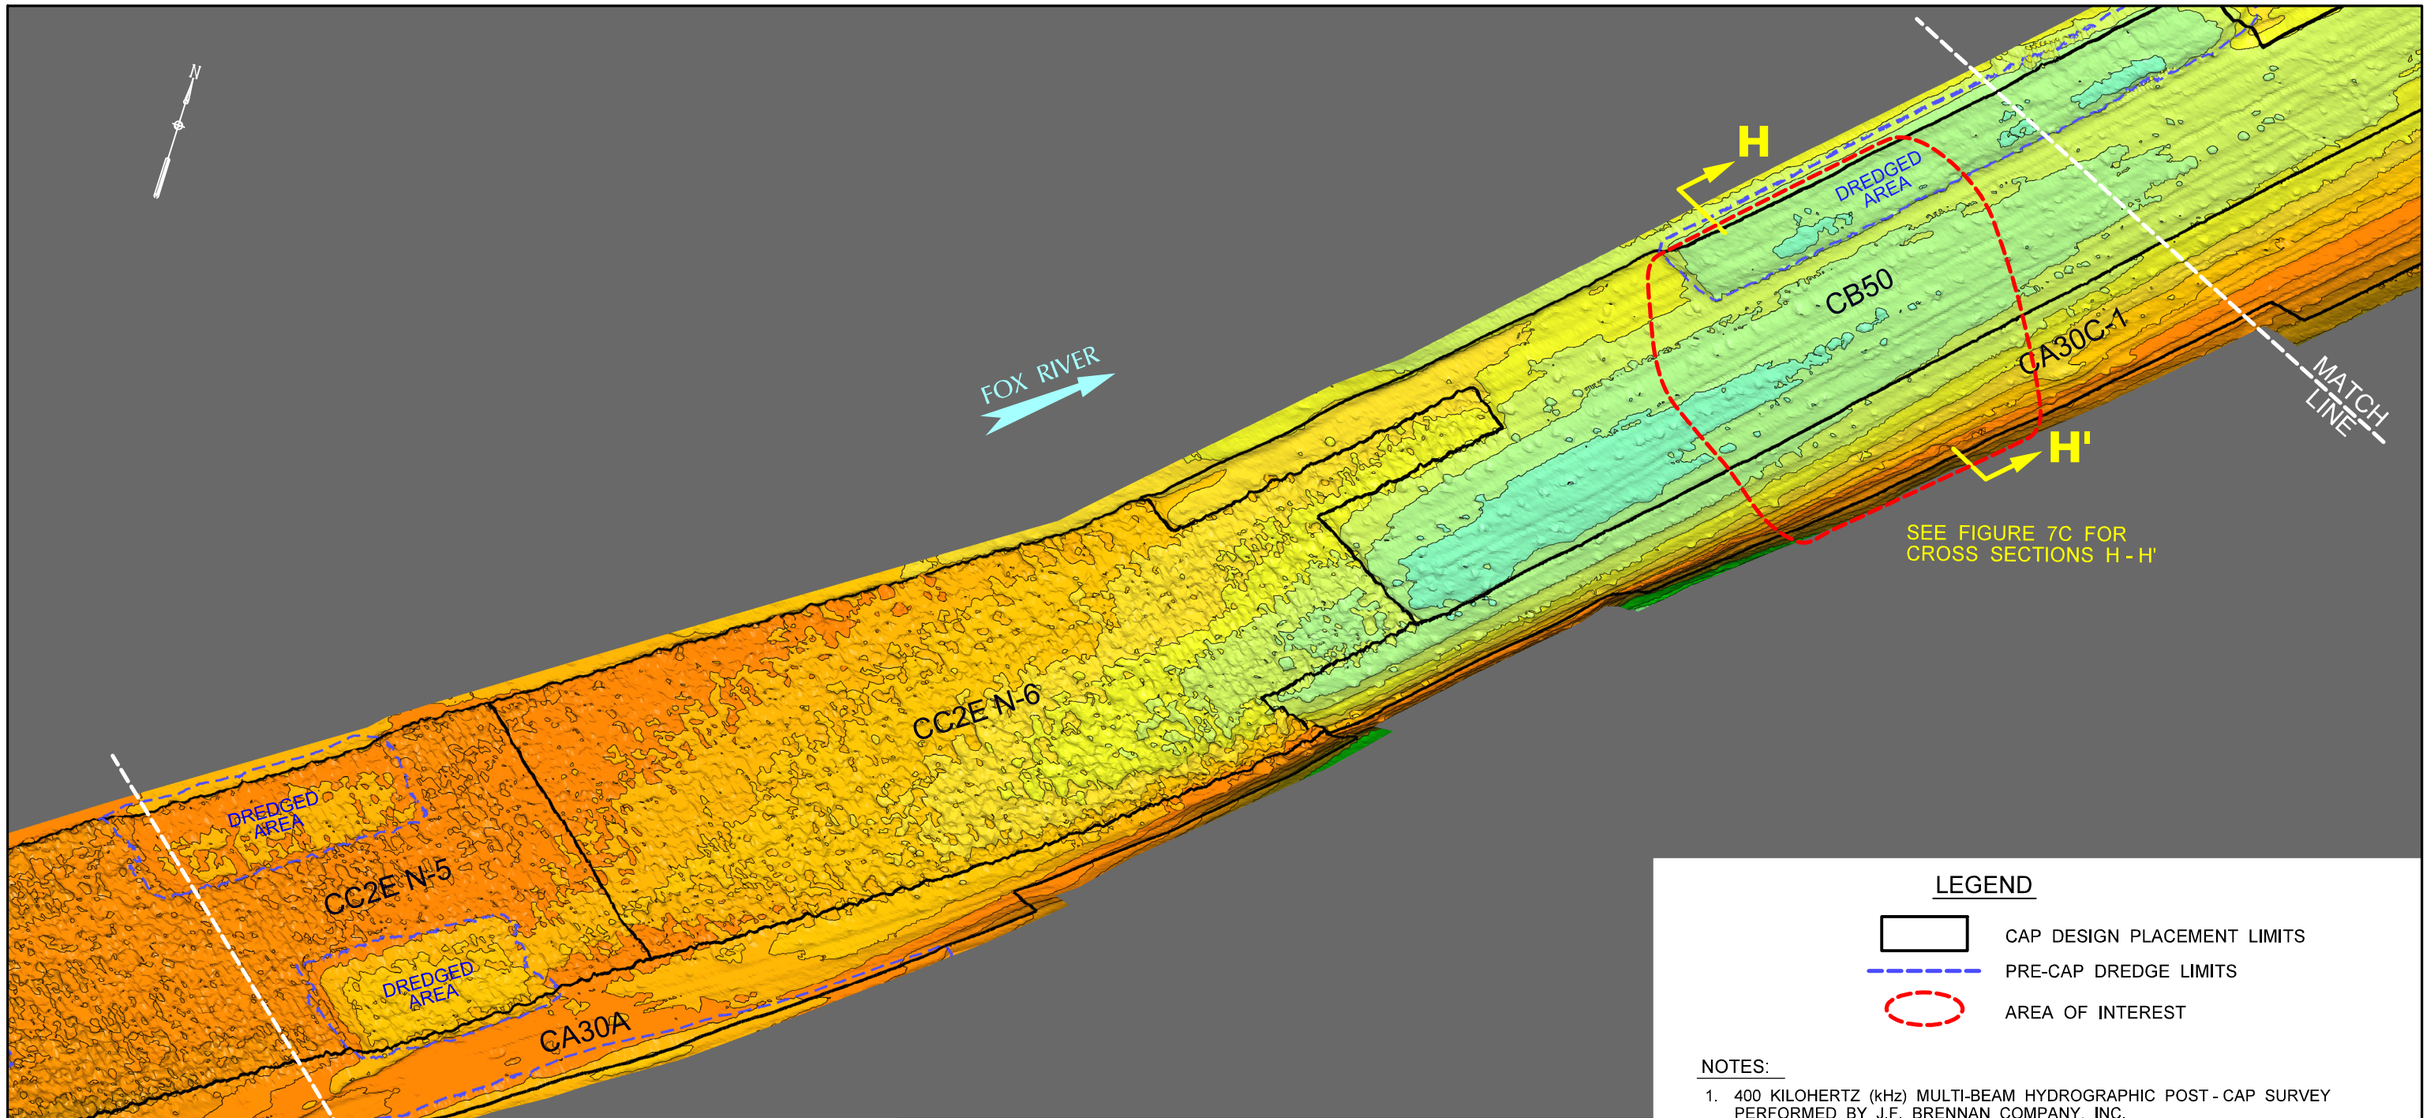
FIGURE 7B

1. To assess depressed top of cap elevations along the east side and central area of CB50 (Figure 7B), a cross-section (H-H') was cut through the area (Figure 7C) and the top of cap elevations were compared to the single-beam 2014 post-dredge and pre-cap placement bathymetry. The two surveys mirror each other well, both in profile and elevation, indicating that the depressed area is a reflection of the river bottom topography rather than the cap having been eroded or undergone significant differential settlement.

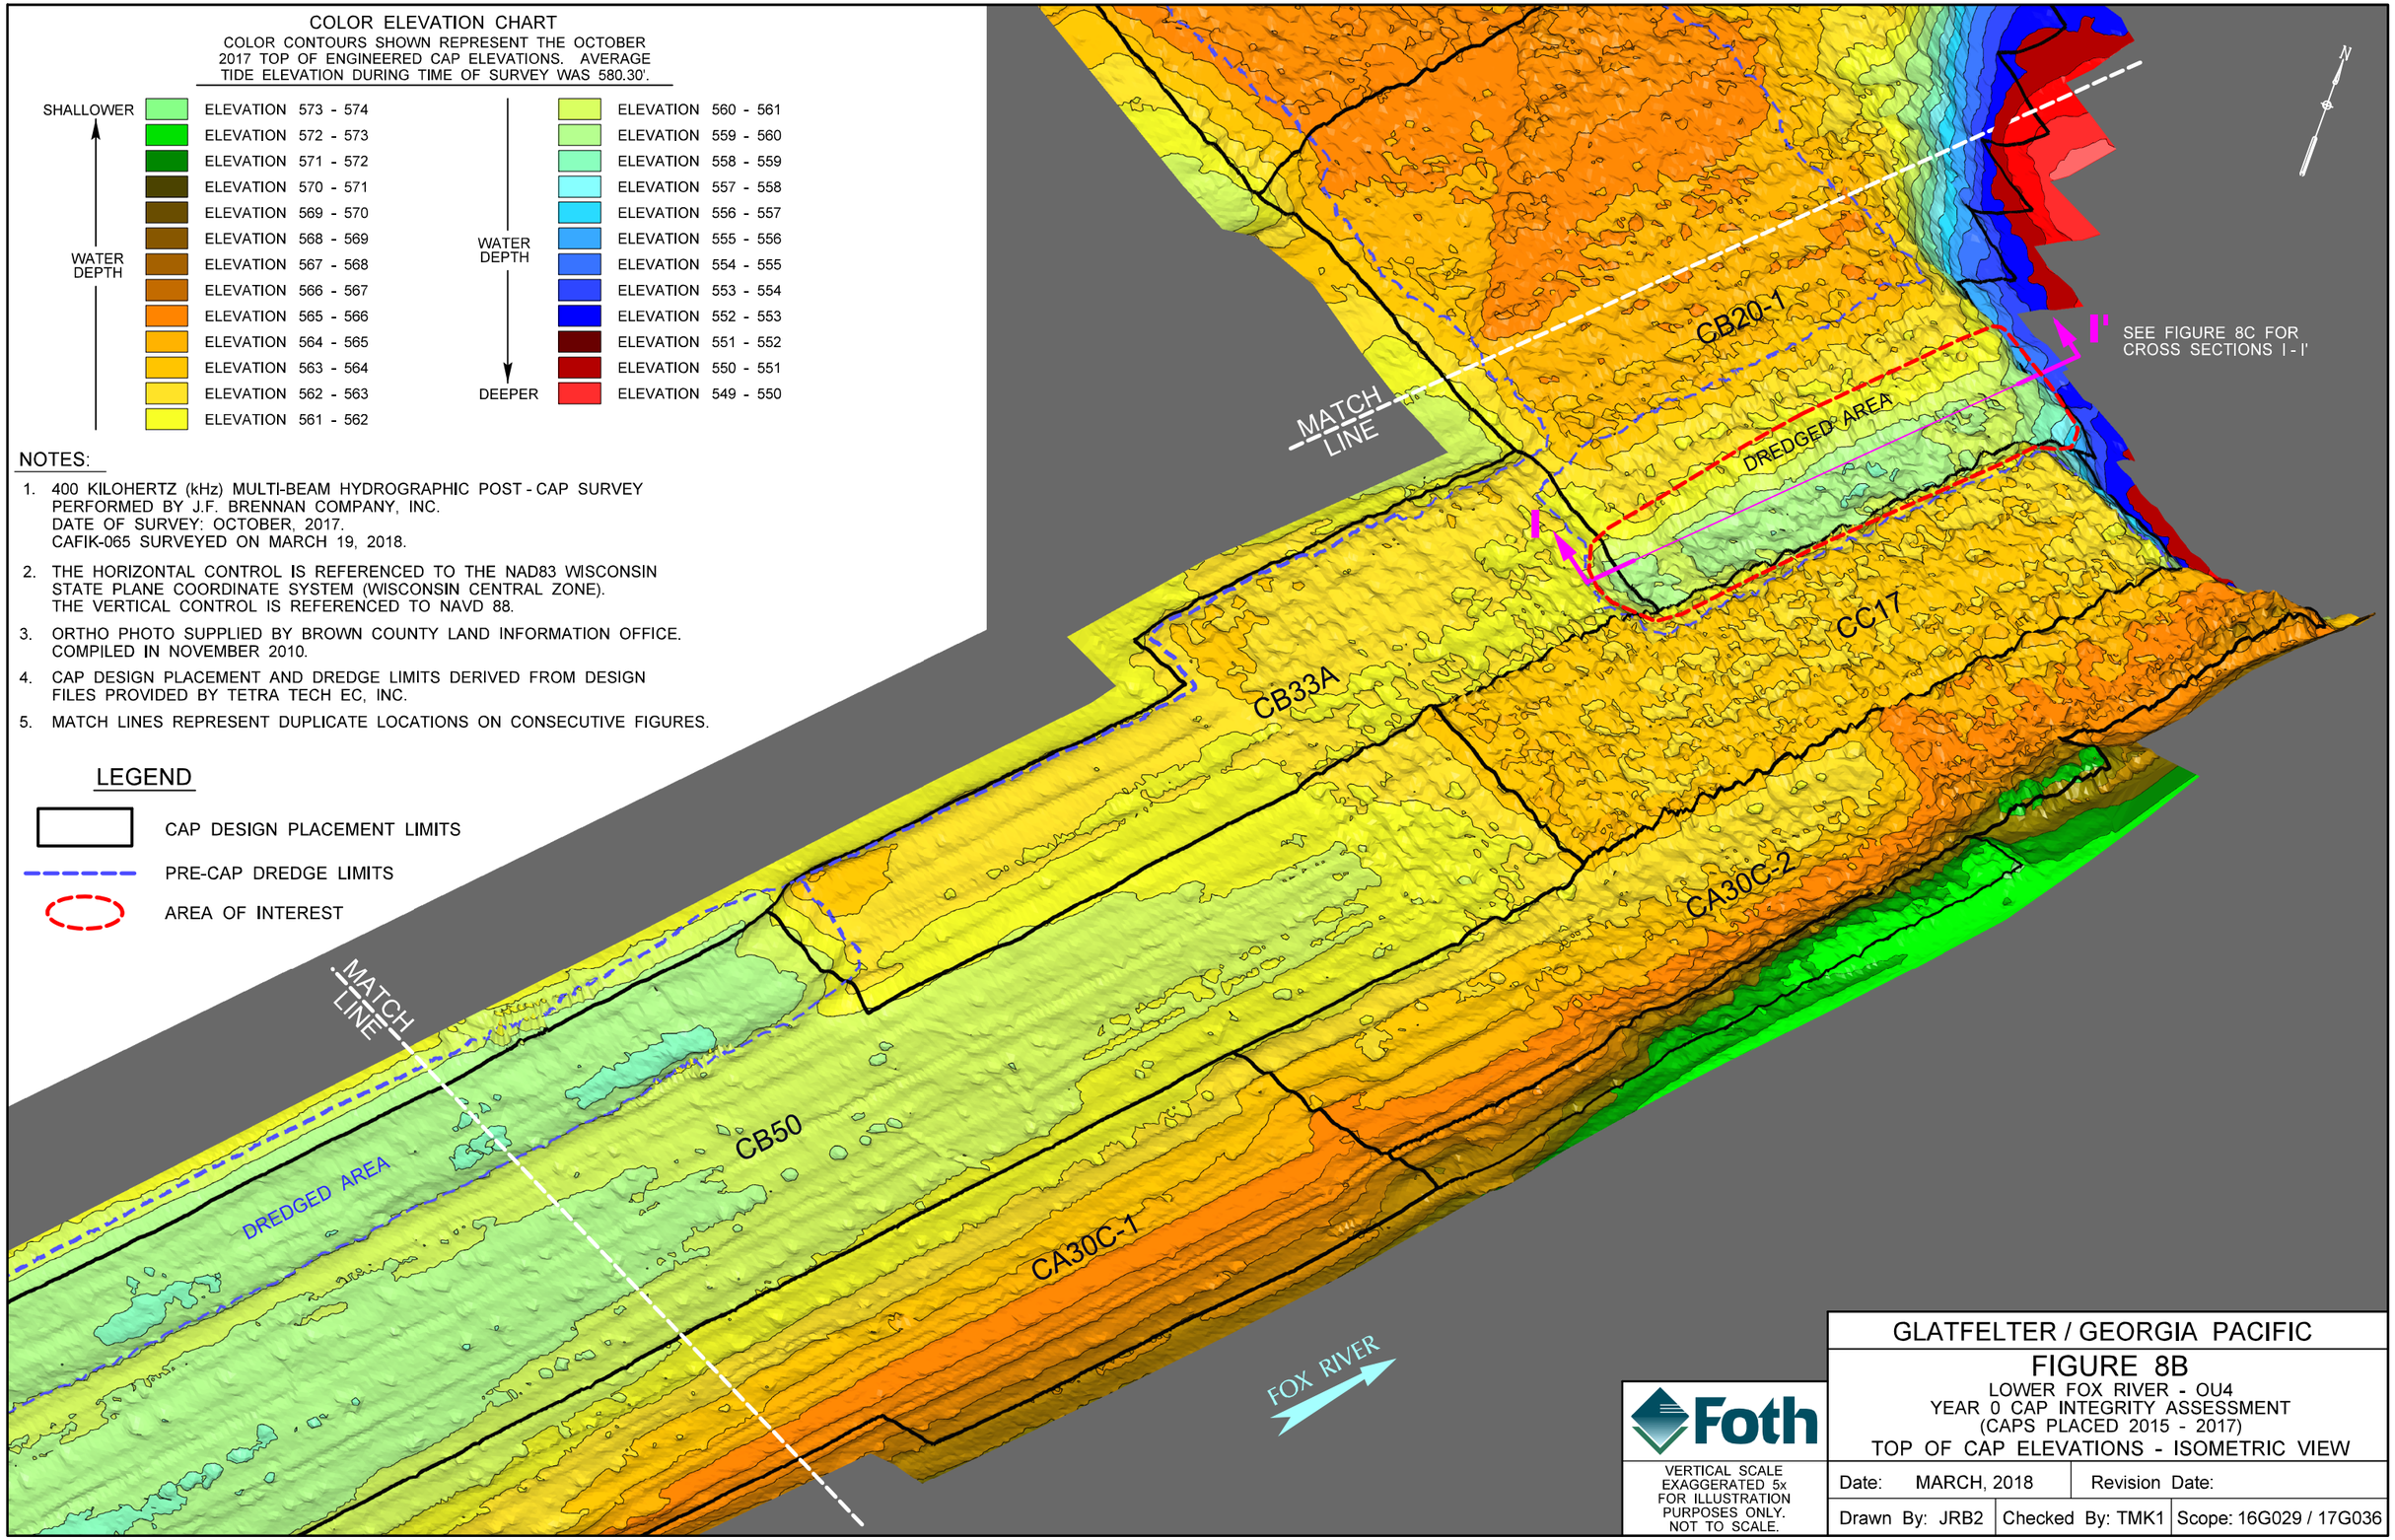
FIGURE 8B

1. To assess if the depressed top of cap elevations in the southern portion of CB20-1 (Figures 8B and 9B) are due to dredging prior to capping, cross-sections (I-I' and L-L', respectively) were cut through the area (Figures 8C and 9D) and the top of cap elevations were compared to the single-beam 2016 pre-cap placement bathymetry. The two surveys follow a similar profile indicating a reflection of the river bottom topography rather than the cap having been eroded or undergone significant differential settlement.

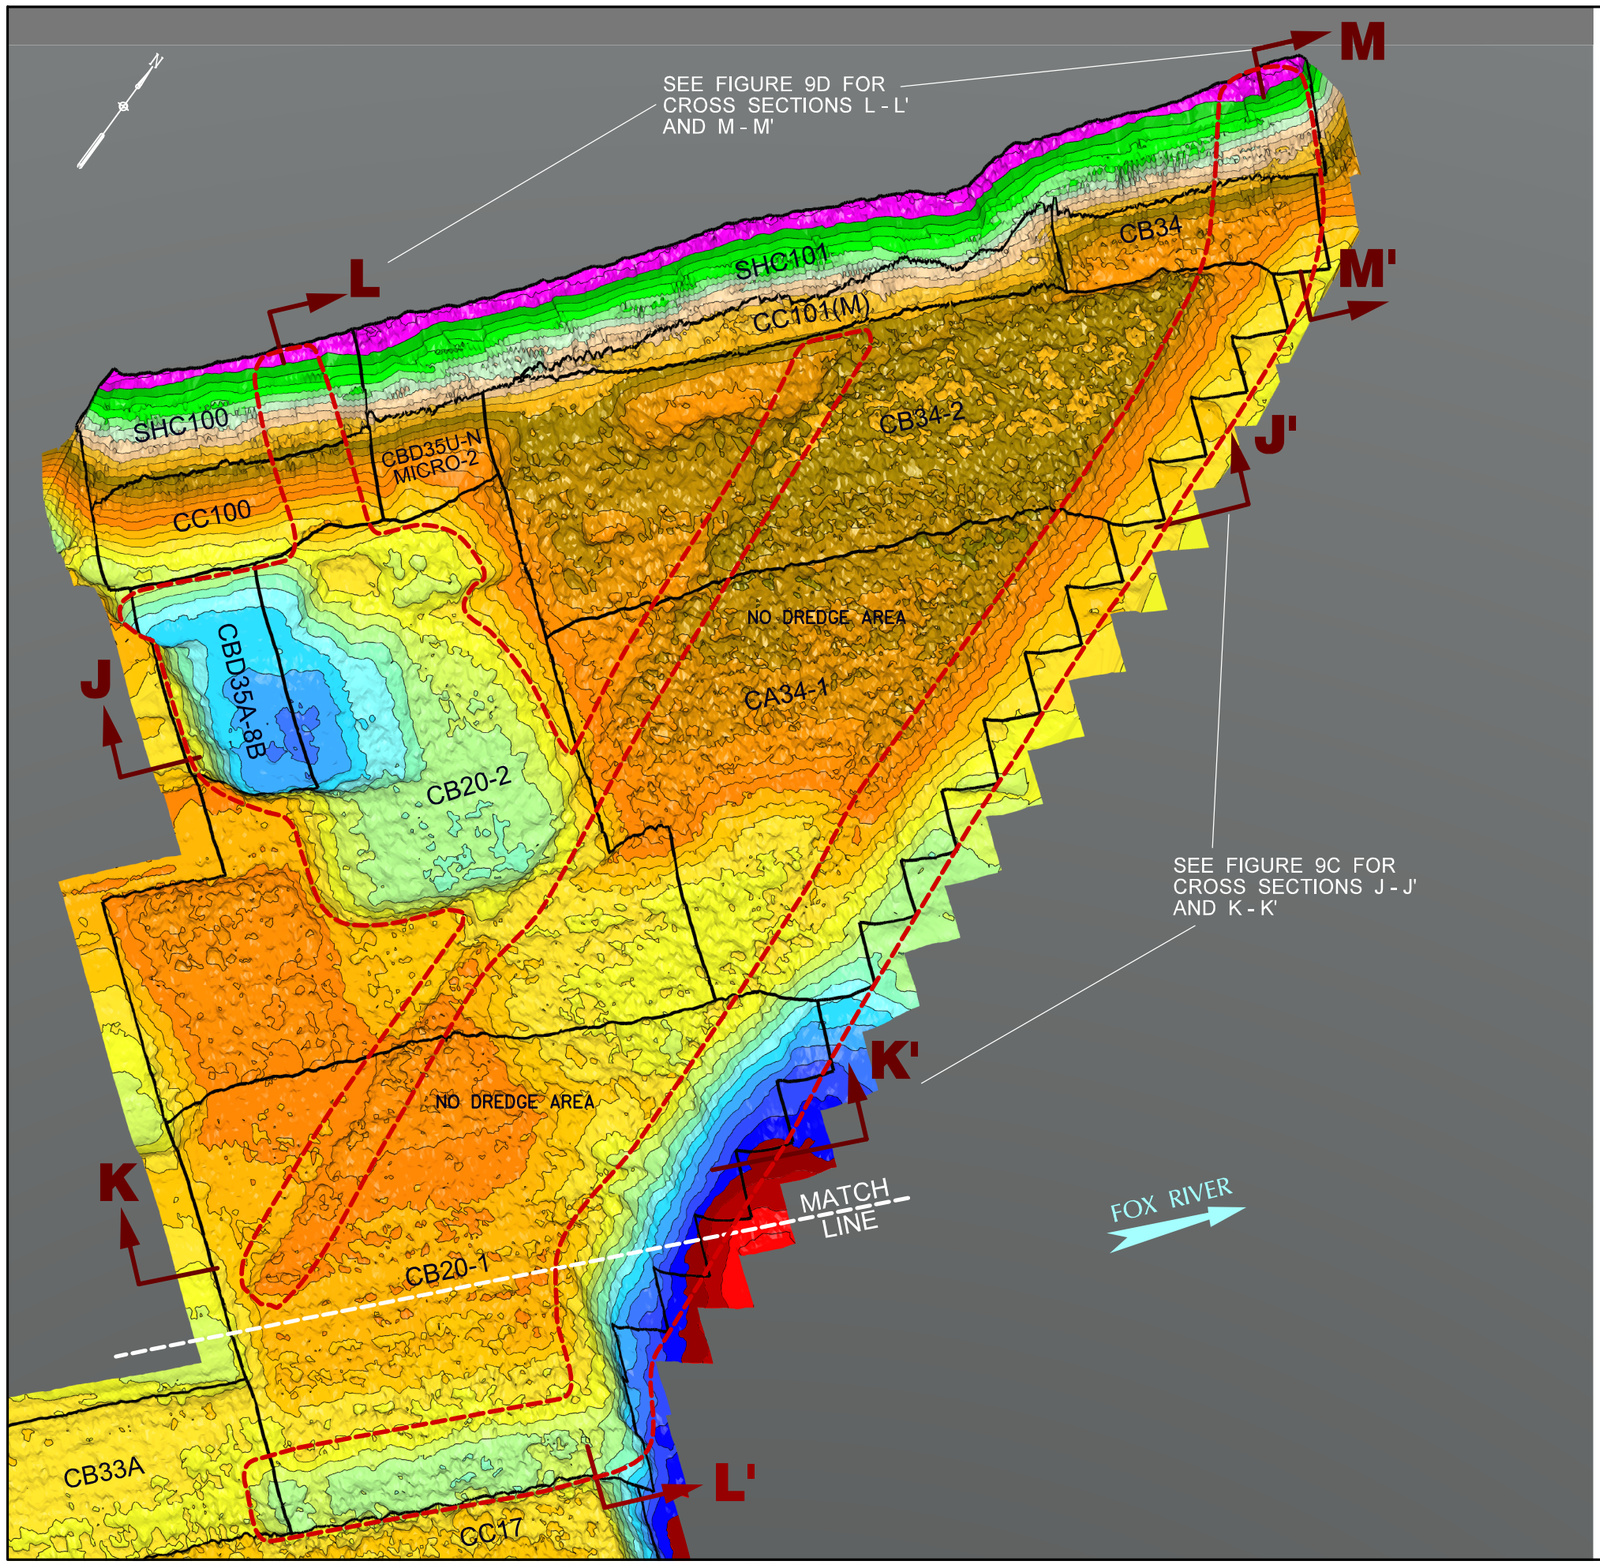
3. To assess the ridge area that runs through the northwest section of CB20-1 (Figure 9B), a cross-section (K-K') was cut through the area (Figures 9C) and the top of cap elevations were compared to the single-beam 2016 pre-cap placement bathymetry. It appears that the ridge is caused by the transition from a B1 cap type (12-inch minimum required thickness) to a B3 with Q(M1) cap type (22-inch minimum required thickness).

2. To assess the ridge area that runs through the southeast corner of CB20-2 (Figure 9B), a cross-section (L-L') was cut through the area (Figure 9D) and the top of cap elevations were compared to the single-beam 2016 pre-cap placement bathymetry. It appears that the ridge is caused by a combination of change in pre-cap river bottom topography and transition from a B1 cap type (12-inch minimum required thickness) to a B3 with Q(M1) cap type (22-inch minimum required thickness).

1. To assess the ridge area that runs through the southwest corner of CA34-1 (Figure 9B), a cross-section (J-J') was cut through the area (Figure 9C) and the top of cap elevations were compared to the single-beam 2016 pre-cap placement bathymetry. It appears that the ridge is caused by a transition from a B1 cap type (12-inch minimum required thickness) to a B3 with Q(M1) cap type (22-inch minimum required thickness).

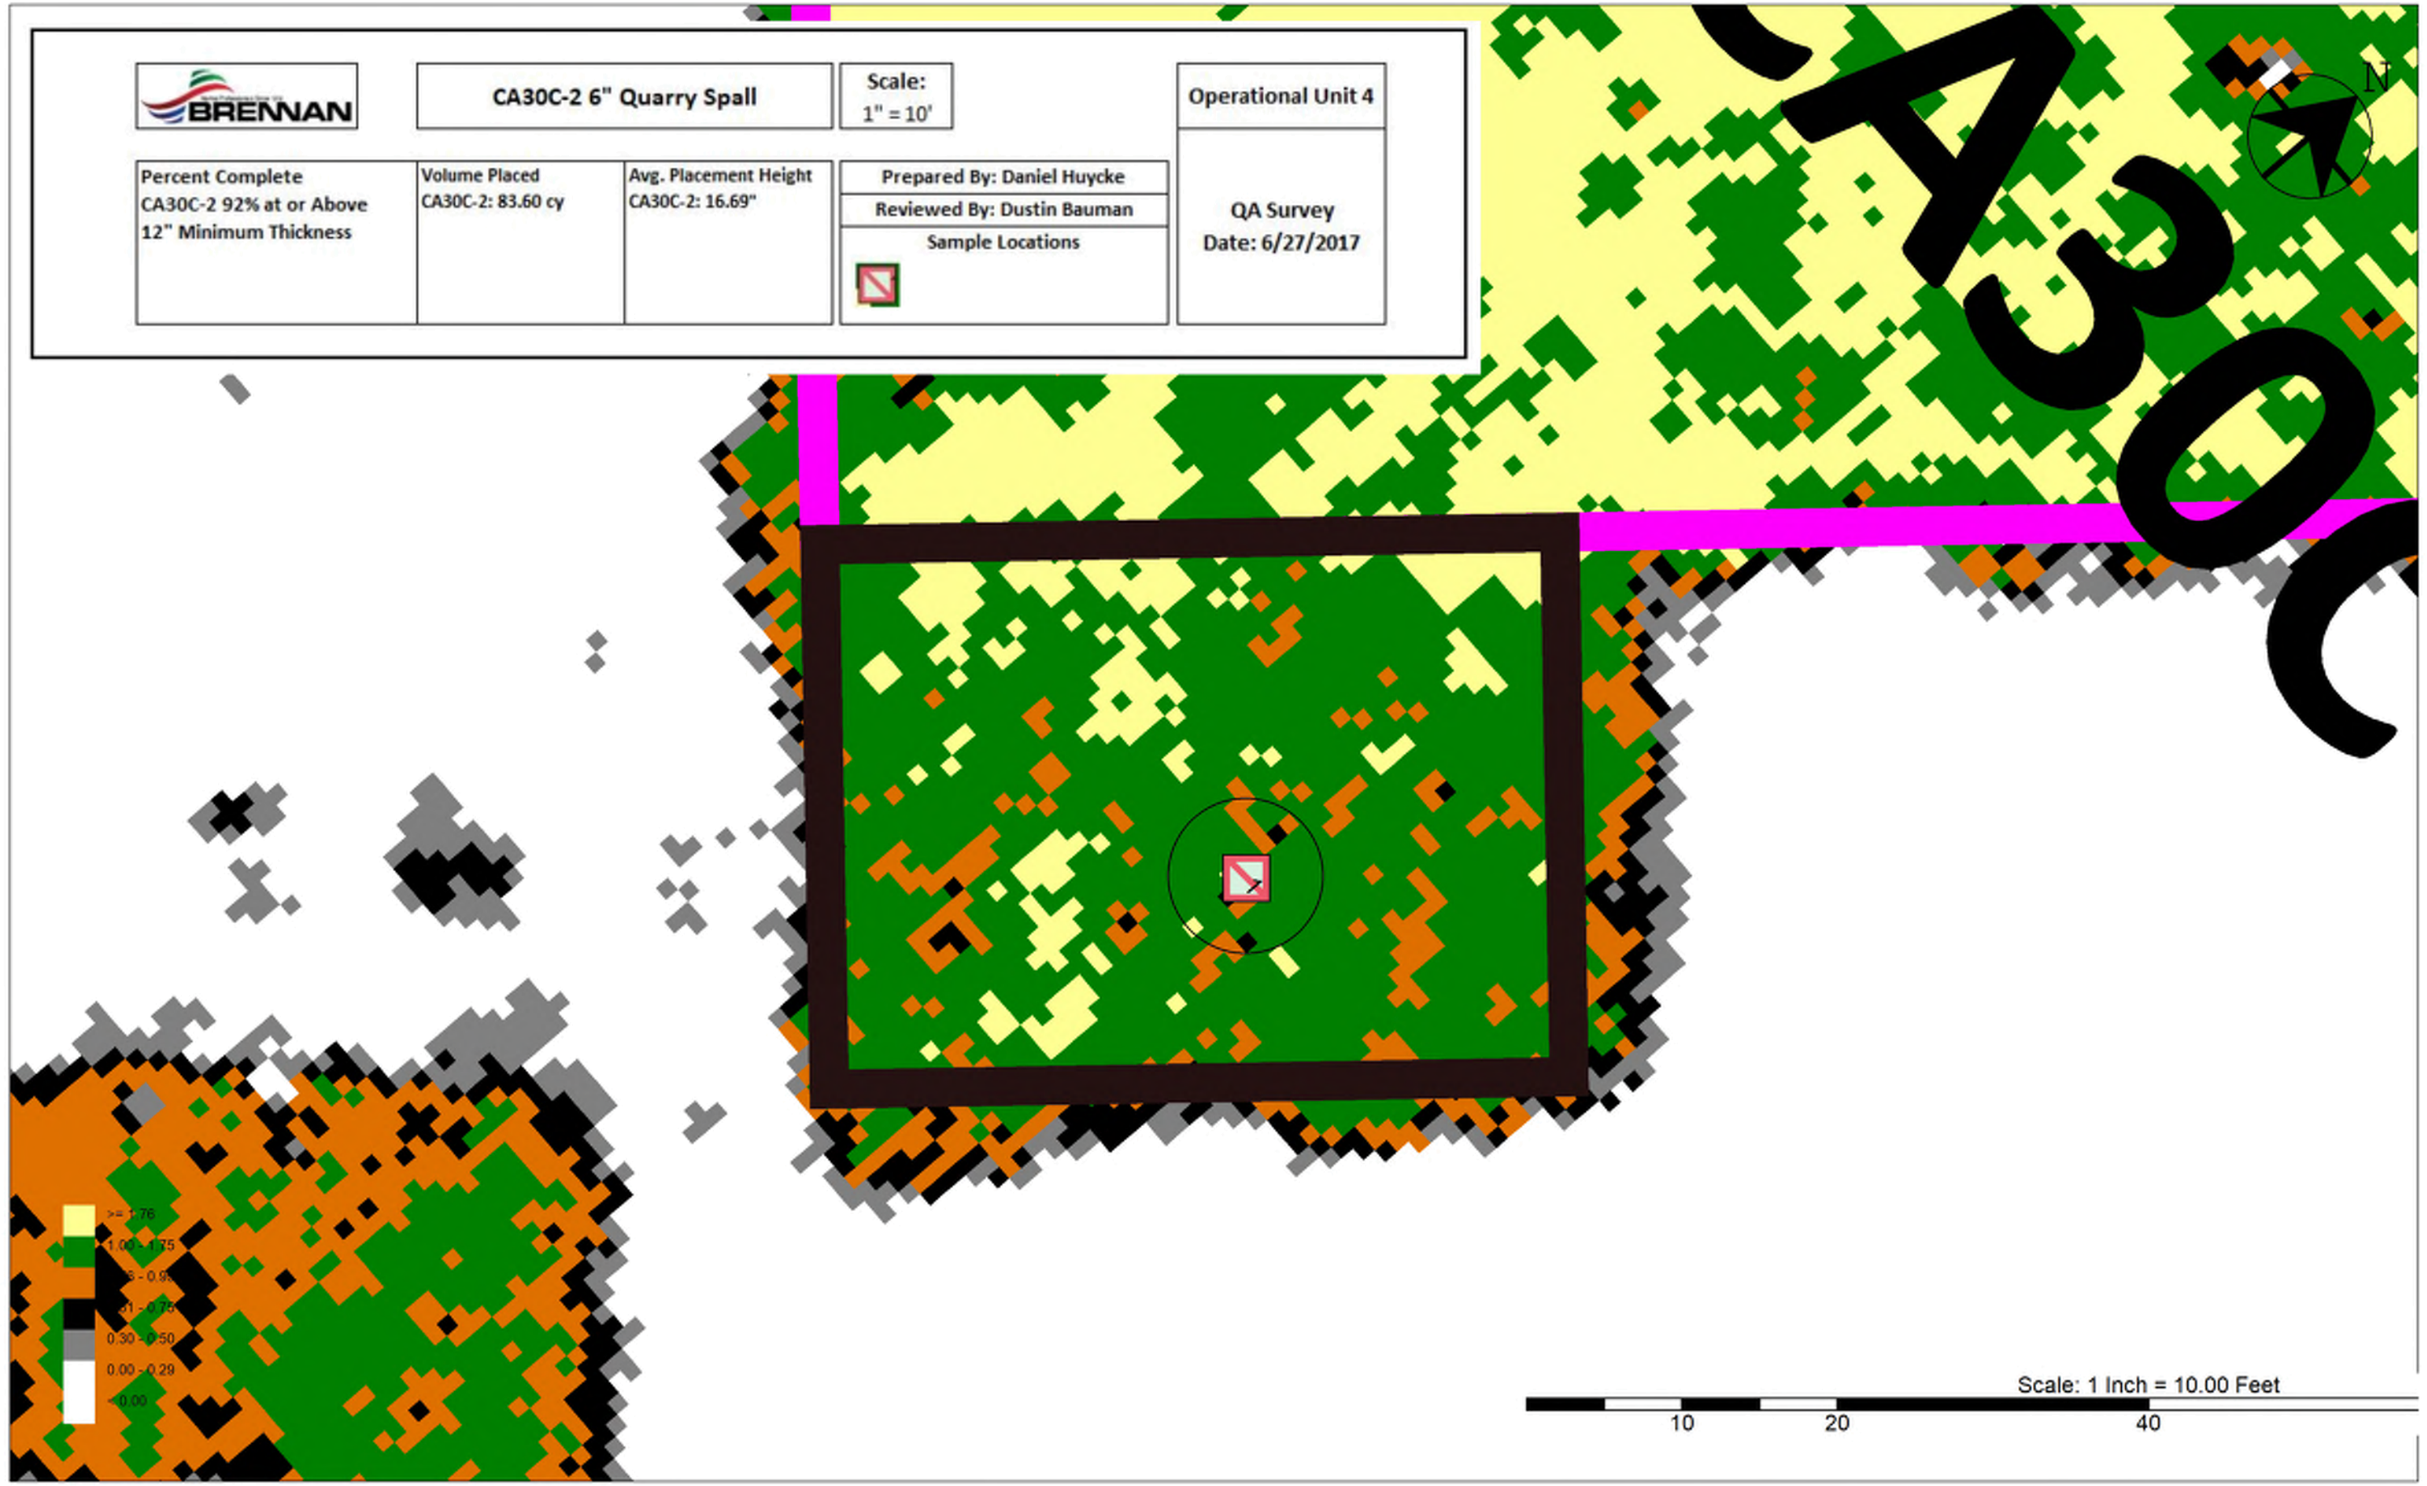
Quarry spall (D50=6") was placed and surveyed within OU4-CA30C-2, OU4-CB20-1, and OU4-CB20-2. The quarry spall thicknesses based on bathymetric survey meet or exceed the minimum thickness requirement of 12-inches. Furthermore, thickness verification poling was conducted at 25 locations. 0 of 1 sample in OU4-CA30C-2 meet or exceed the minimum thickness requirement of 12-inches. 15 of 17 samples in OU4-CB20-1 meet or exceed the minimum thickness requirement of 12-inches. 4 of 7 samples in OU4-CB0-2 meet or exceed the minimum thickness requirement of 12-inches resulting in a total of 19 of 25 passing within all three areas. Tetra Tech recommends use of the J.F. Brennan QC data to accept this area on an exception basis.

BRENNAN	CA30C-2 6" Quarry Spall	Scale: 1" = 10'		Operational Unit 4
Percent Complete CA30C-2 92% at or Above 12" Minimum Thickness	Volume Placed CA30C-2: 83.60 cy	Avg. Placement Height CA30C-2: 16.69"	Prepared By: Daniel Huycke Reviewed By: Dustin Bauman Sample Locations	QA Survey Date: 6/27/2017
