Memorandum

March 4, 2019

RE: Lower Fox River OU4 *COMMP* Year 0 Cap Integrity Assessment – Caps Completed 2015-2017

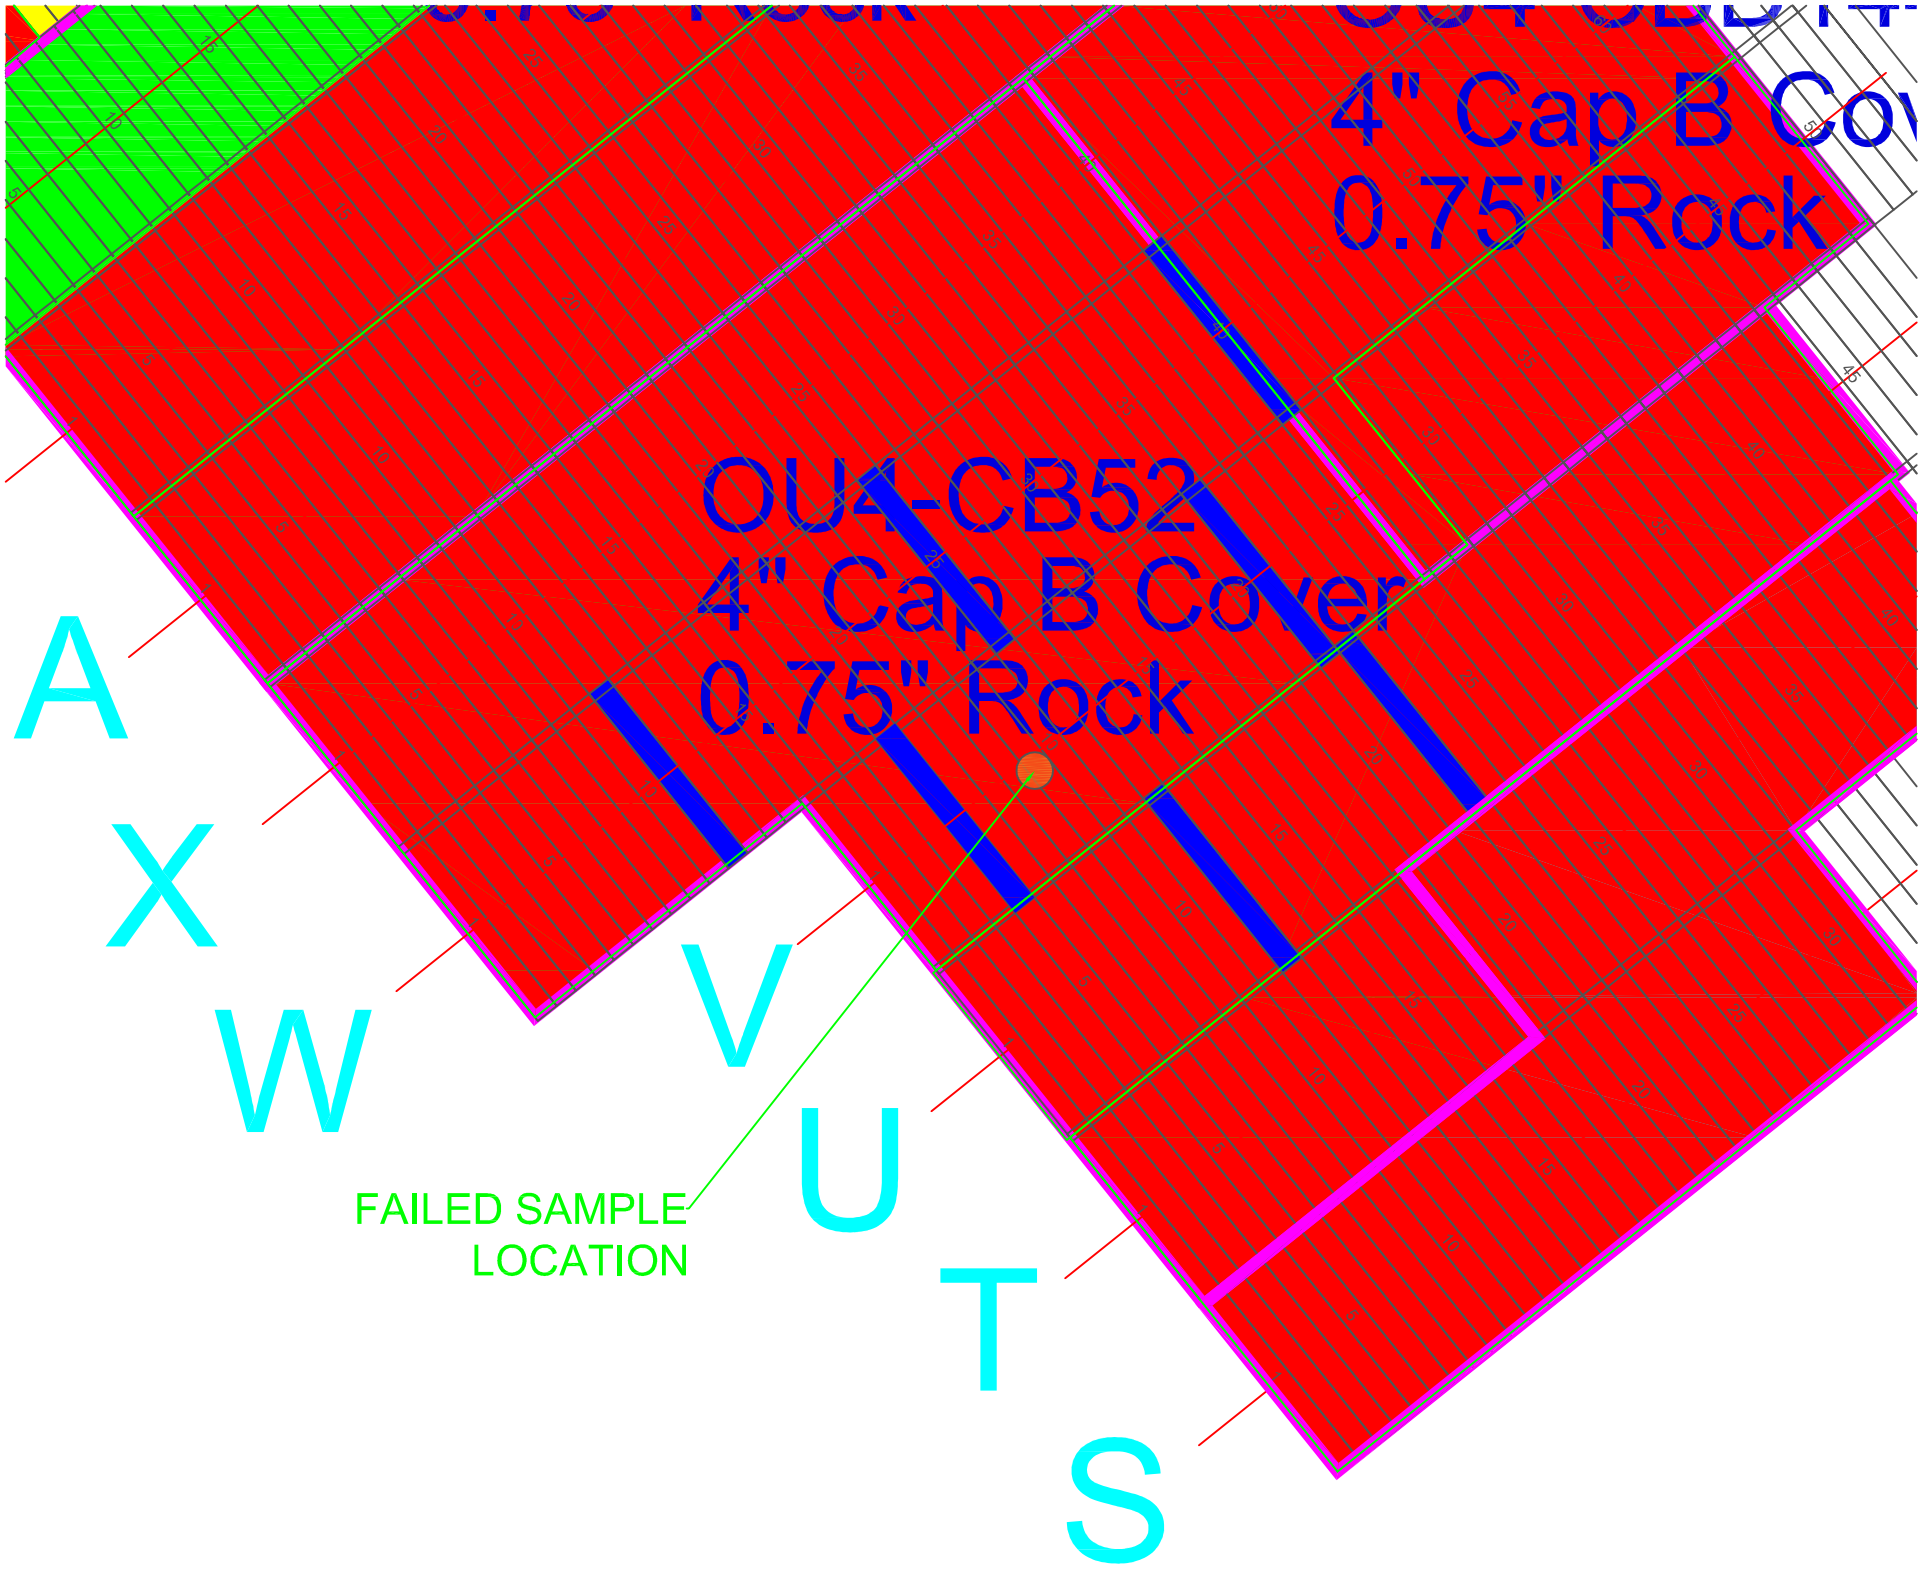
CB52 QC SAMPLE LOG

Verification samples were collected in 11 locations within OU4-CB52-1. 10 of 11 samples meet or exceed the minimum thickness requirement of 4-inches. Tetra Tech recommends use of J.F. Brennan QC data to accept this area on an exception basis.

4" Cap B Cov
0.75" Rock
OU4-CB52
4" Cap B Cover
0.75" Rock
A
X
W
V
U
T
S
FAILED SAMPLE
LOCATION

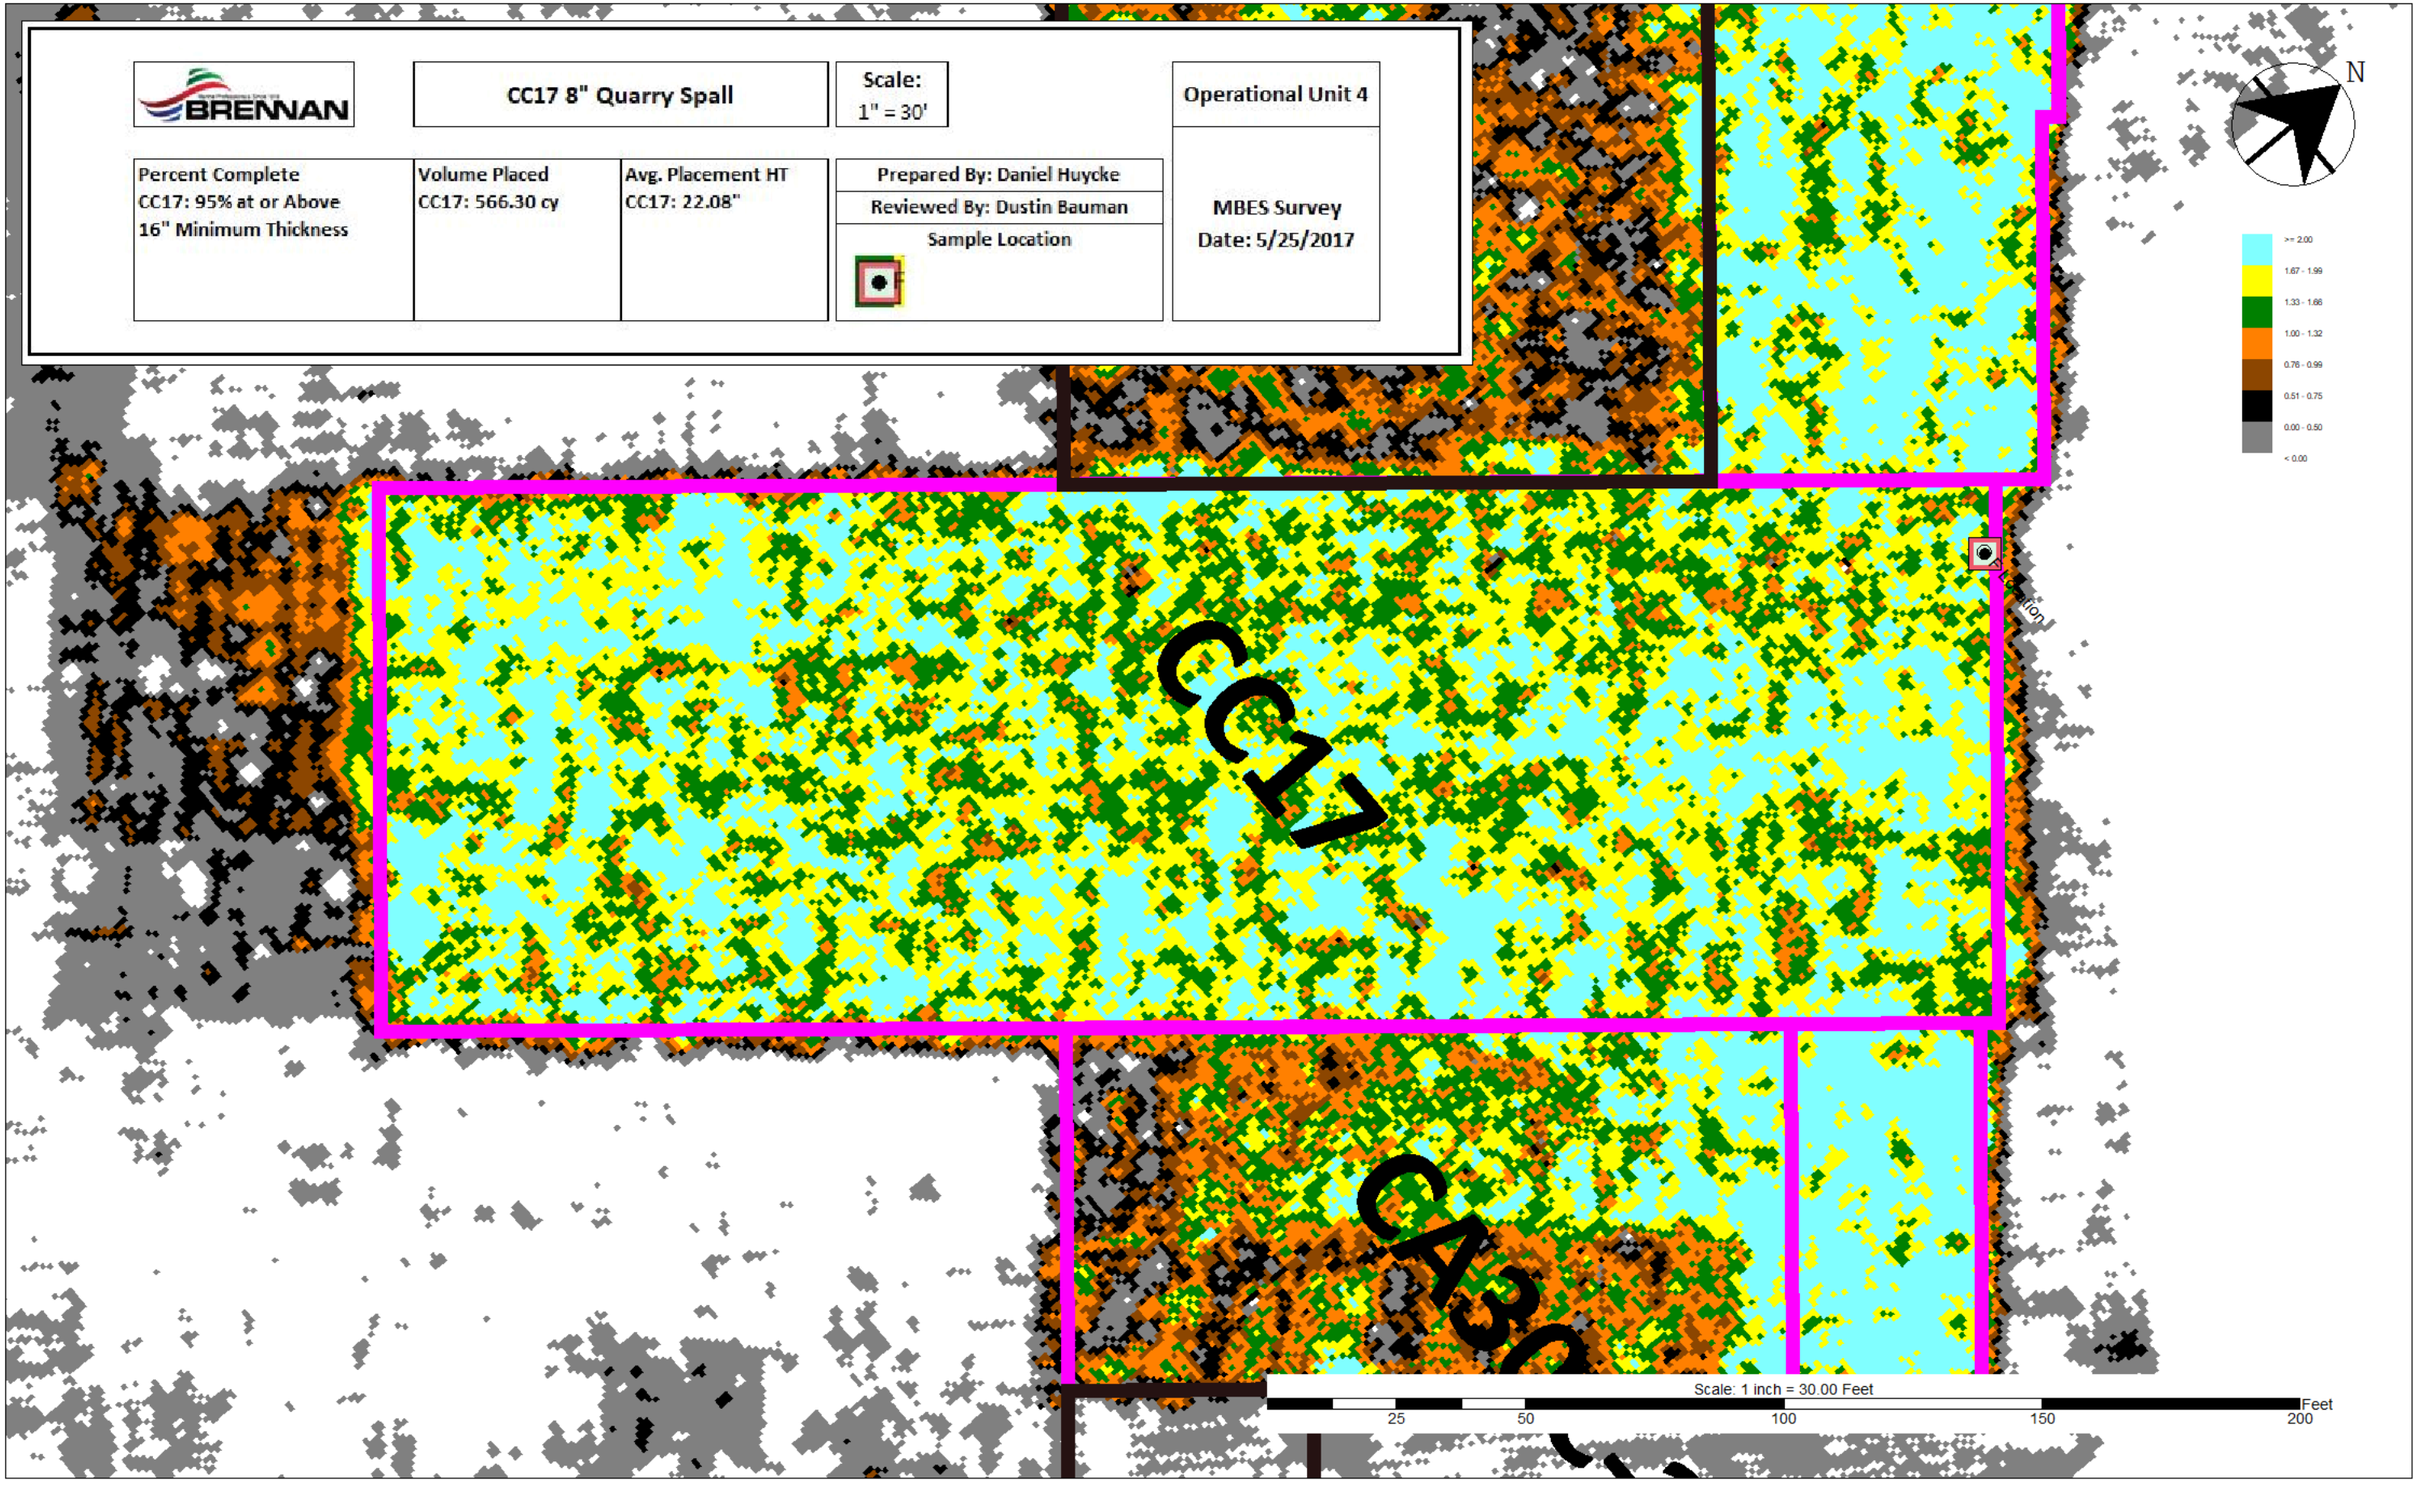
CC17 8" Quarry Spall	Scale: 1" = 30'	Operational Unit 4

Percent Complete CC17: 95% at or Above 16" Minimum Thickness	Volume Placed CC17: 566.30 cy	Avg. Placement HT CC17: 22.08"	Prepared By: Daniel Huycke Reviewed By: Dustin Bauman Sample Location	MBES Survey Date: 5/25/2017

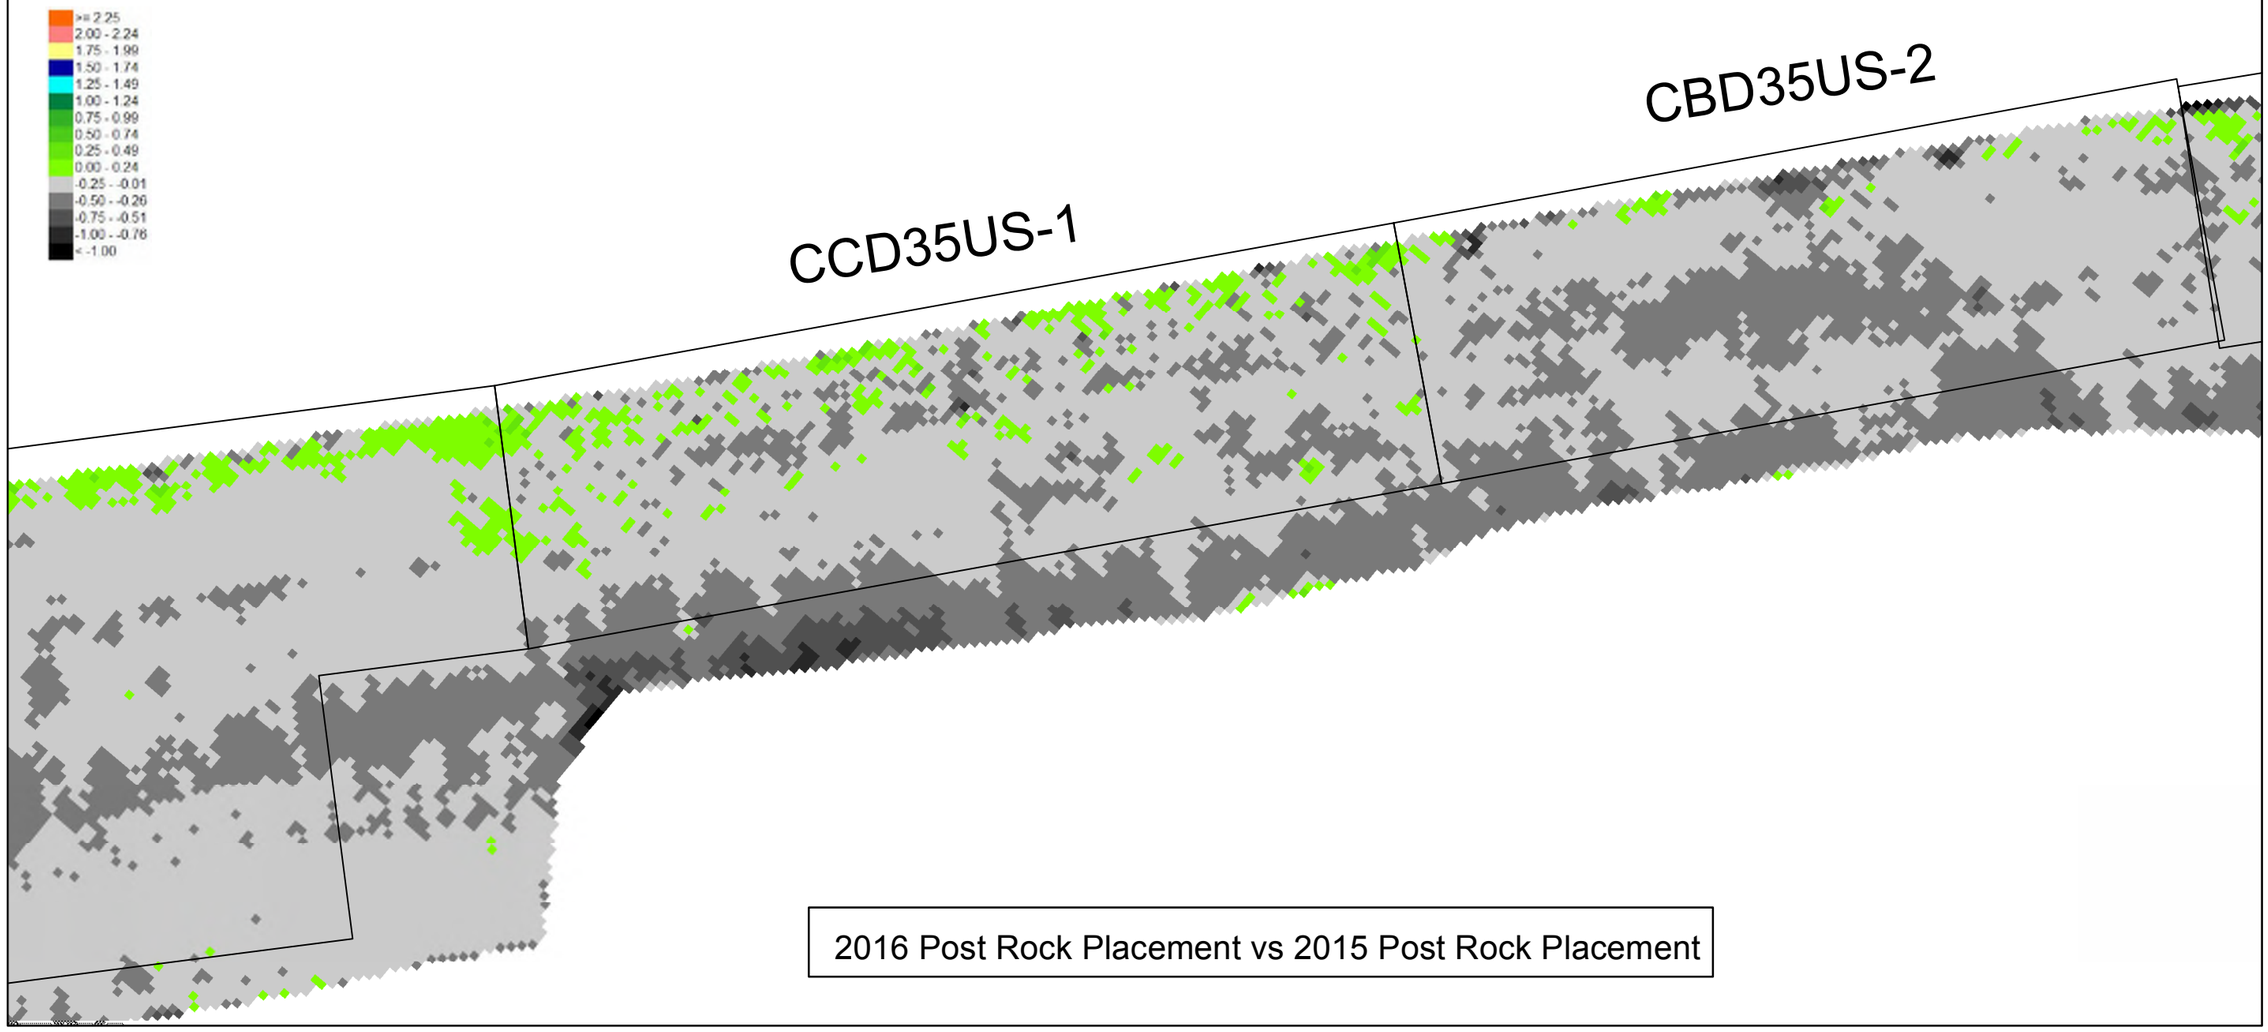
2016 OU2-5 Fox River Enviromental Remediation CCD35US-2

2016 Post Rock Placement vs 2015 Post Rock Placement

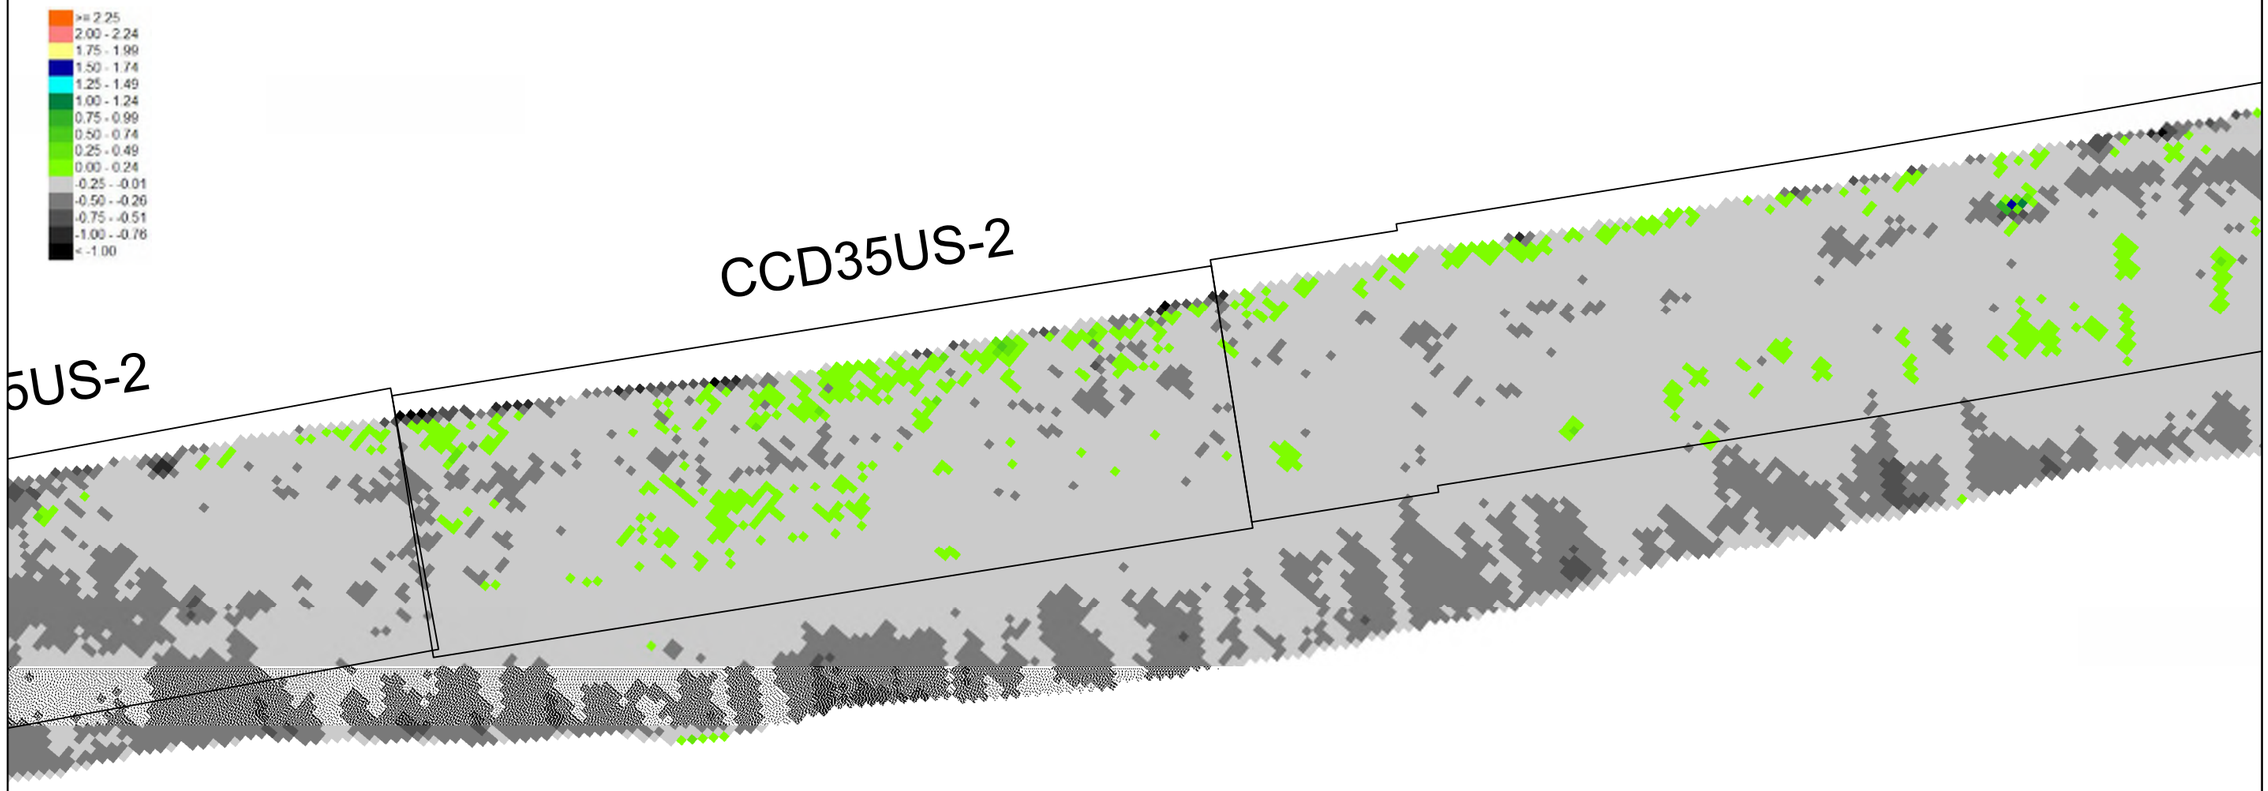
2016 Post Rock Placement vs 2015 Post Rock Placement

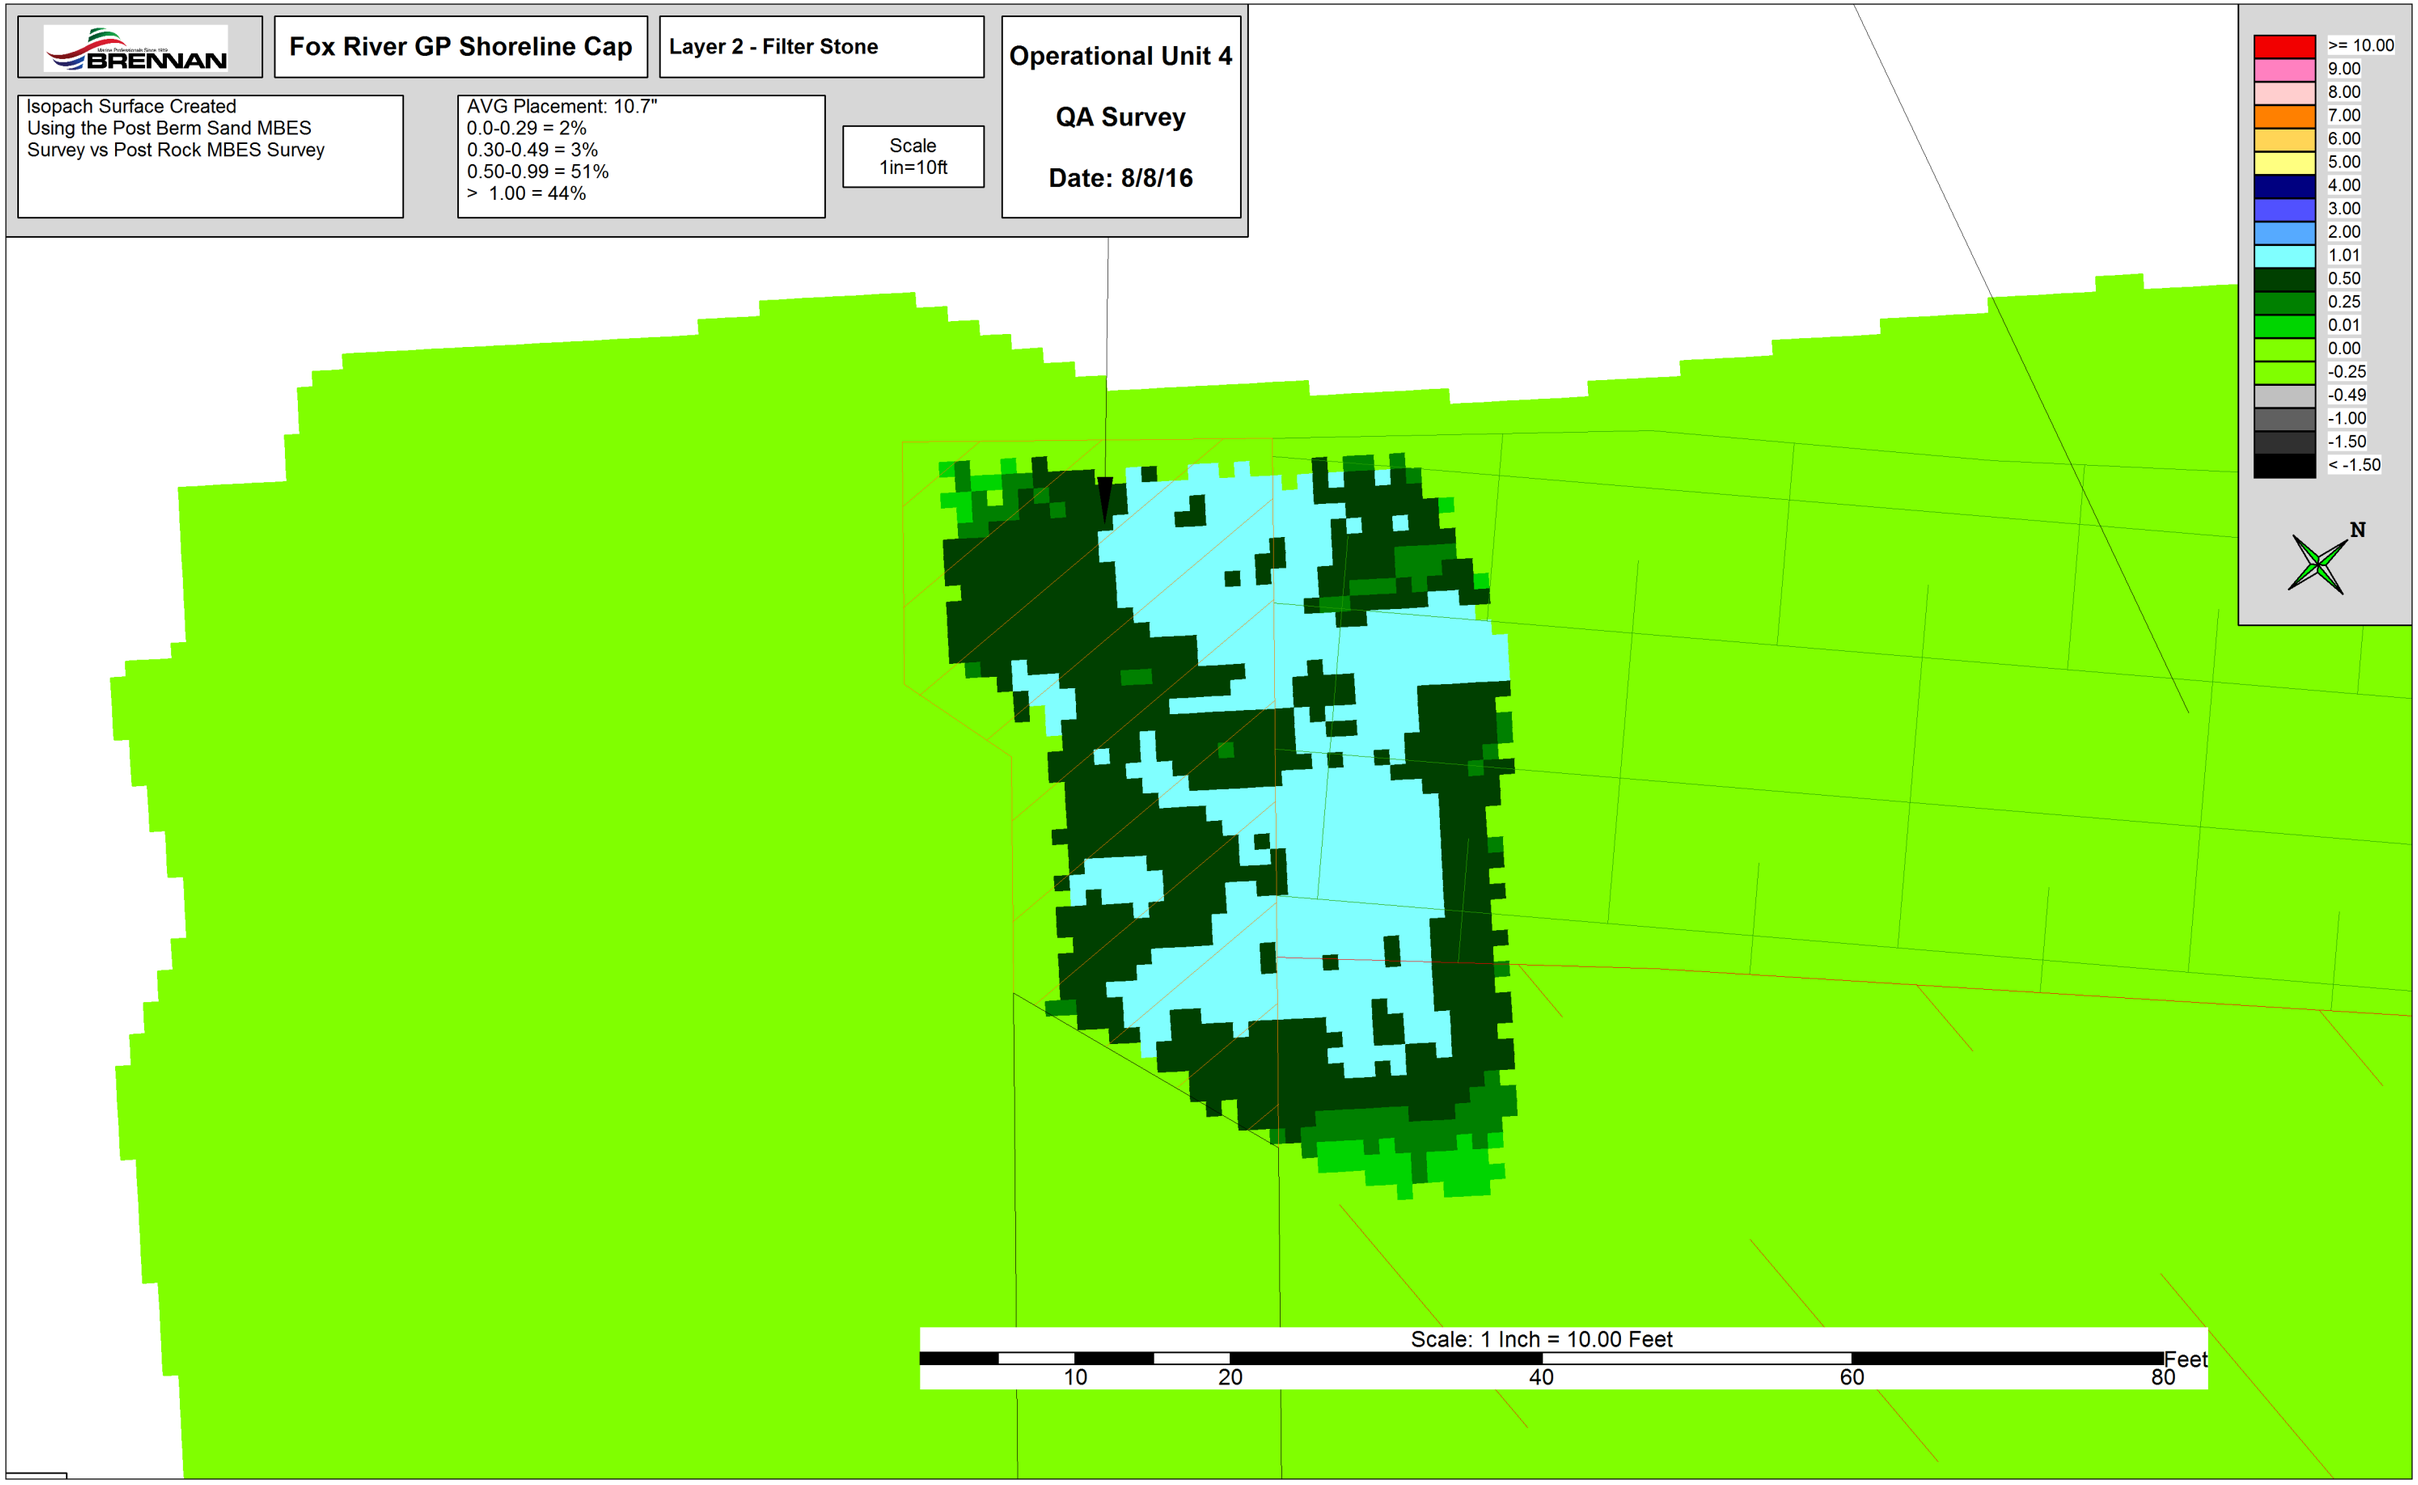
AVG Placement: 10.7"
0.0-0.29 = 2%
0.30-0.49 = 3%
0.50-0.99 = 51%
> 1.00 = 44%

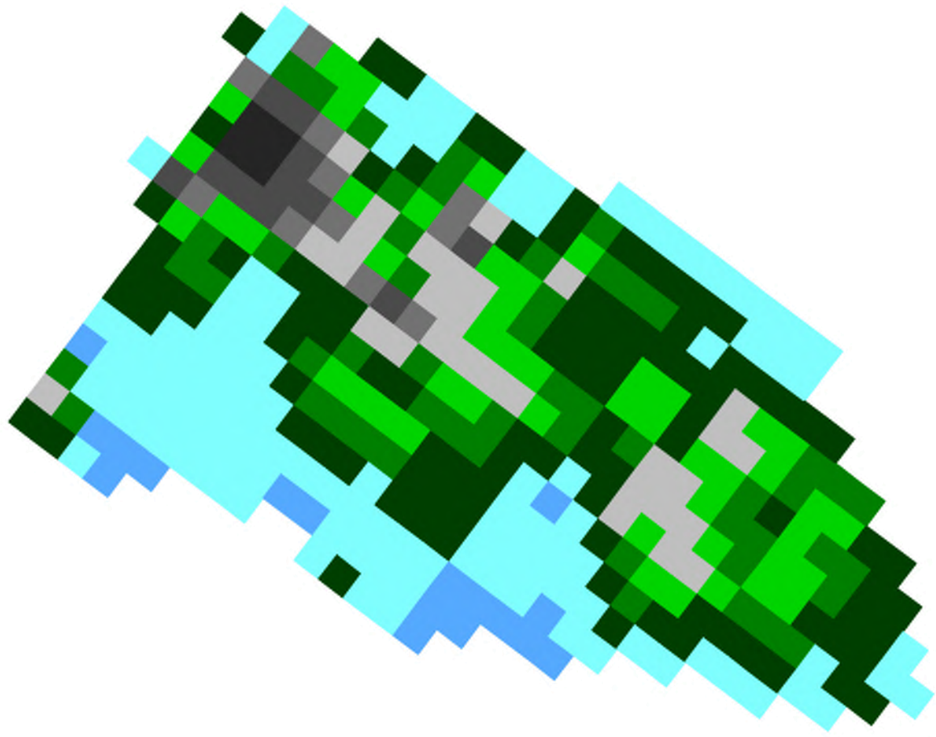
Values Below Design are Gray/Black and all other Colors Represent Placement that is Above Design

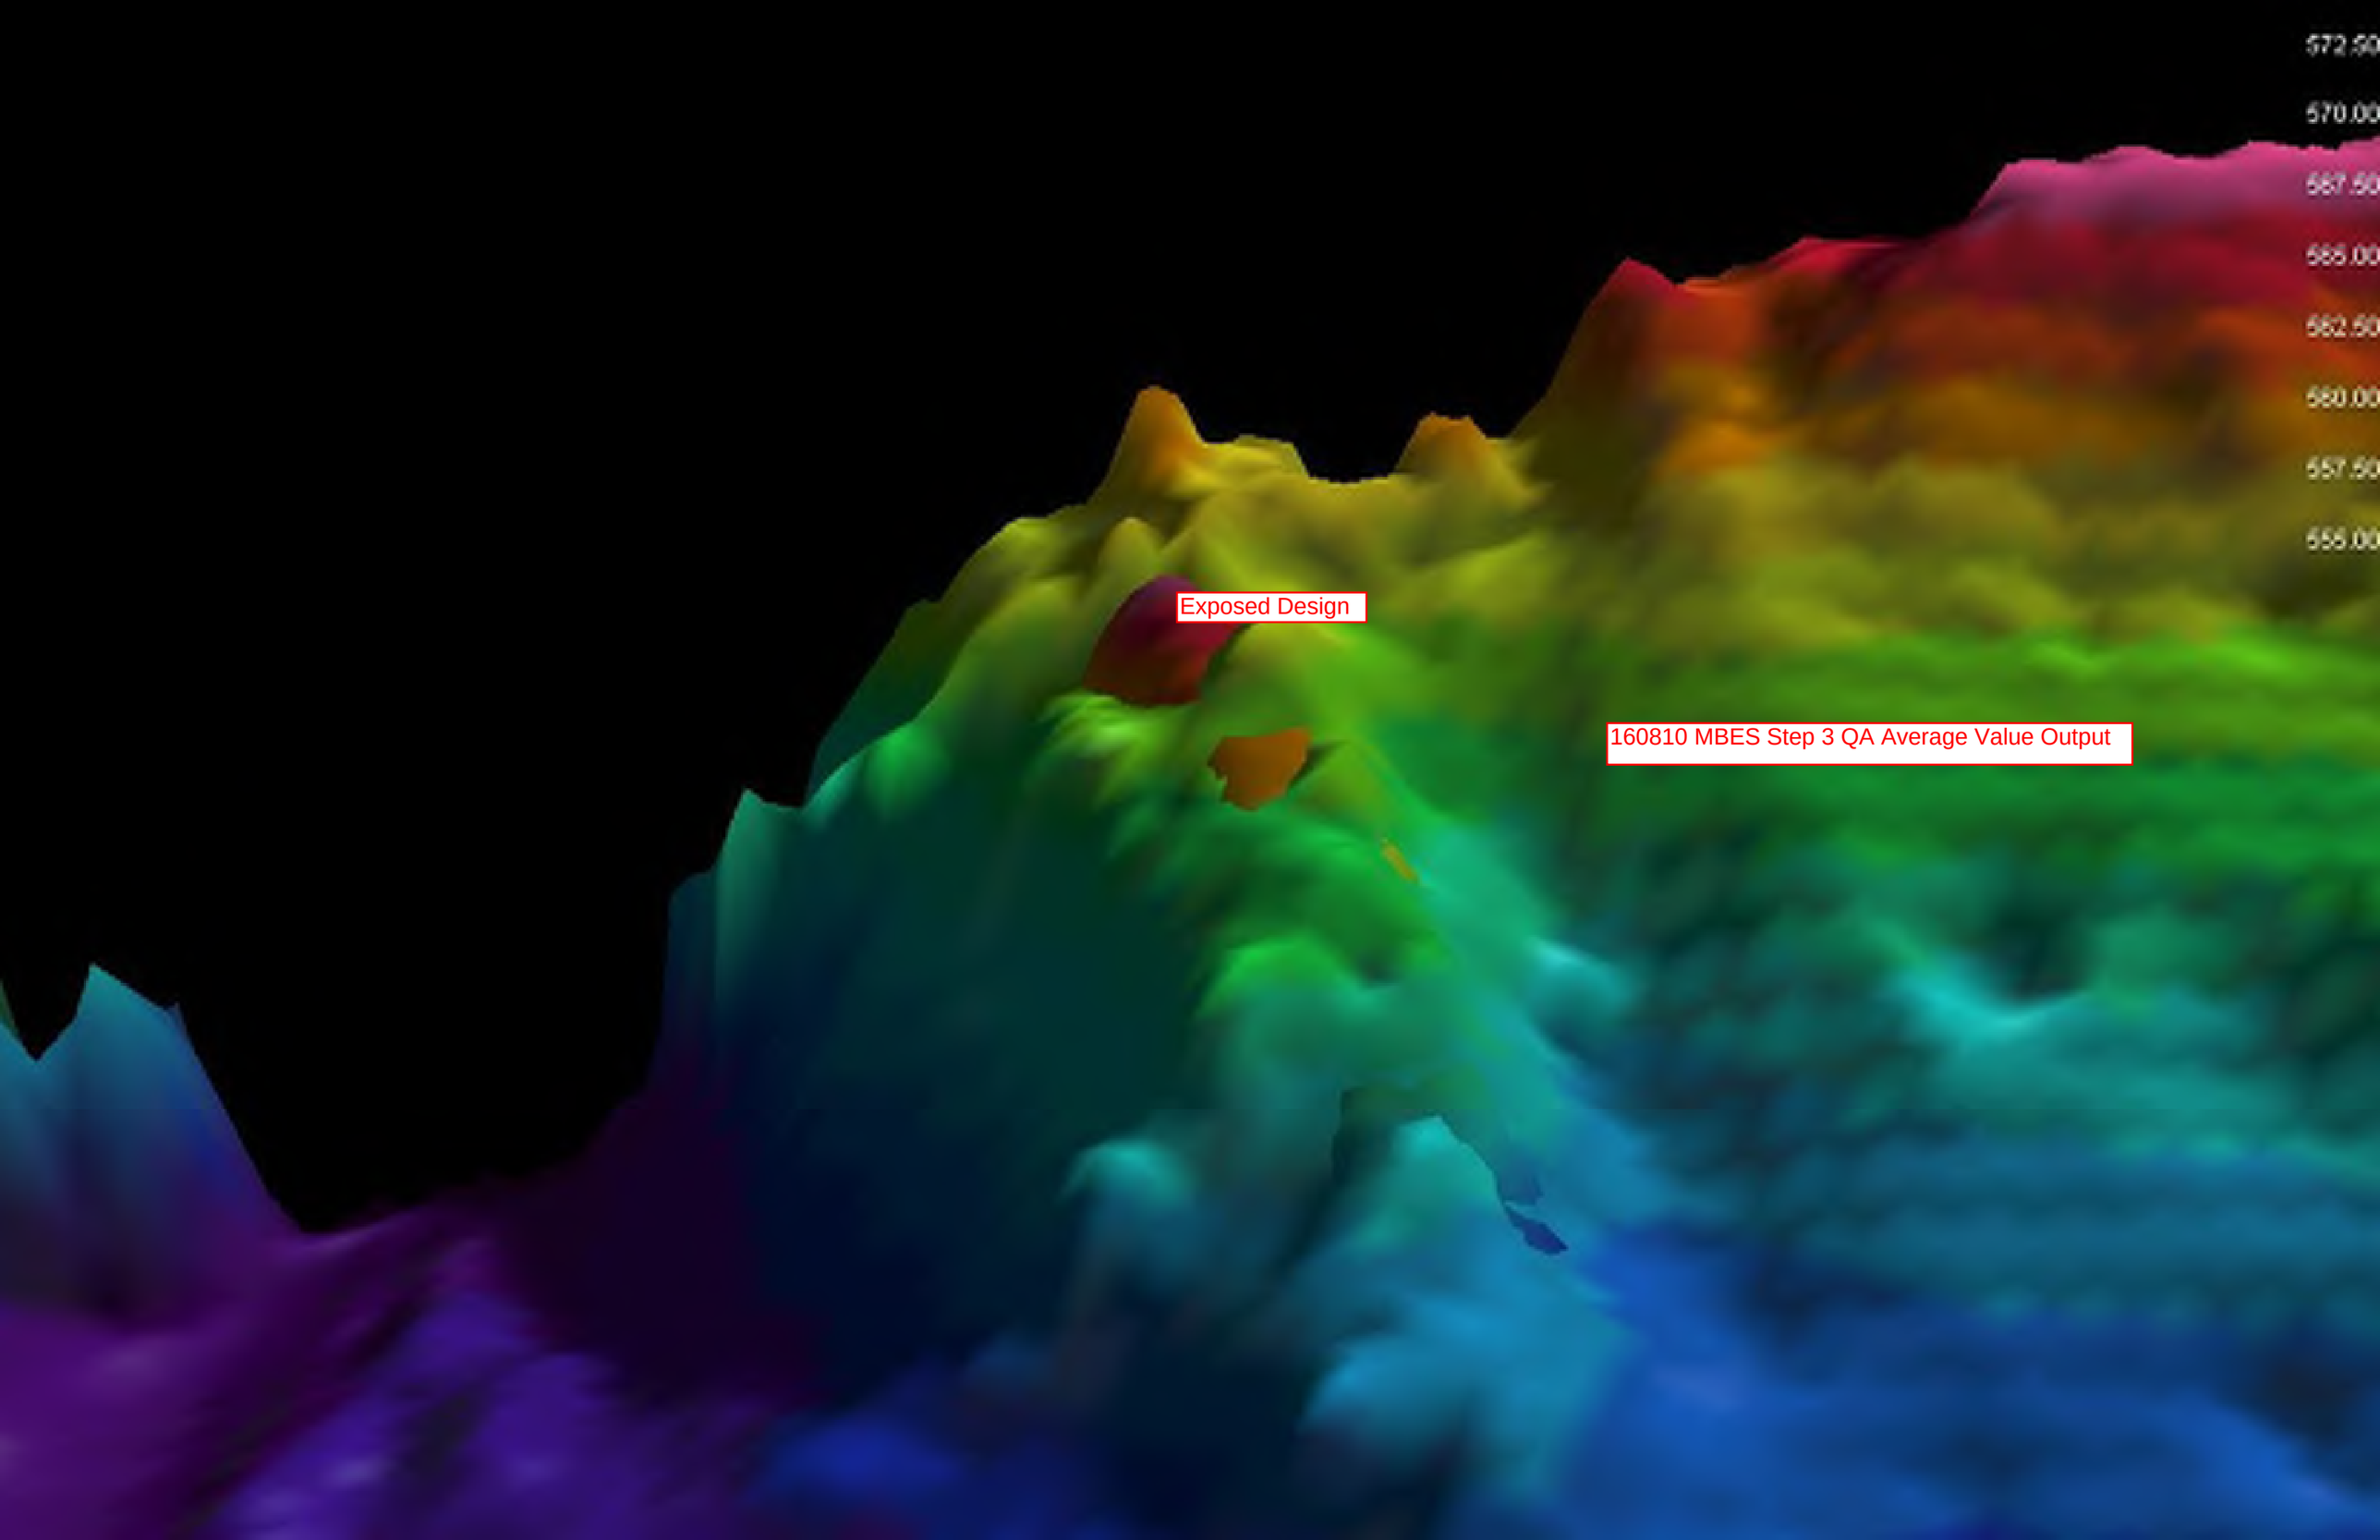
572.50
570.00
567.50
565.00
562.50
560.00
557.50
555.00
Exposed Design
160810 MBES Step 3 QA Average Value Output

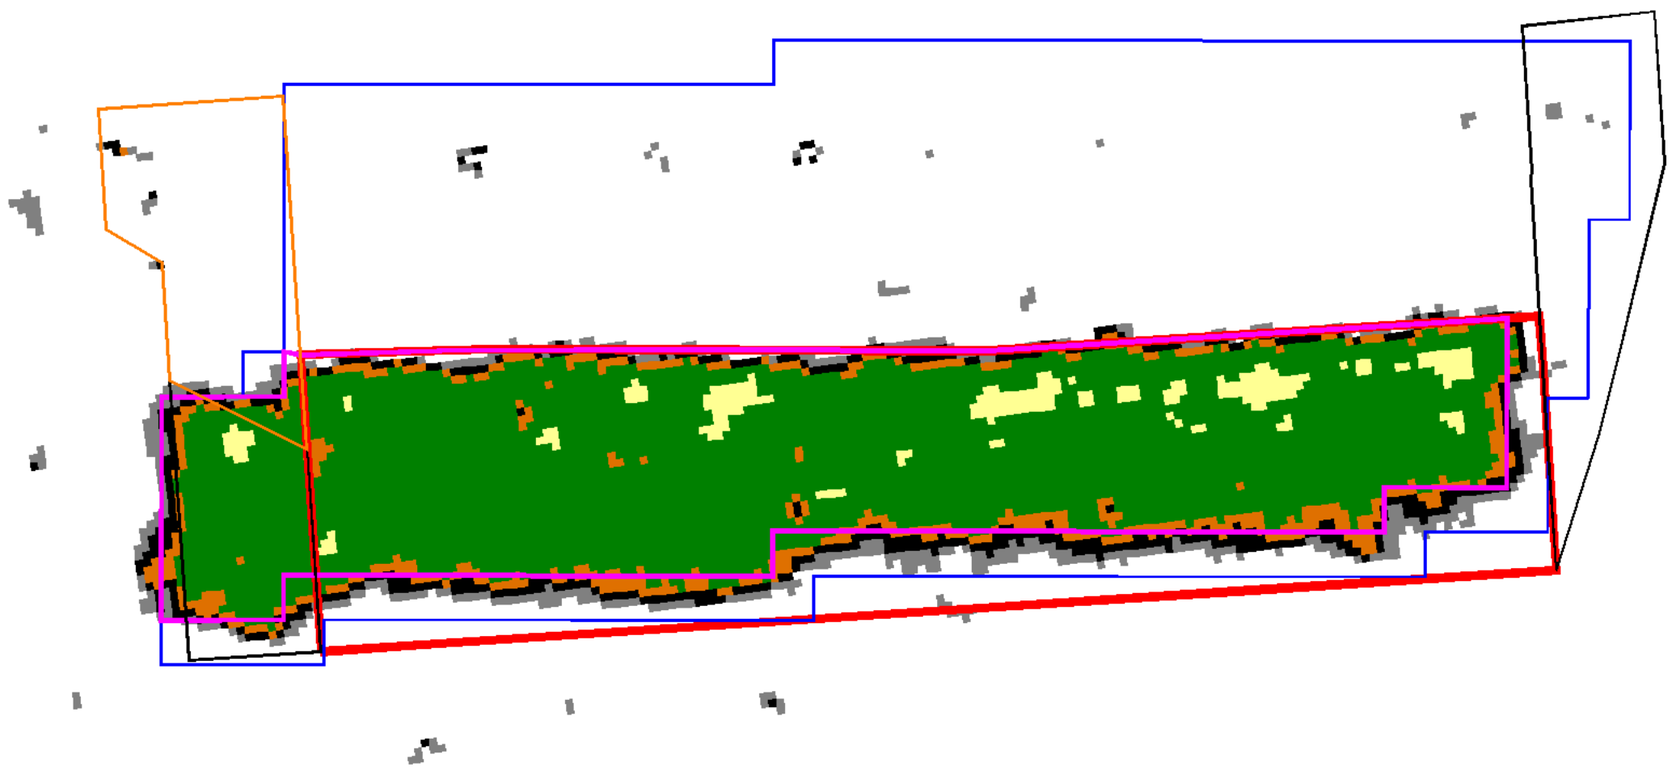
SHC100-CC100
Layer 7 Quarry Spall
Isopach Based on
160830 MBES QA Survey vs.
160826 MBES QA Survey

Per our OTS earlier with the Agencies, Foth, Tetra Tech and Brennan attached is the submittal for approval of placement of layer 7 quarry spall. As discussed in the OTS 86% of the area meets or exceeds the 12 inch minimum thickness. It is understood that after the placement of CB20 and cap extensions to the north, further quarry spall will be required to meet the extents of CC100.
